# Table of Contents

OLD CANTON BRIDGE SIGNED APPLICATION.pdf .....	104
WASHBURN BRIDGE SIGNED APPLICATION.pdf .....	106

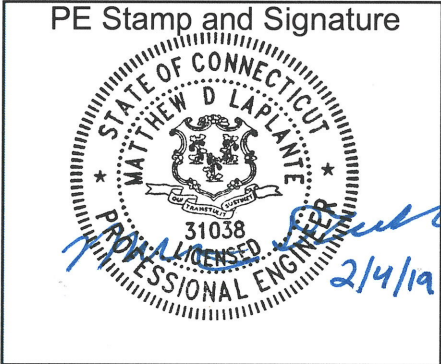
**INSPECTION REPORT**

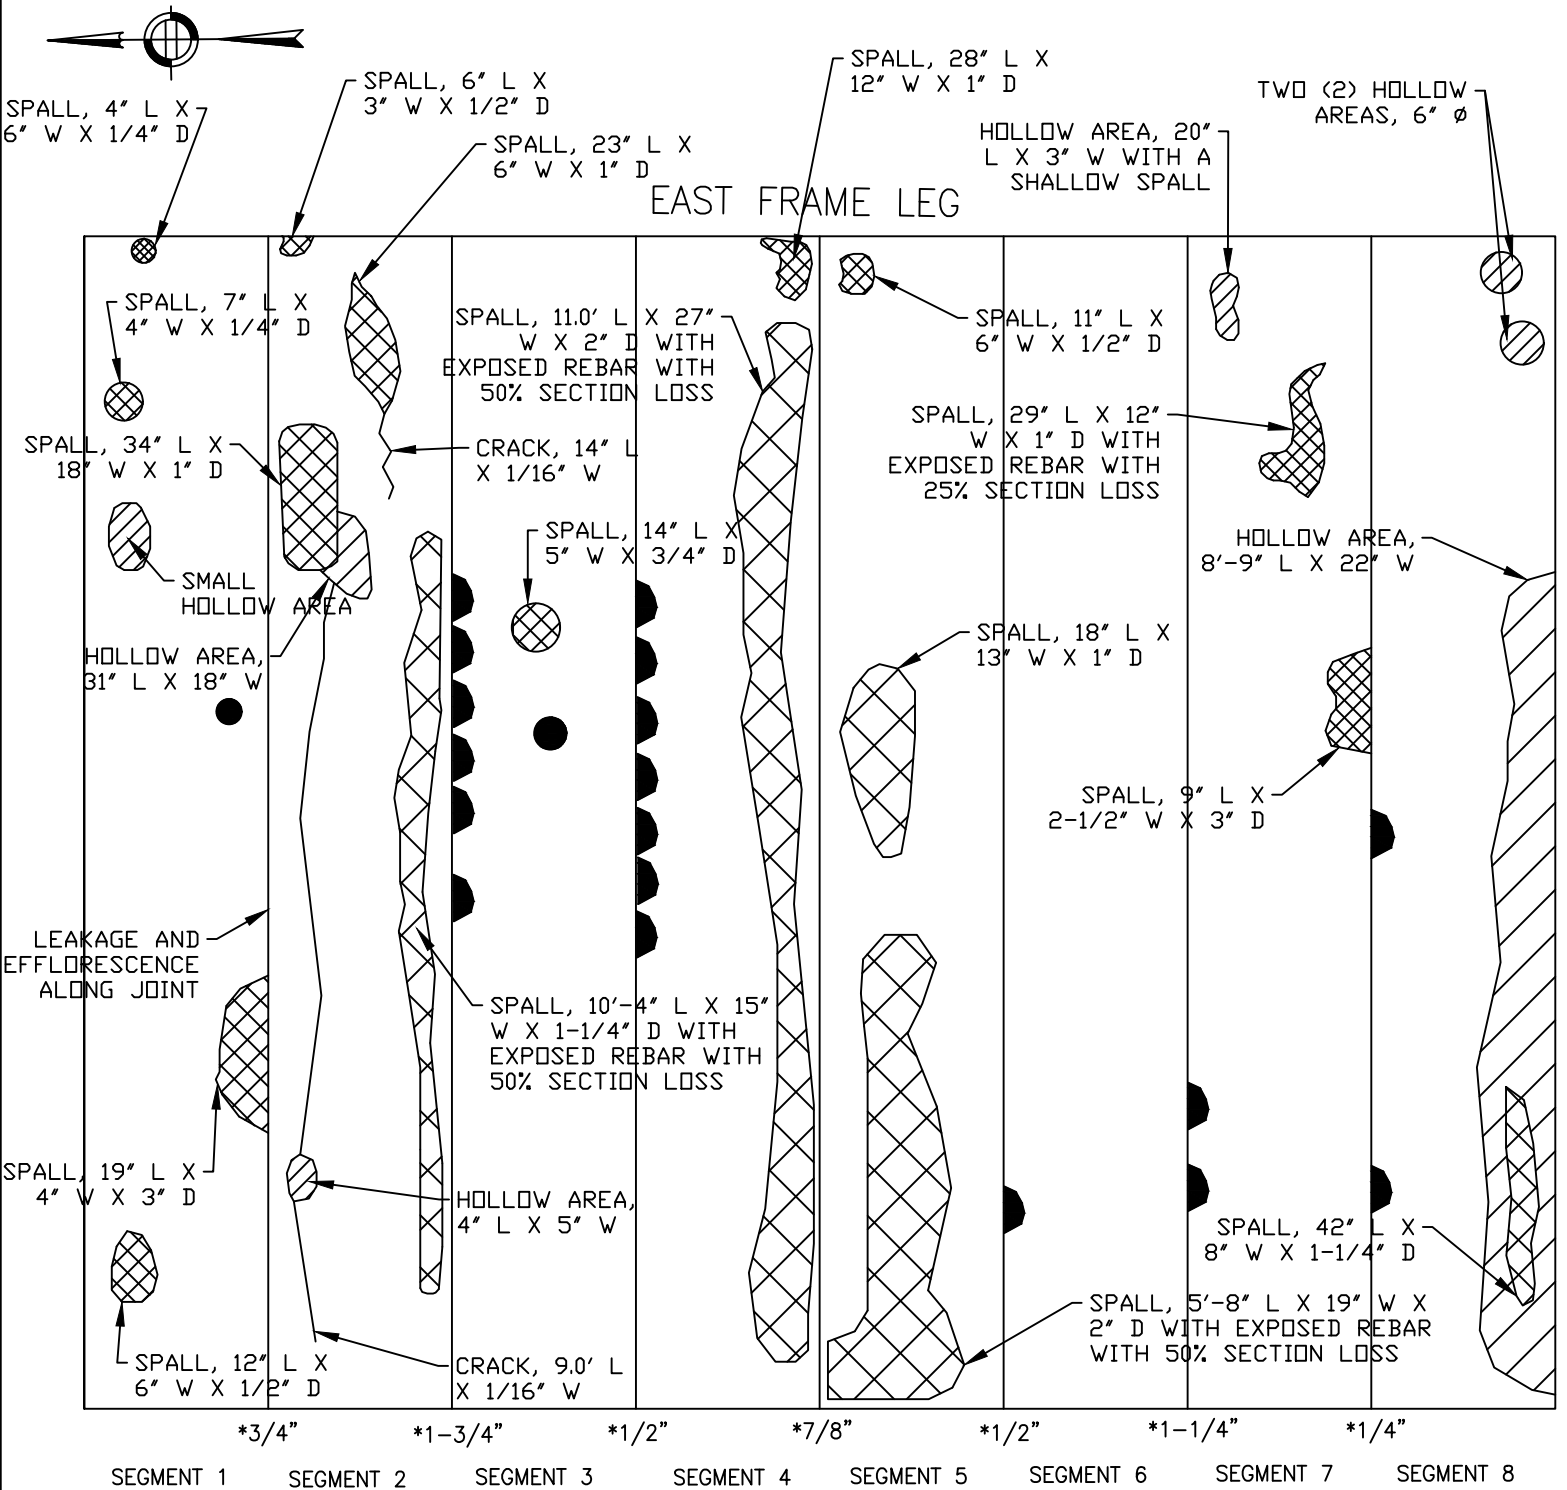
- MINOR SPALL
- ▨ HOLLOW AREA
- ⊗ SPALL
- \* JOINT DIFFERENTIAL

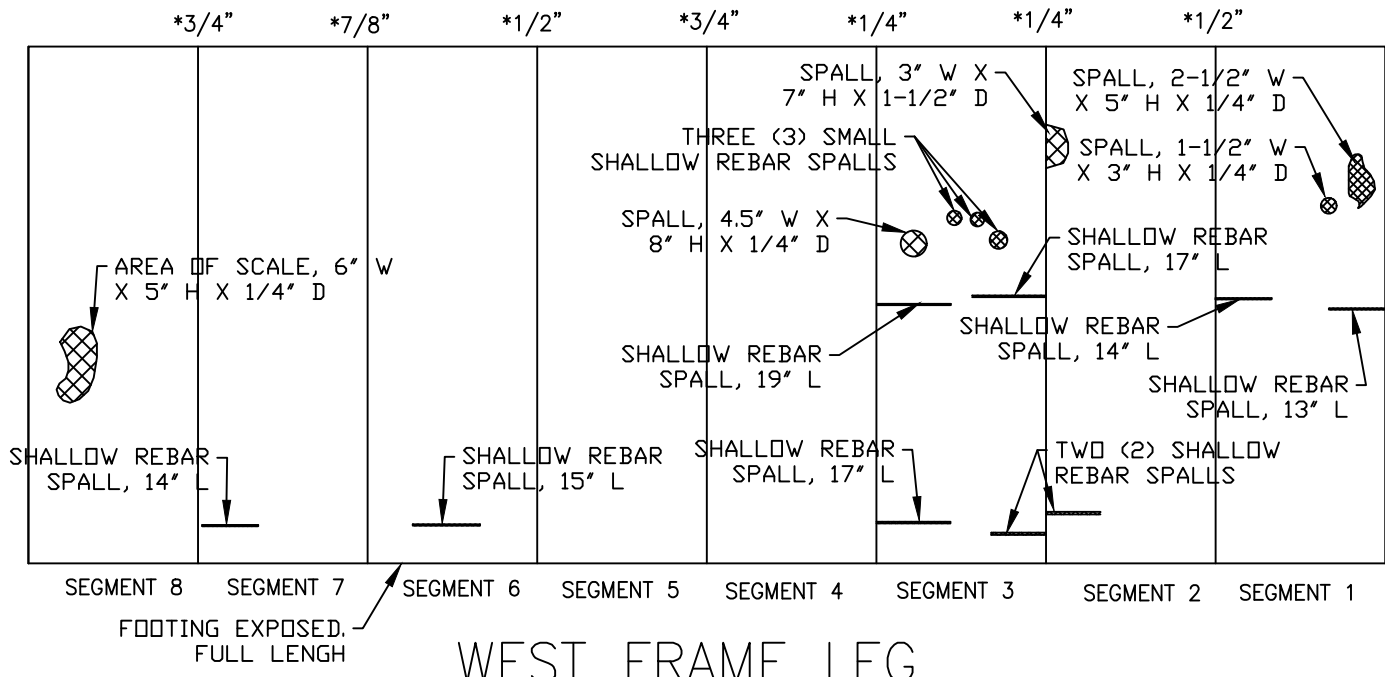
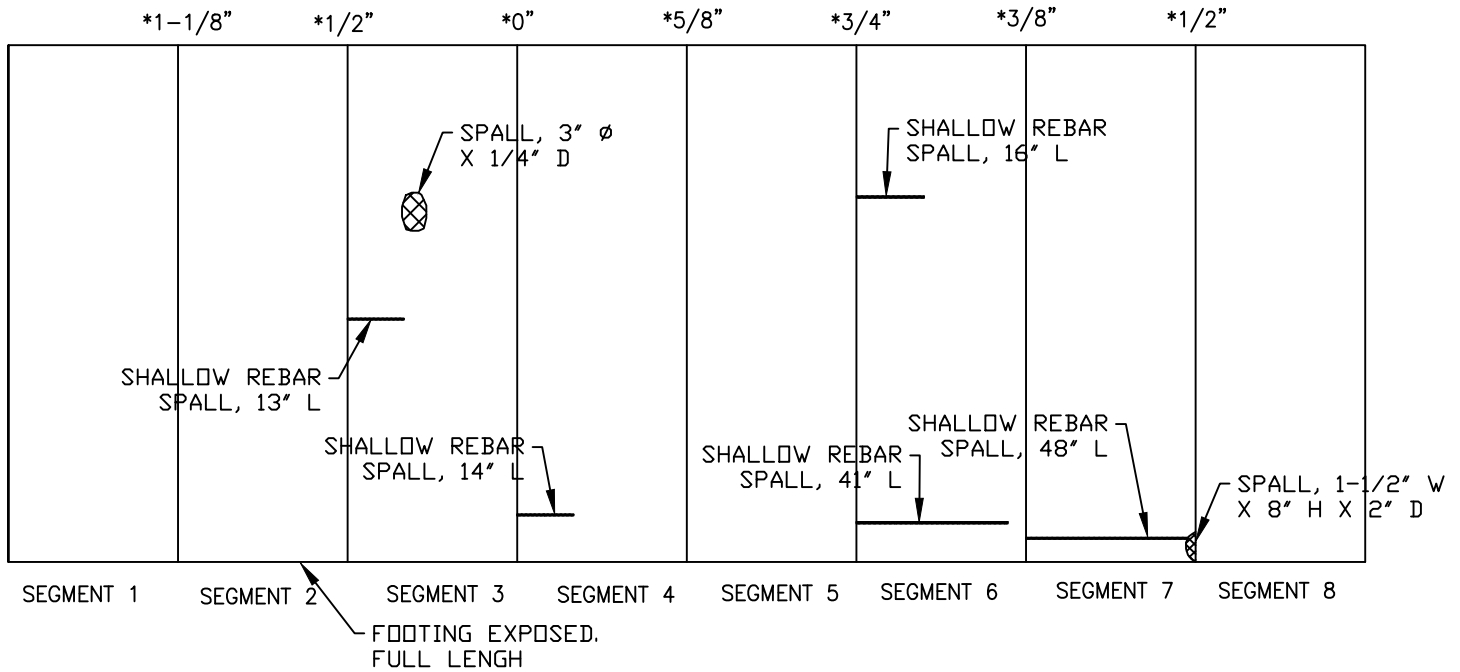
- MINOR SPALL
- ⊘ HOLLOW AREA
- ⊗ SPALL
- JOINT
- \* DIFFERENTIAL

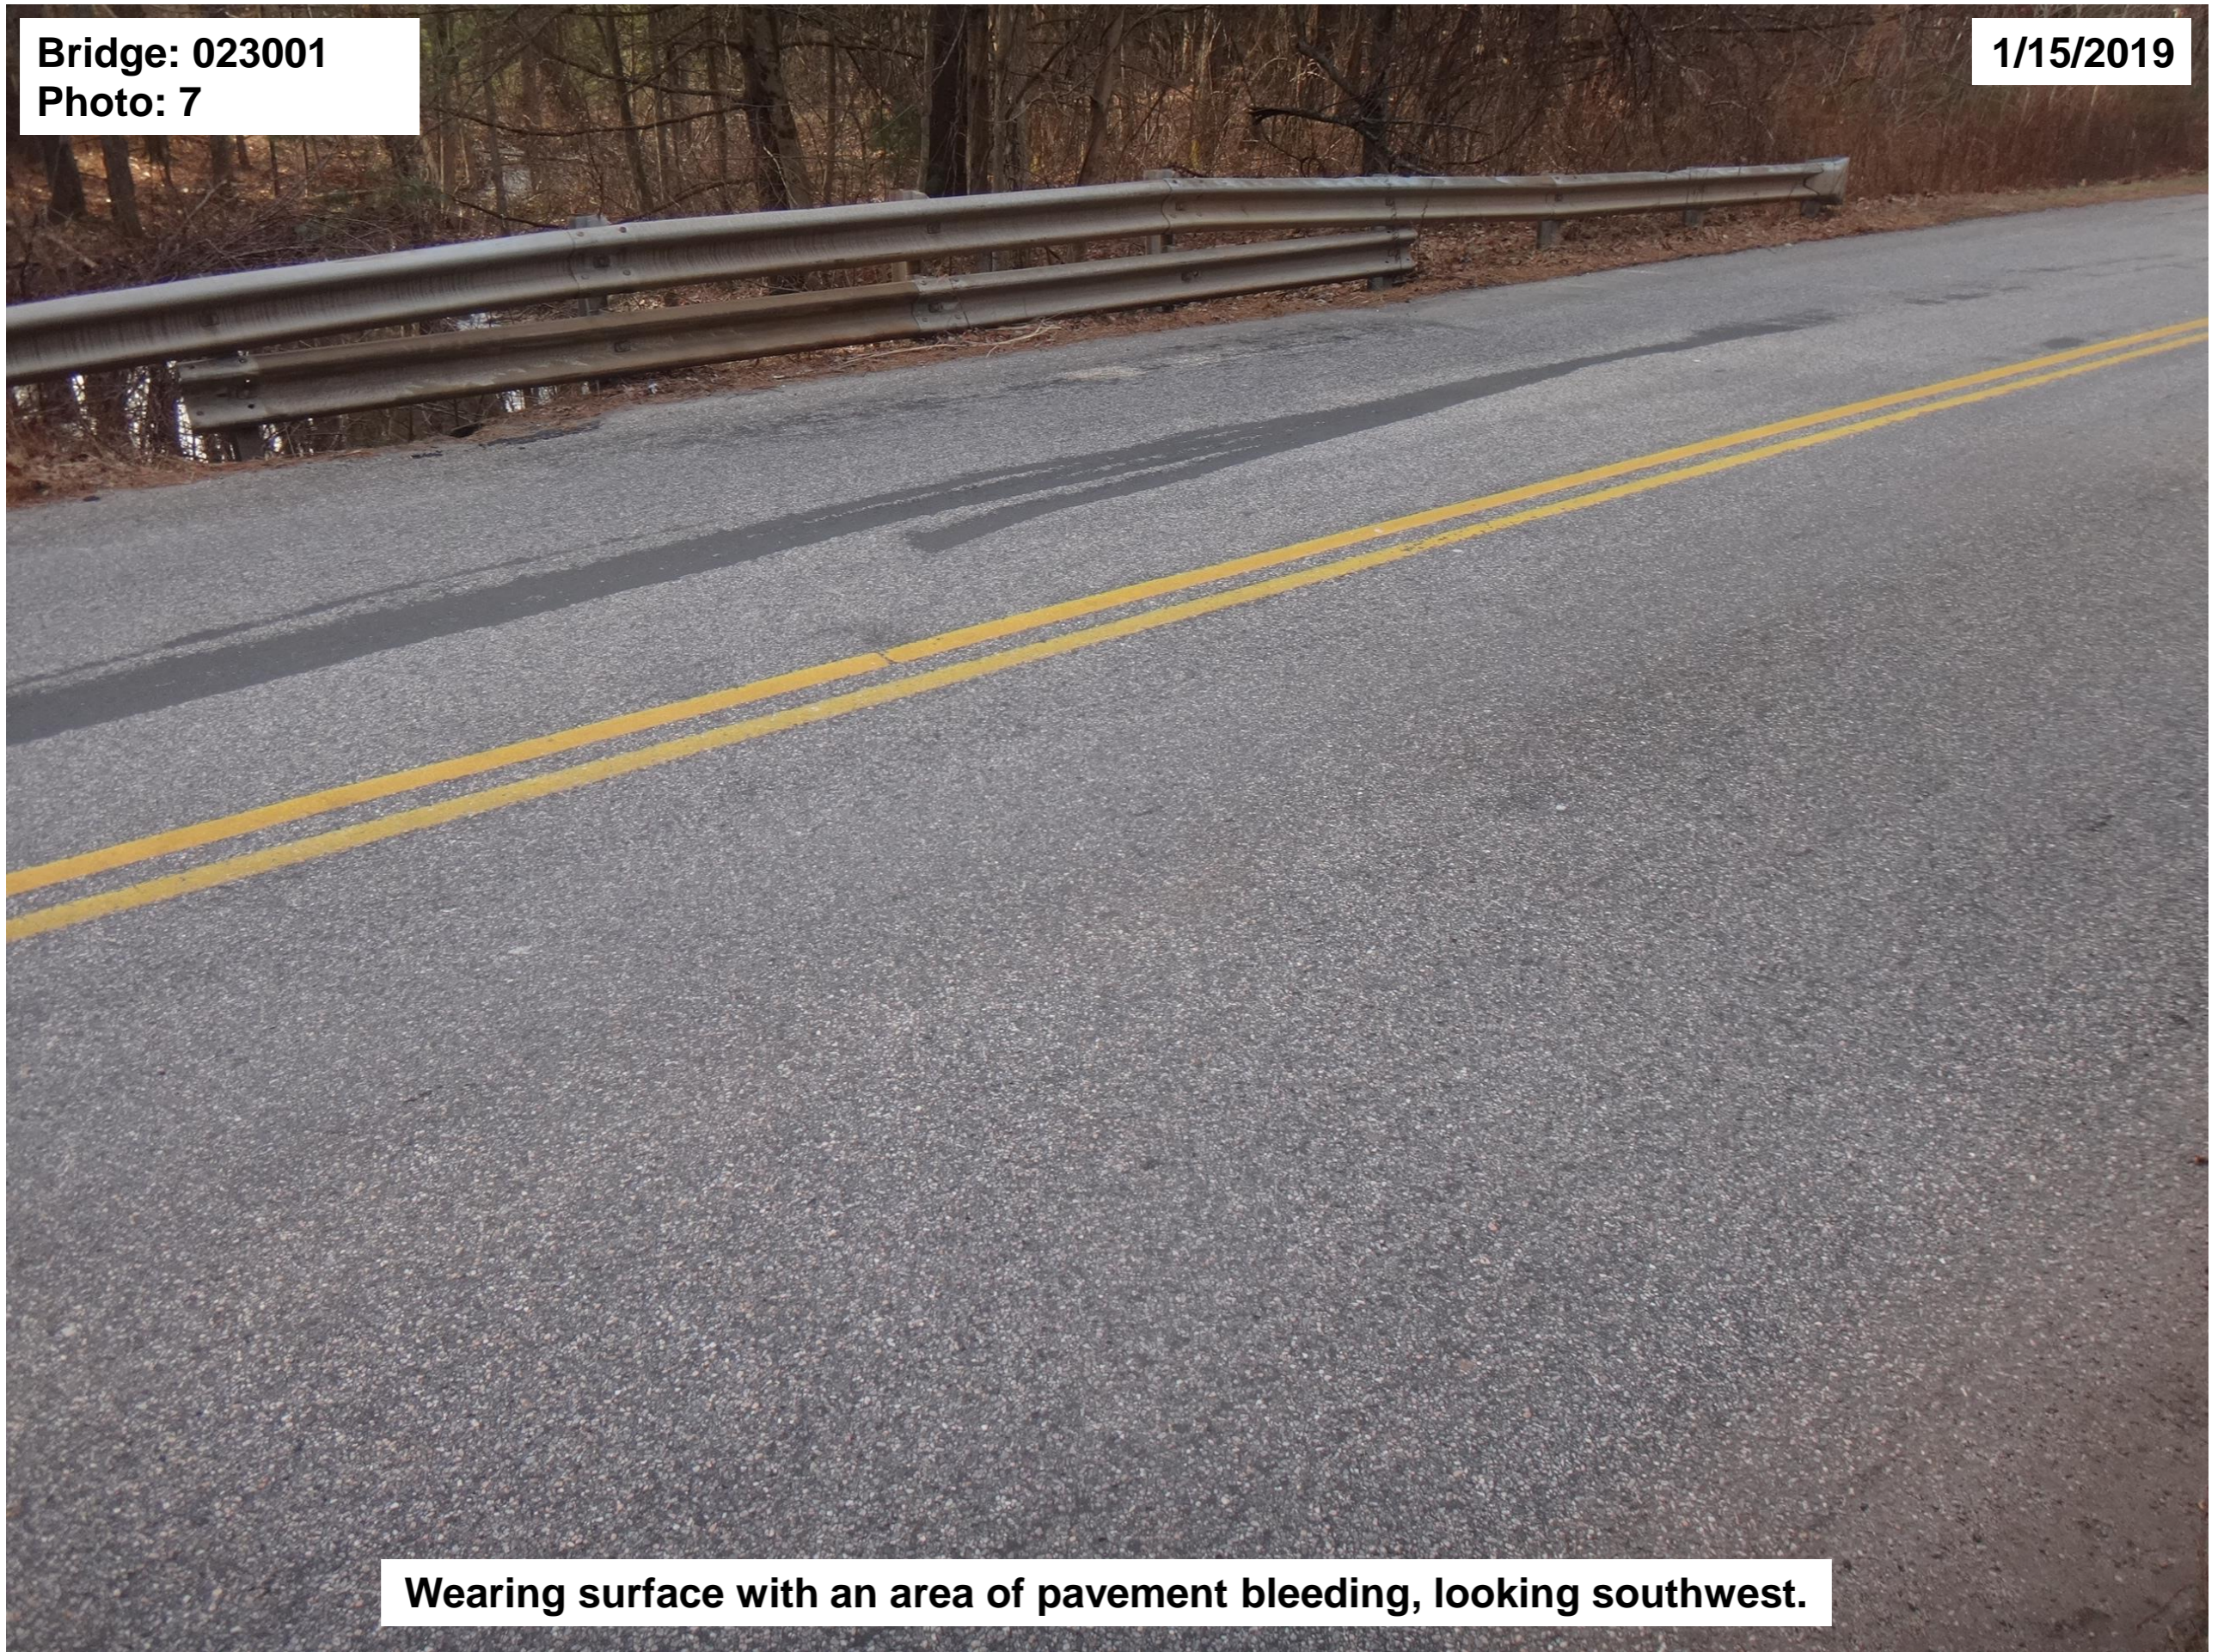
**Bridge: 023001**  
**Photo: 8**

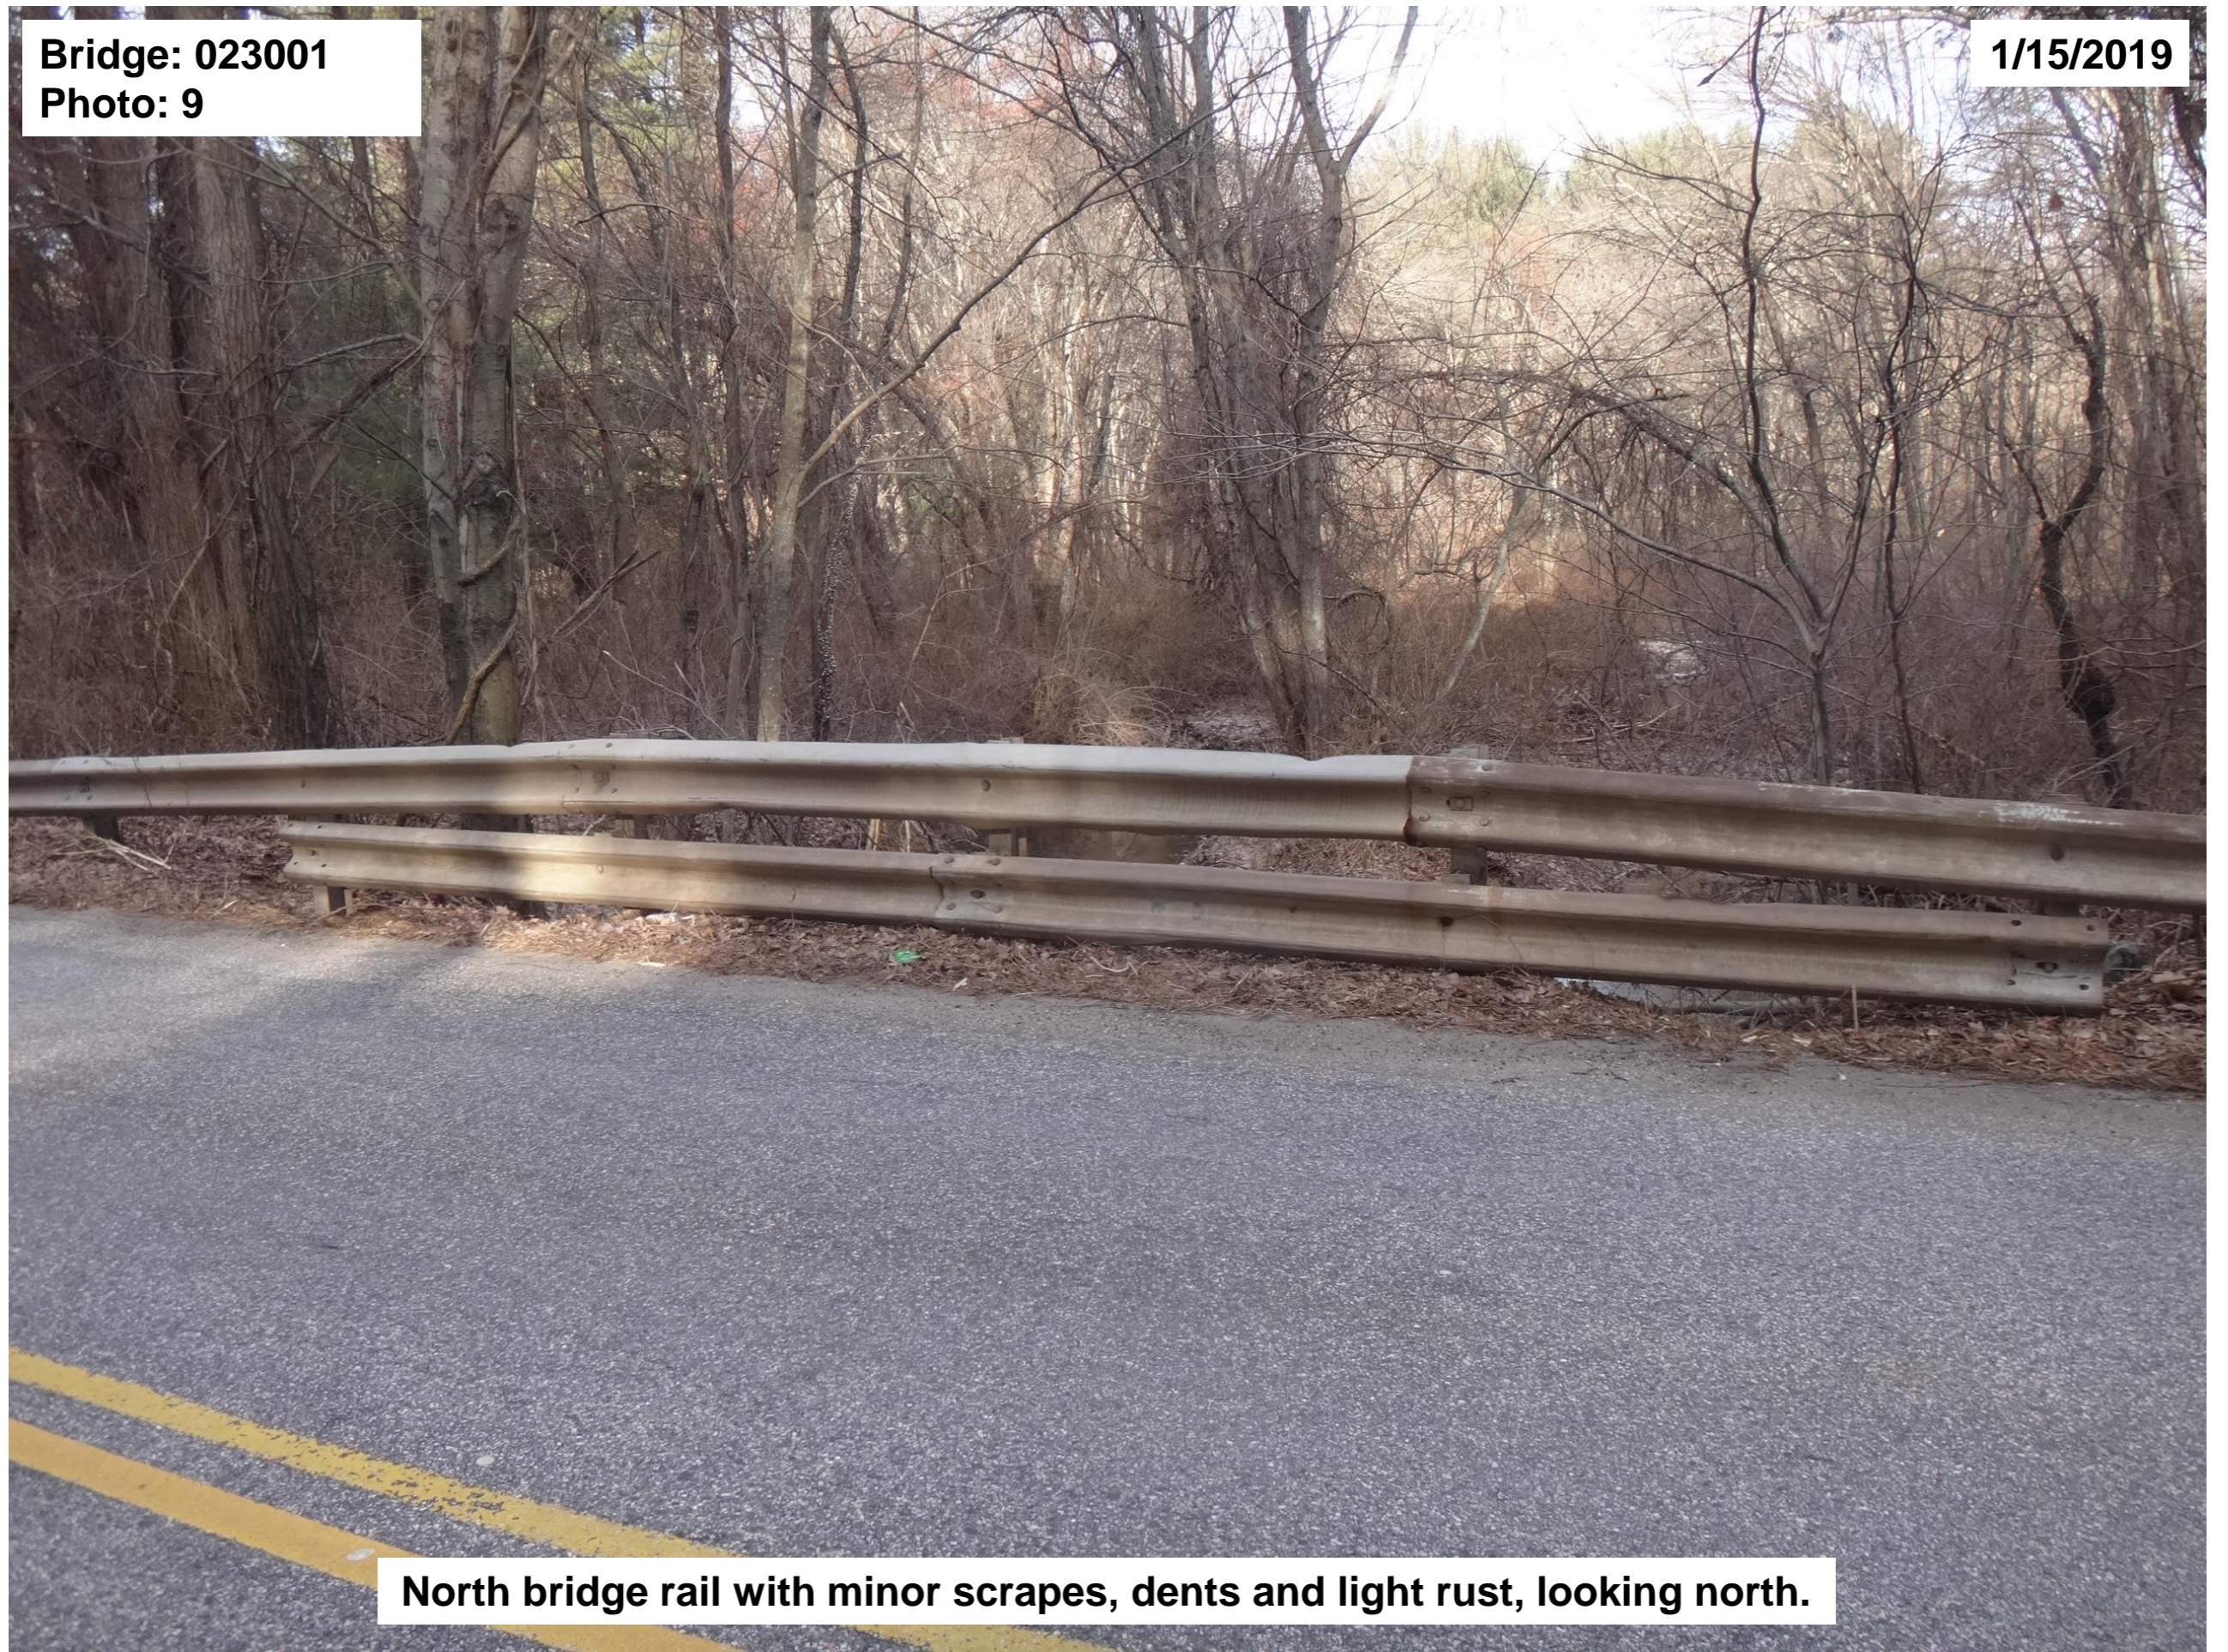
**North bridge rail with minor scrapes, dents and light rust, looking north.**

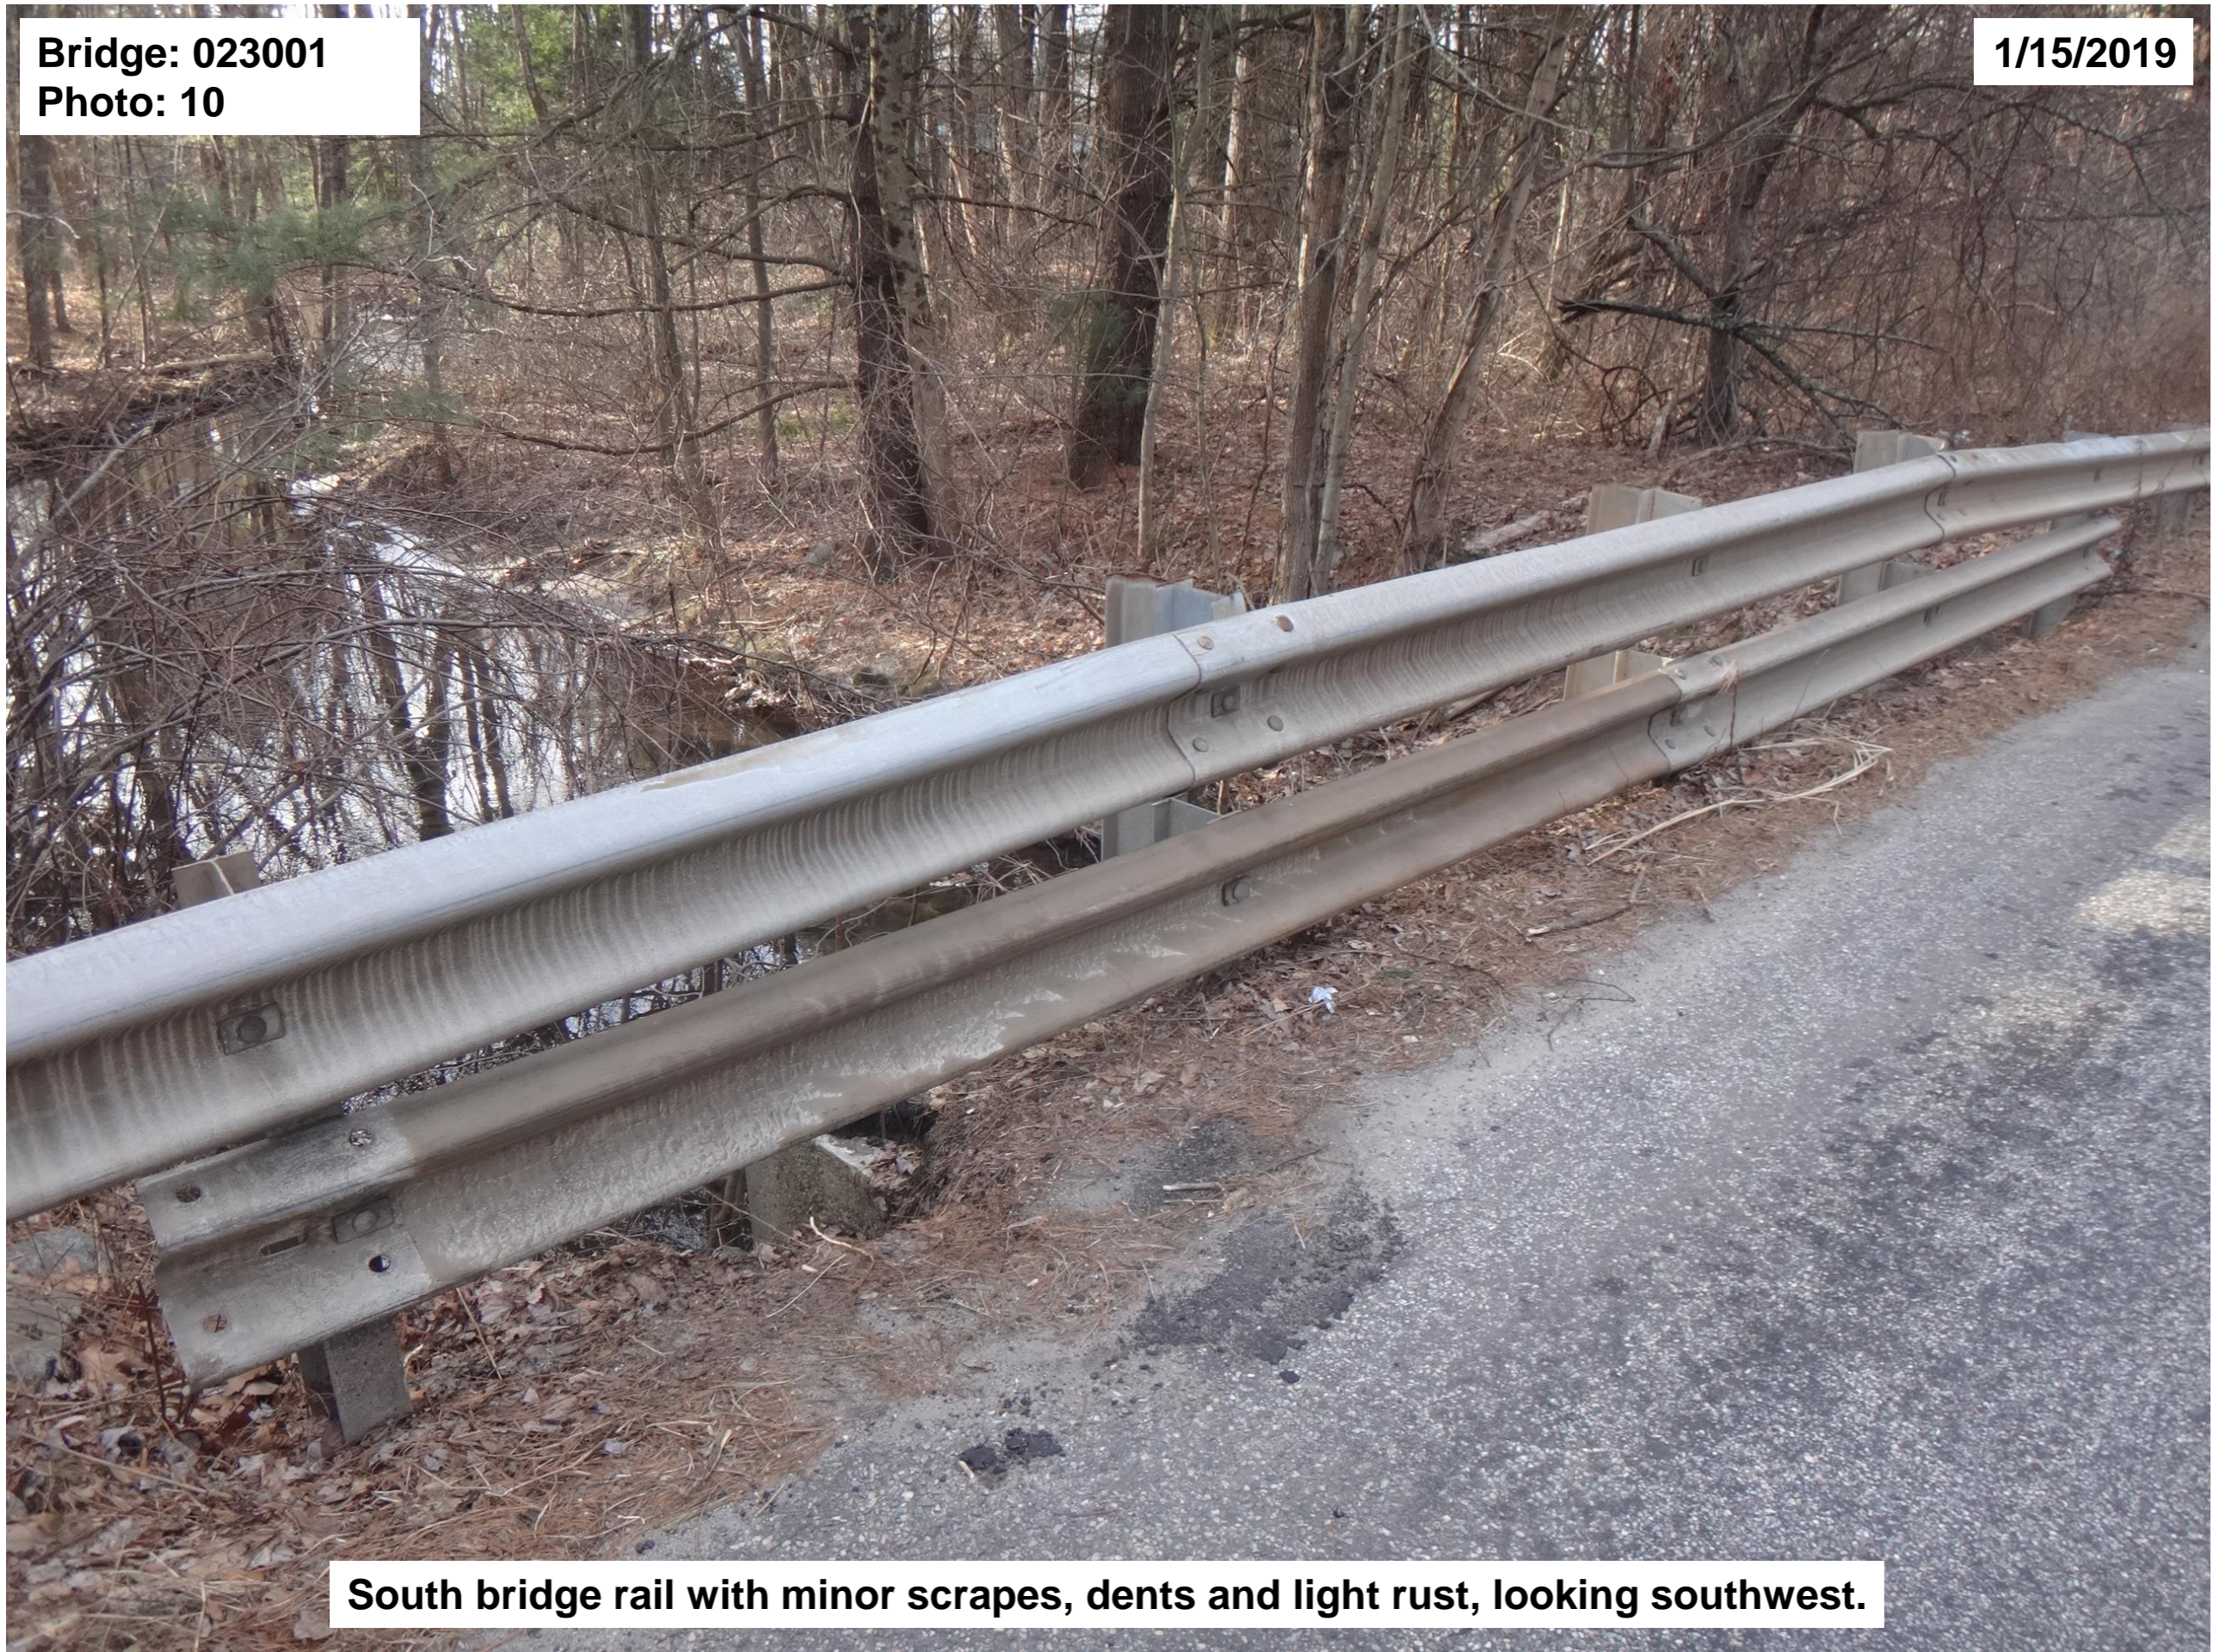
**South bridge rail with minor scrapes, dents and light rust, looking southwest.**

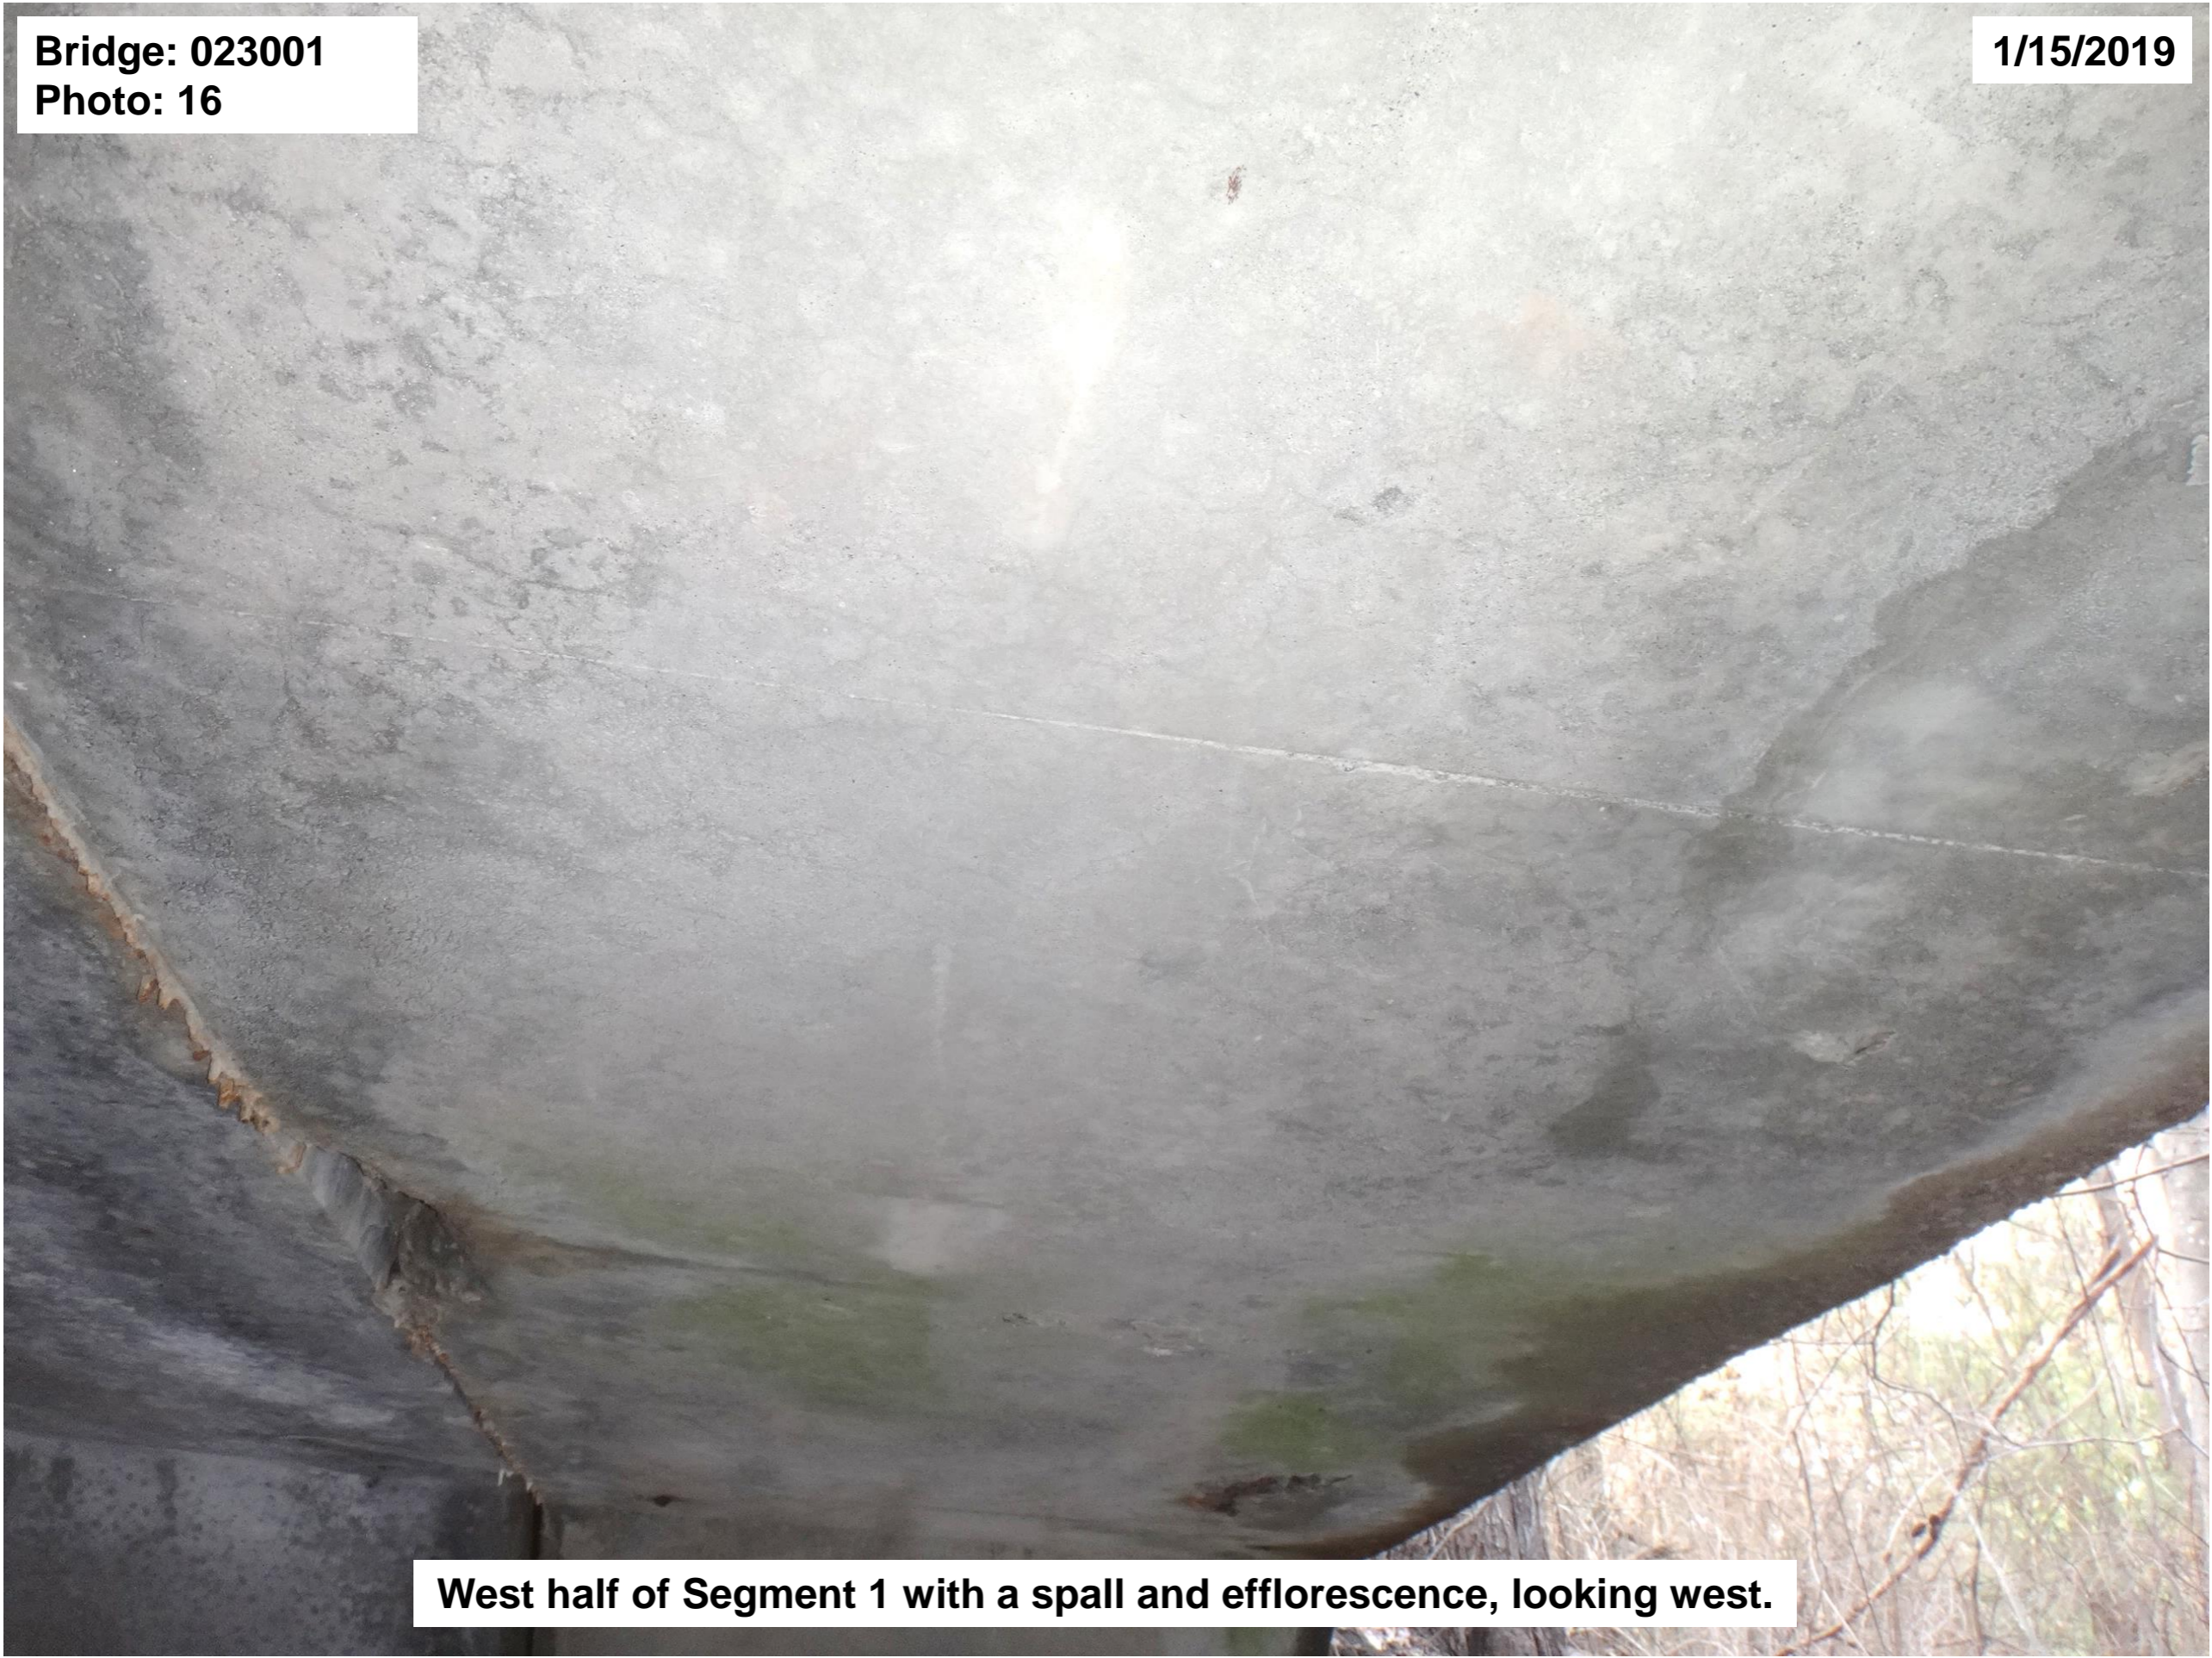
**Bridge: 023001**  
**Photo: 17**

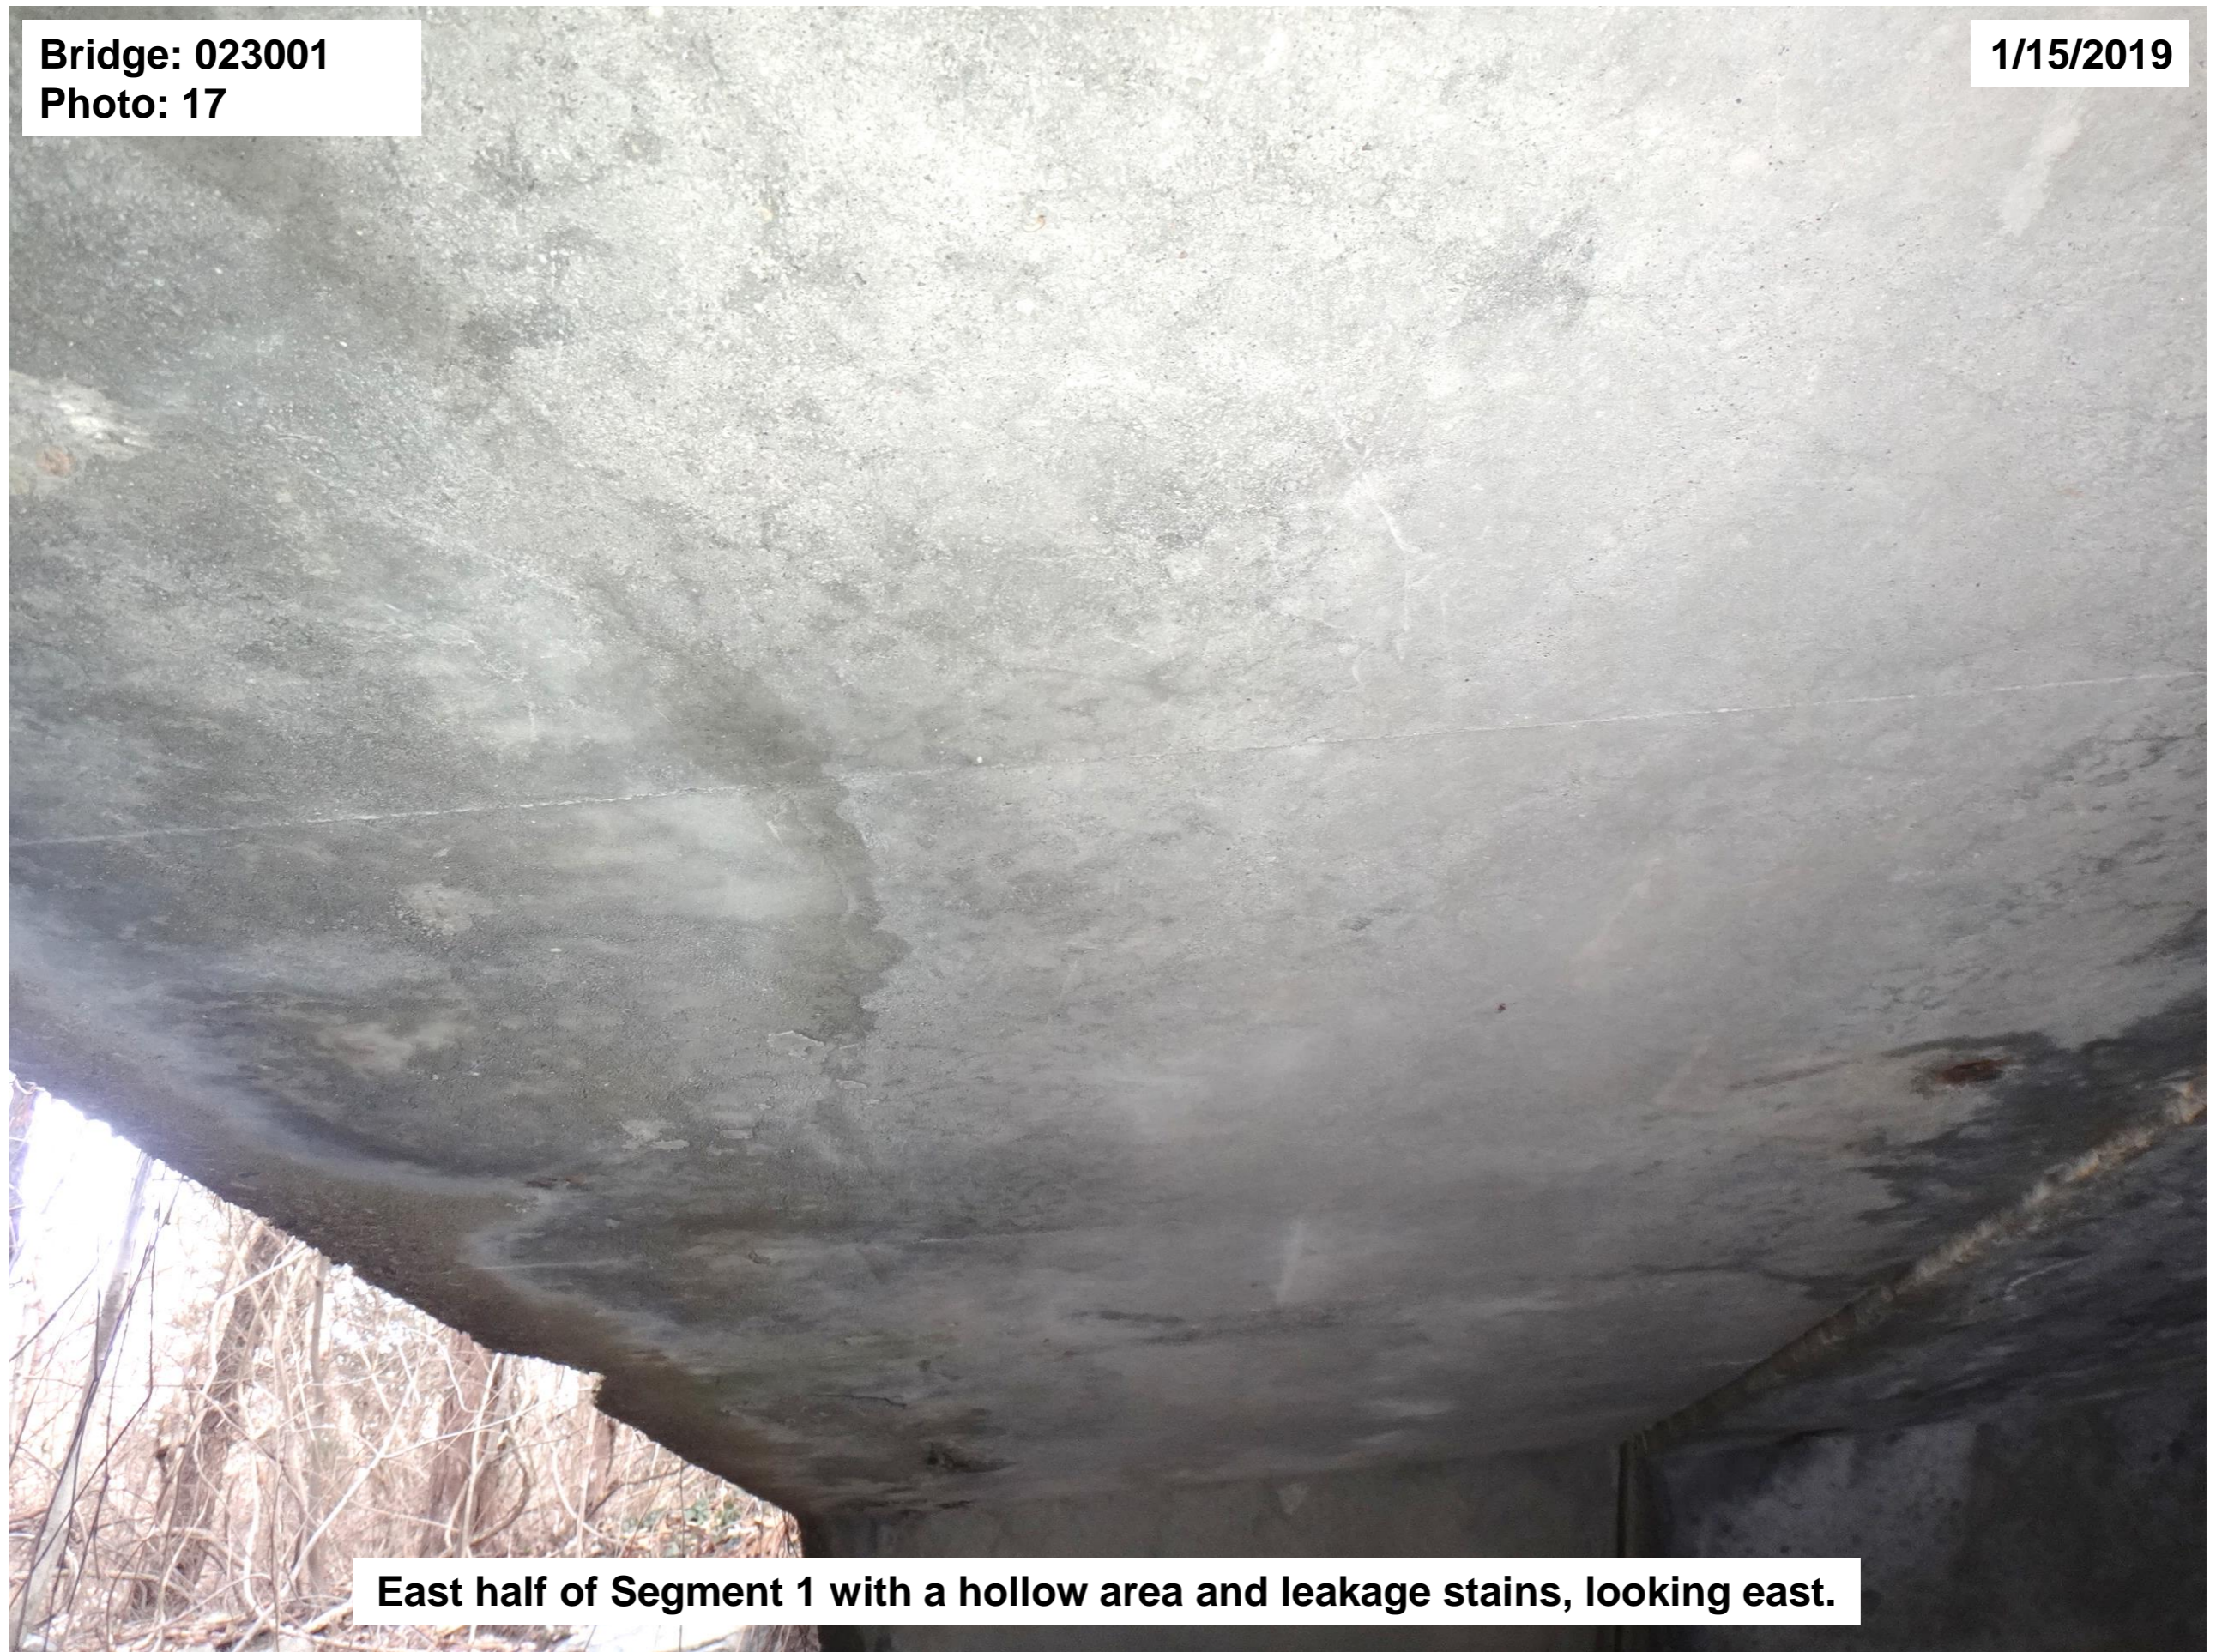
**East half of Segment 1 with a hollow area and leakage stains, looking east.**
