# Table of Contents

OLD CANTON BRIDGE SIGNED APPLICATION.pdf .....	104
WASHBURN BRIDGE SIGNED APPLICATION.pdf .....	106

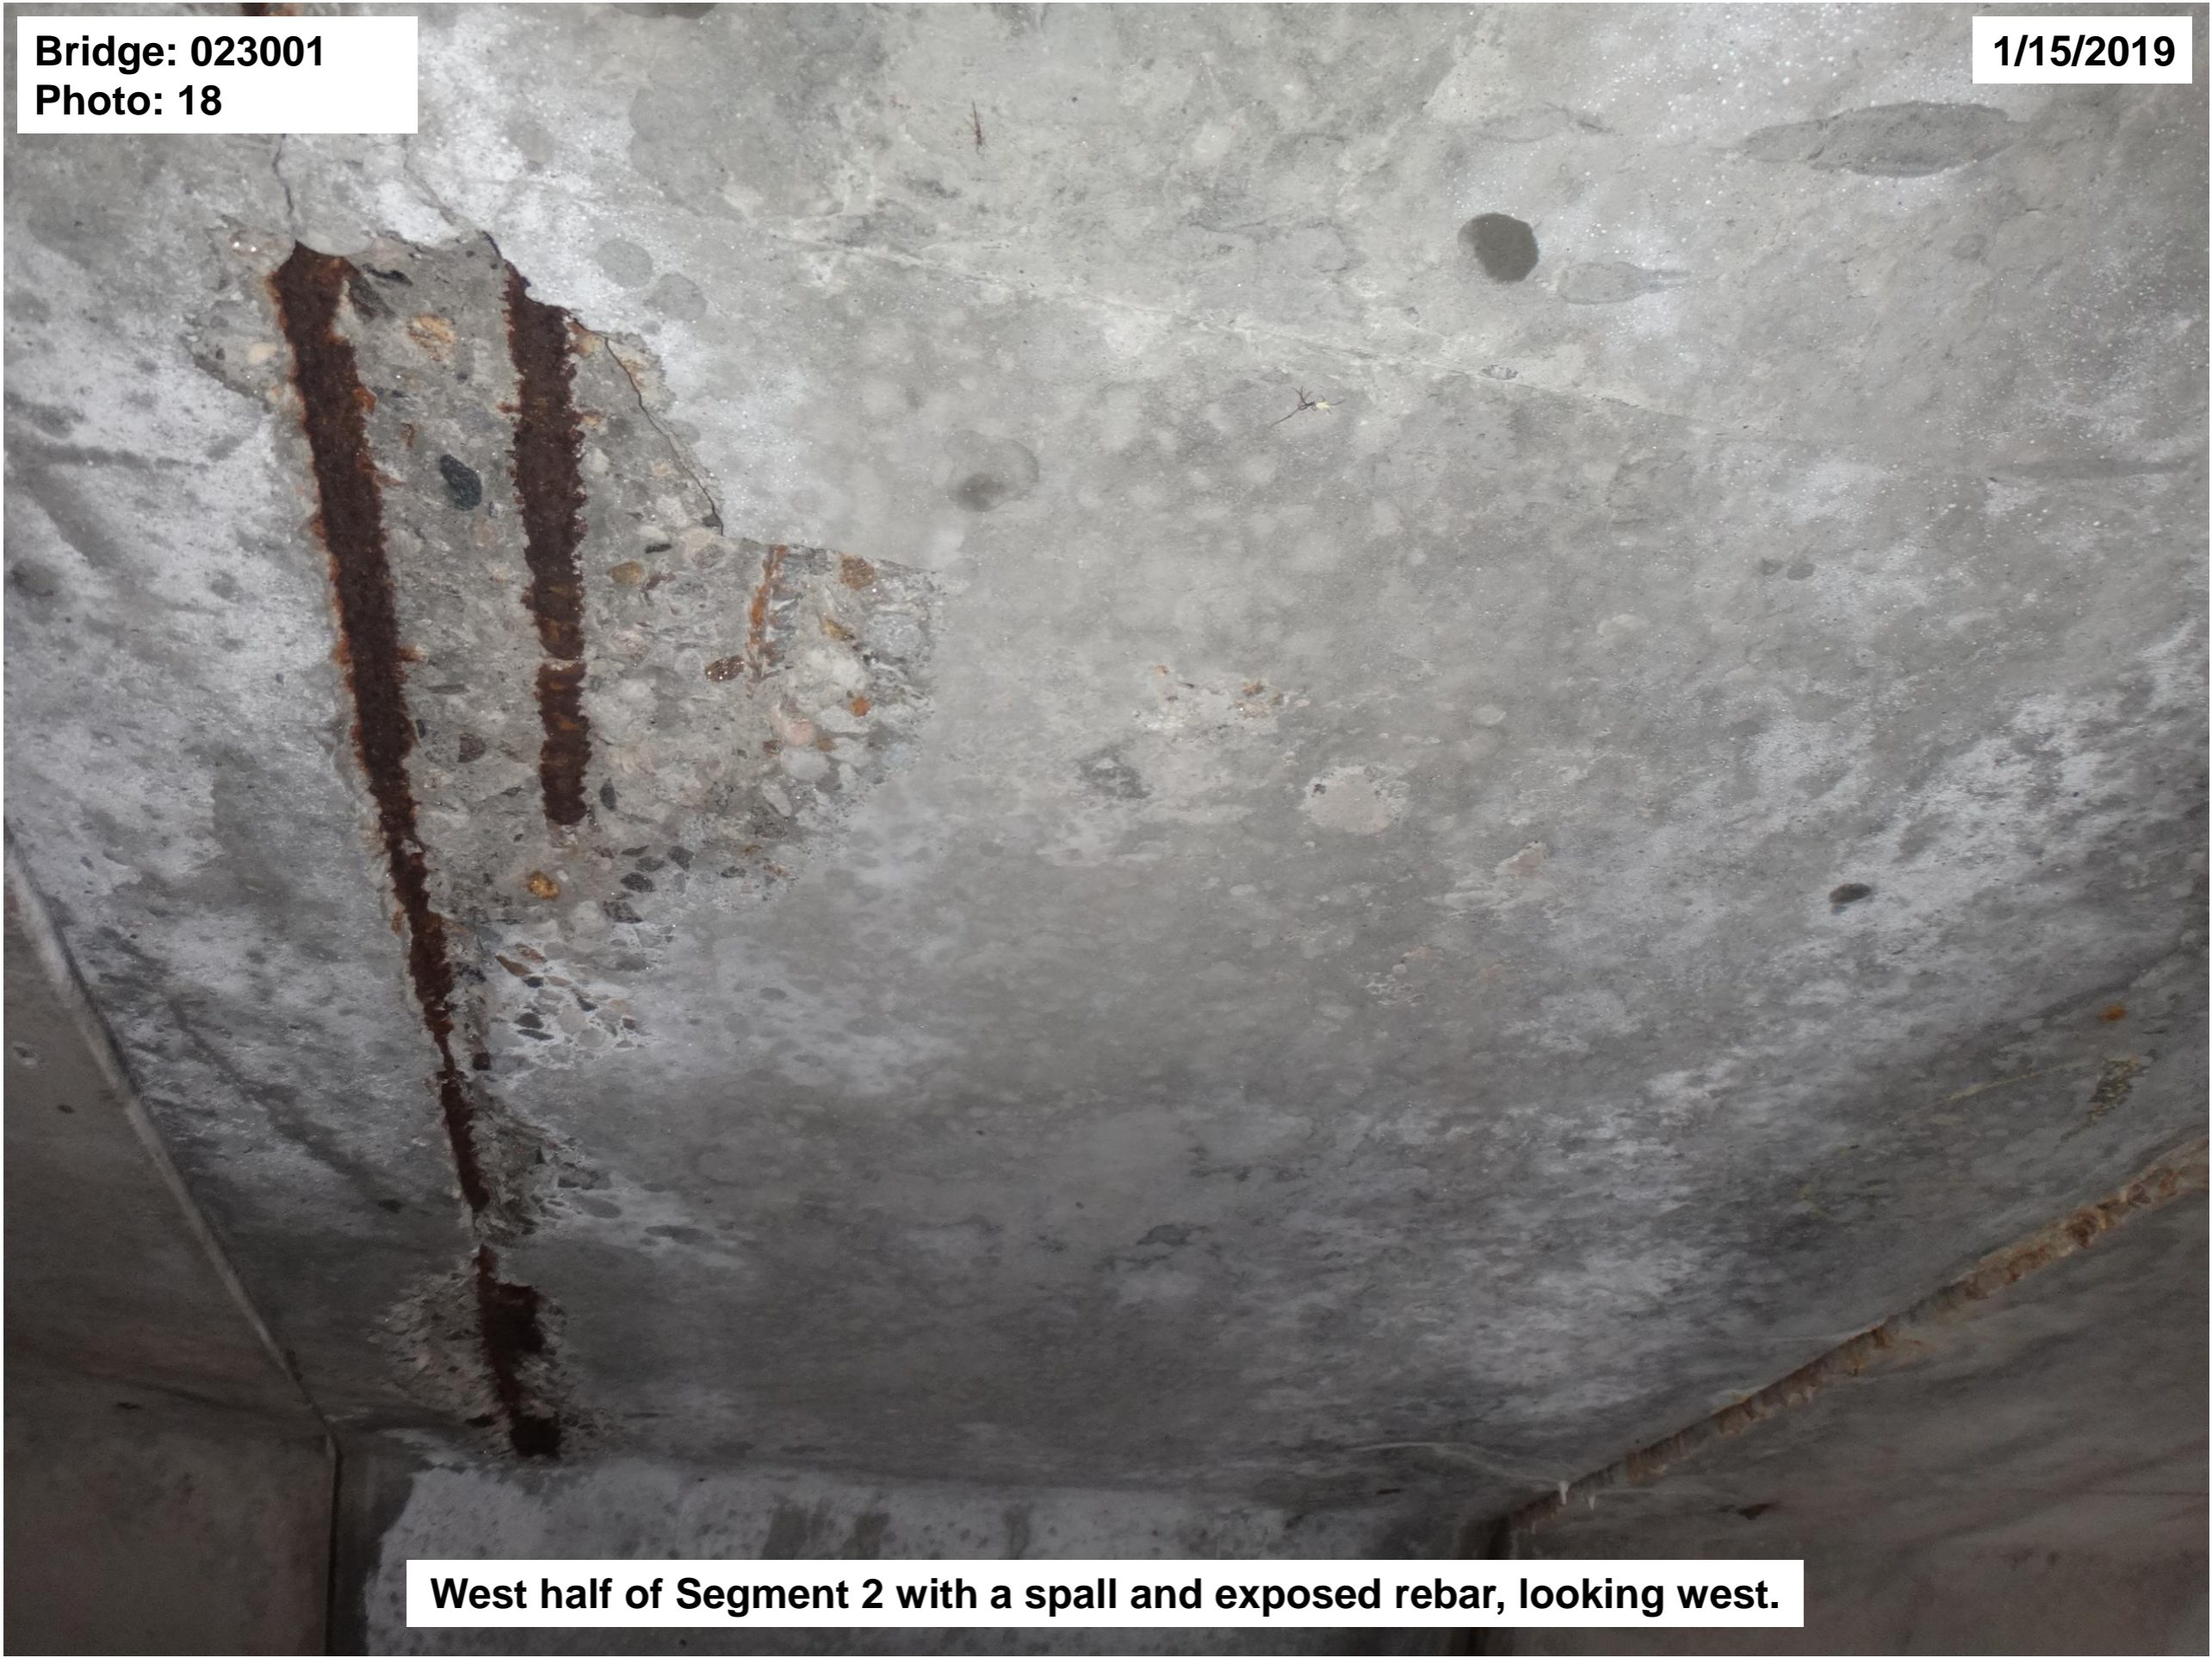
Bridge: 023001  
Photo: 19

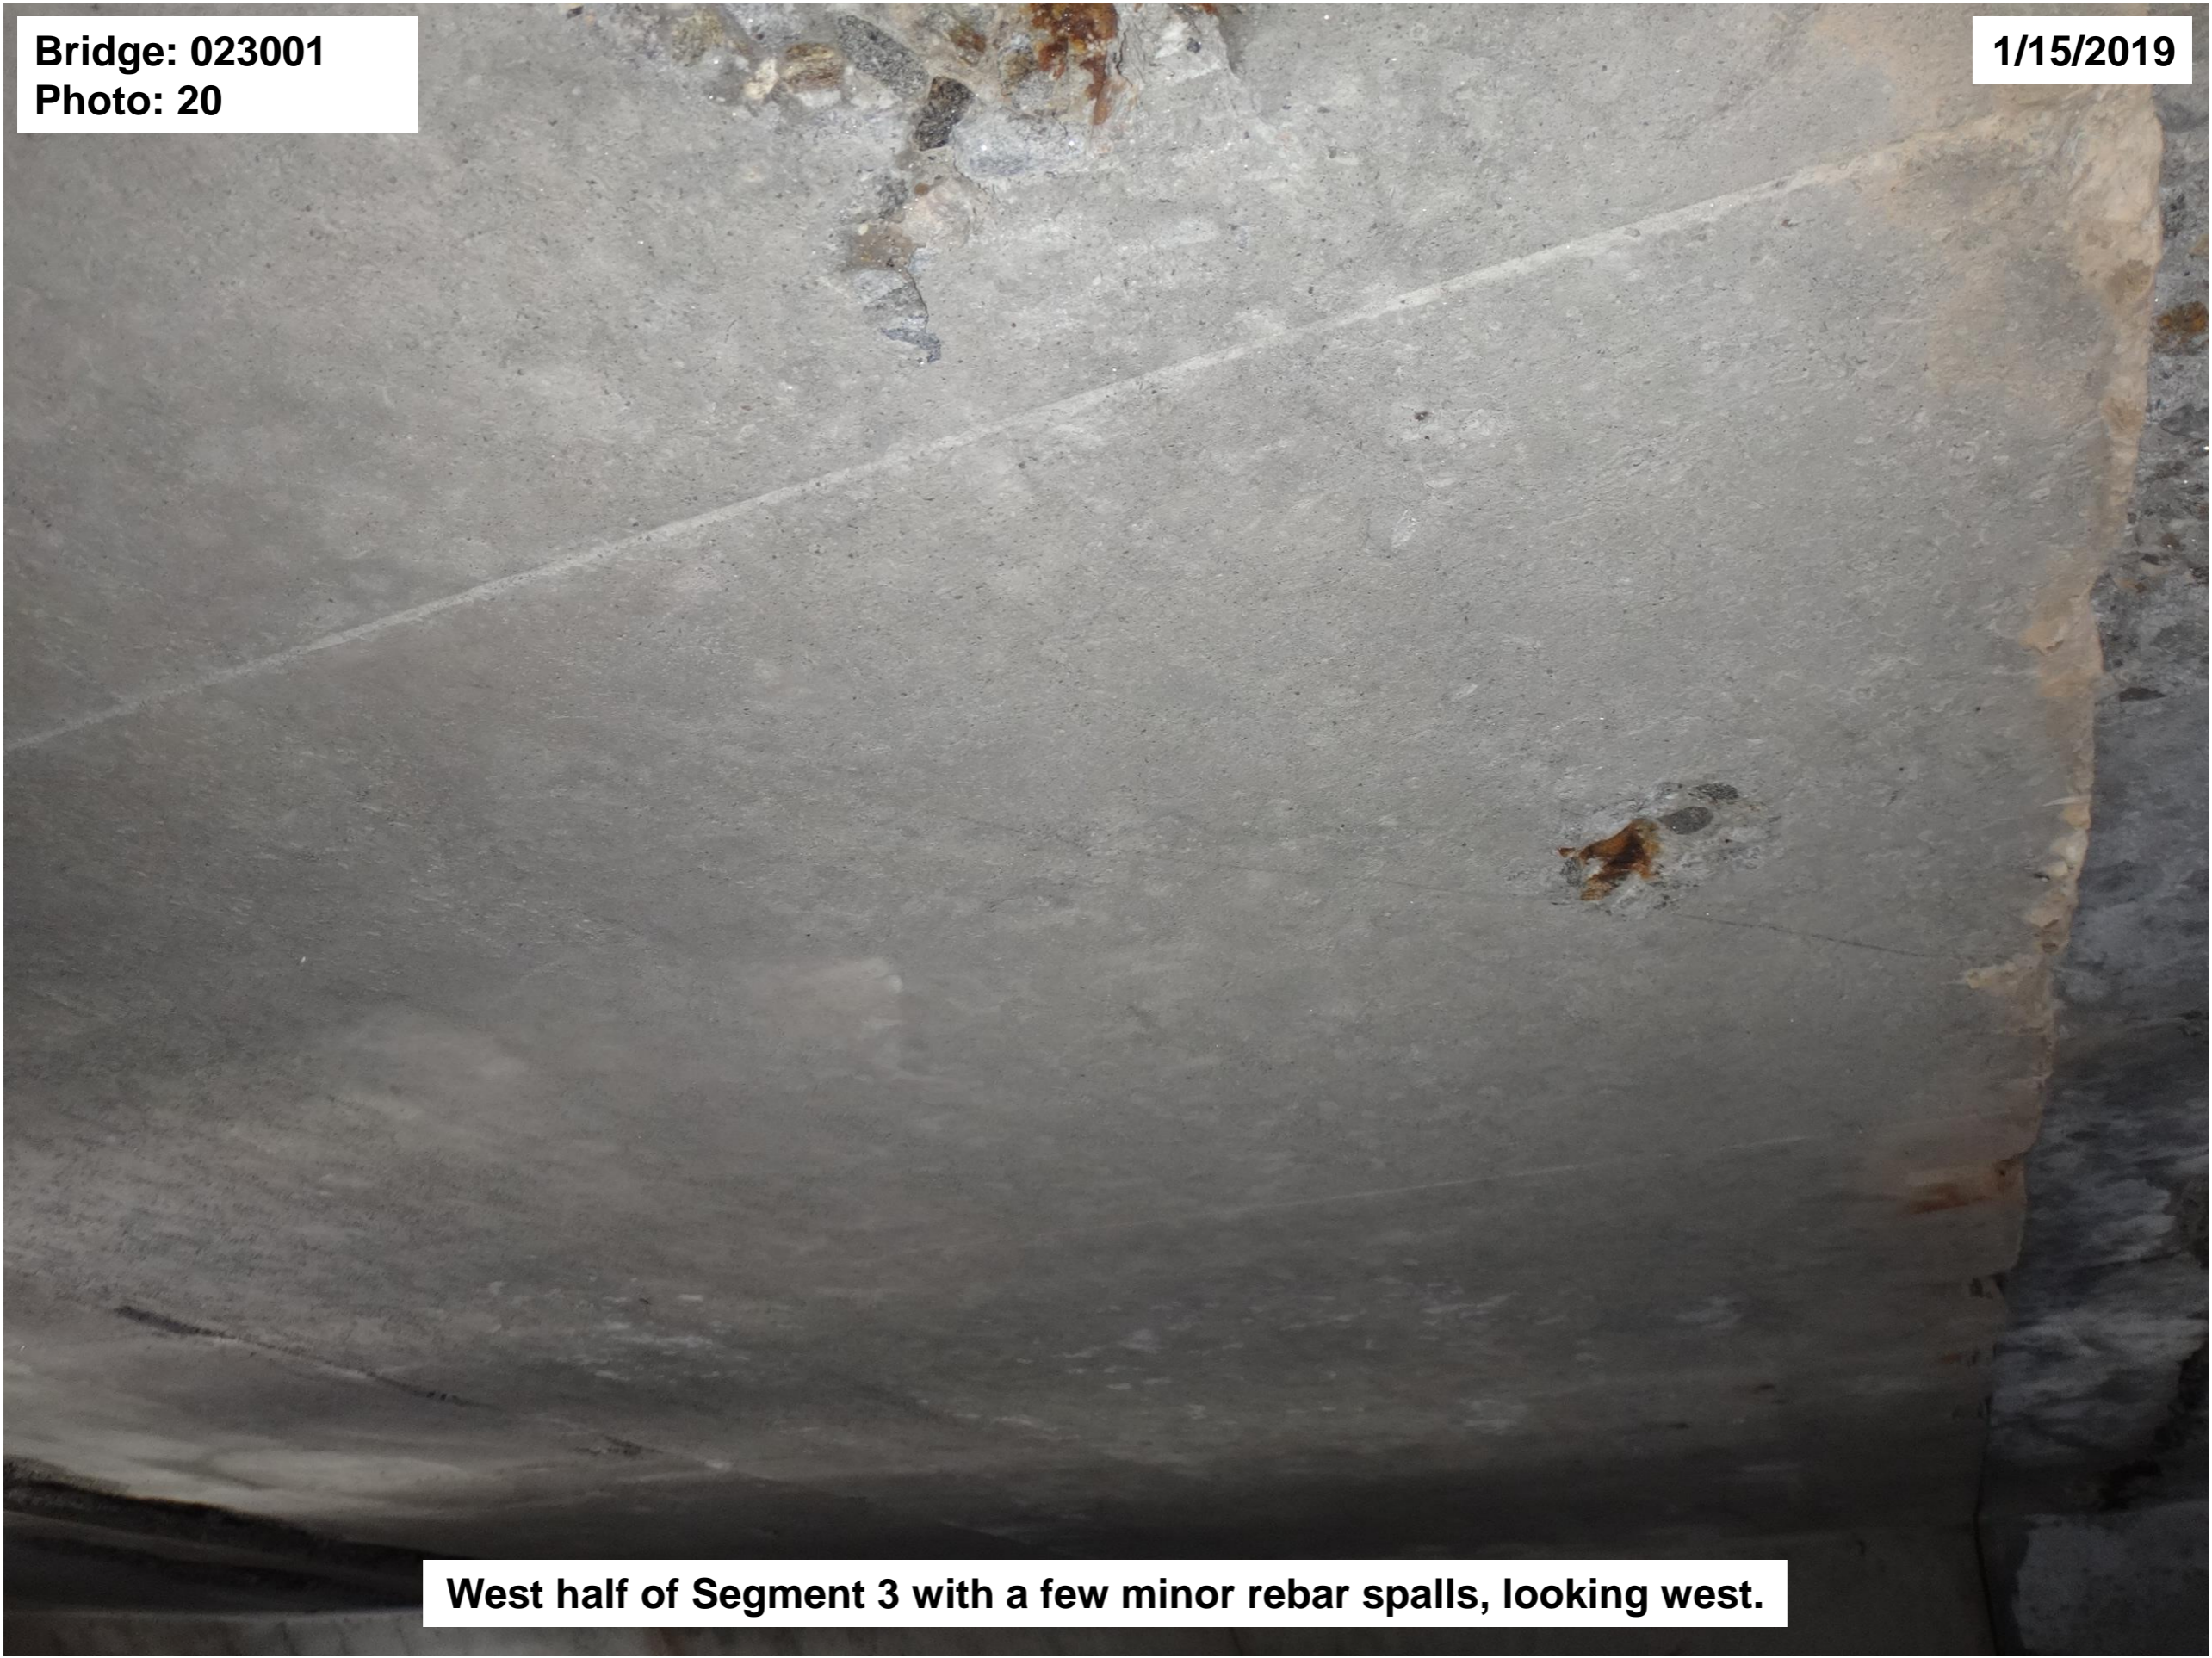
**Bridge: 023001**  
**Photo: 21**

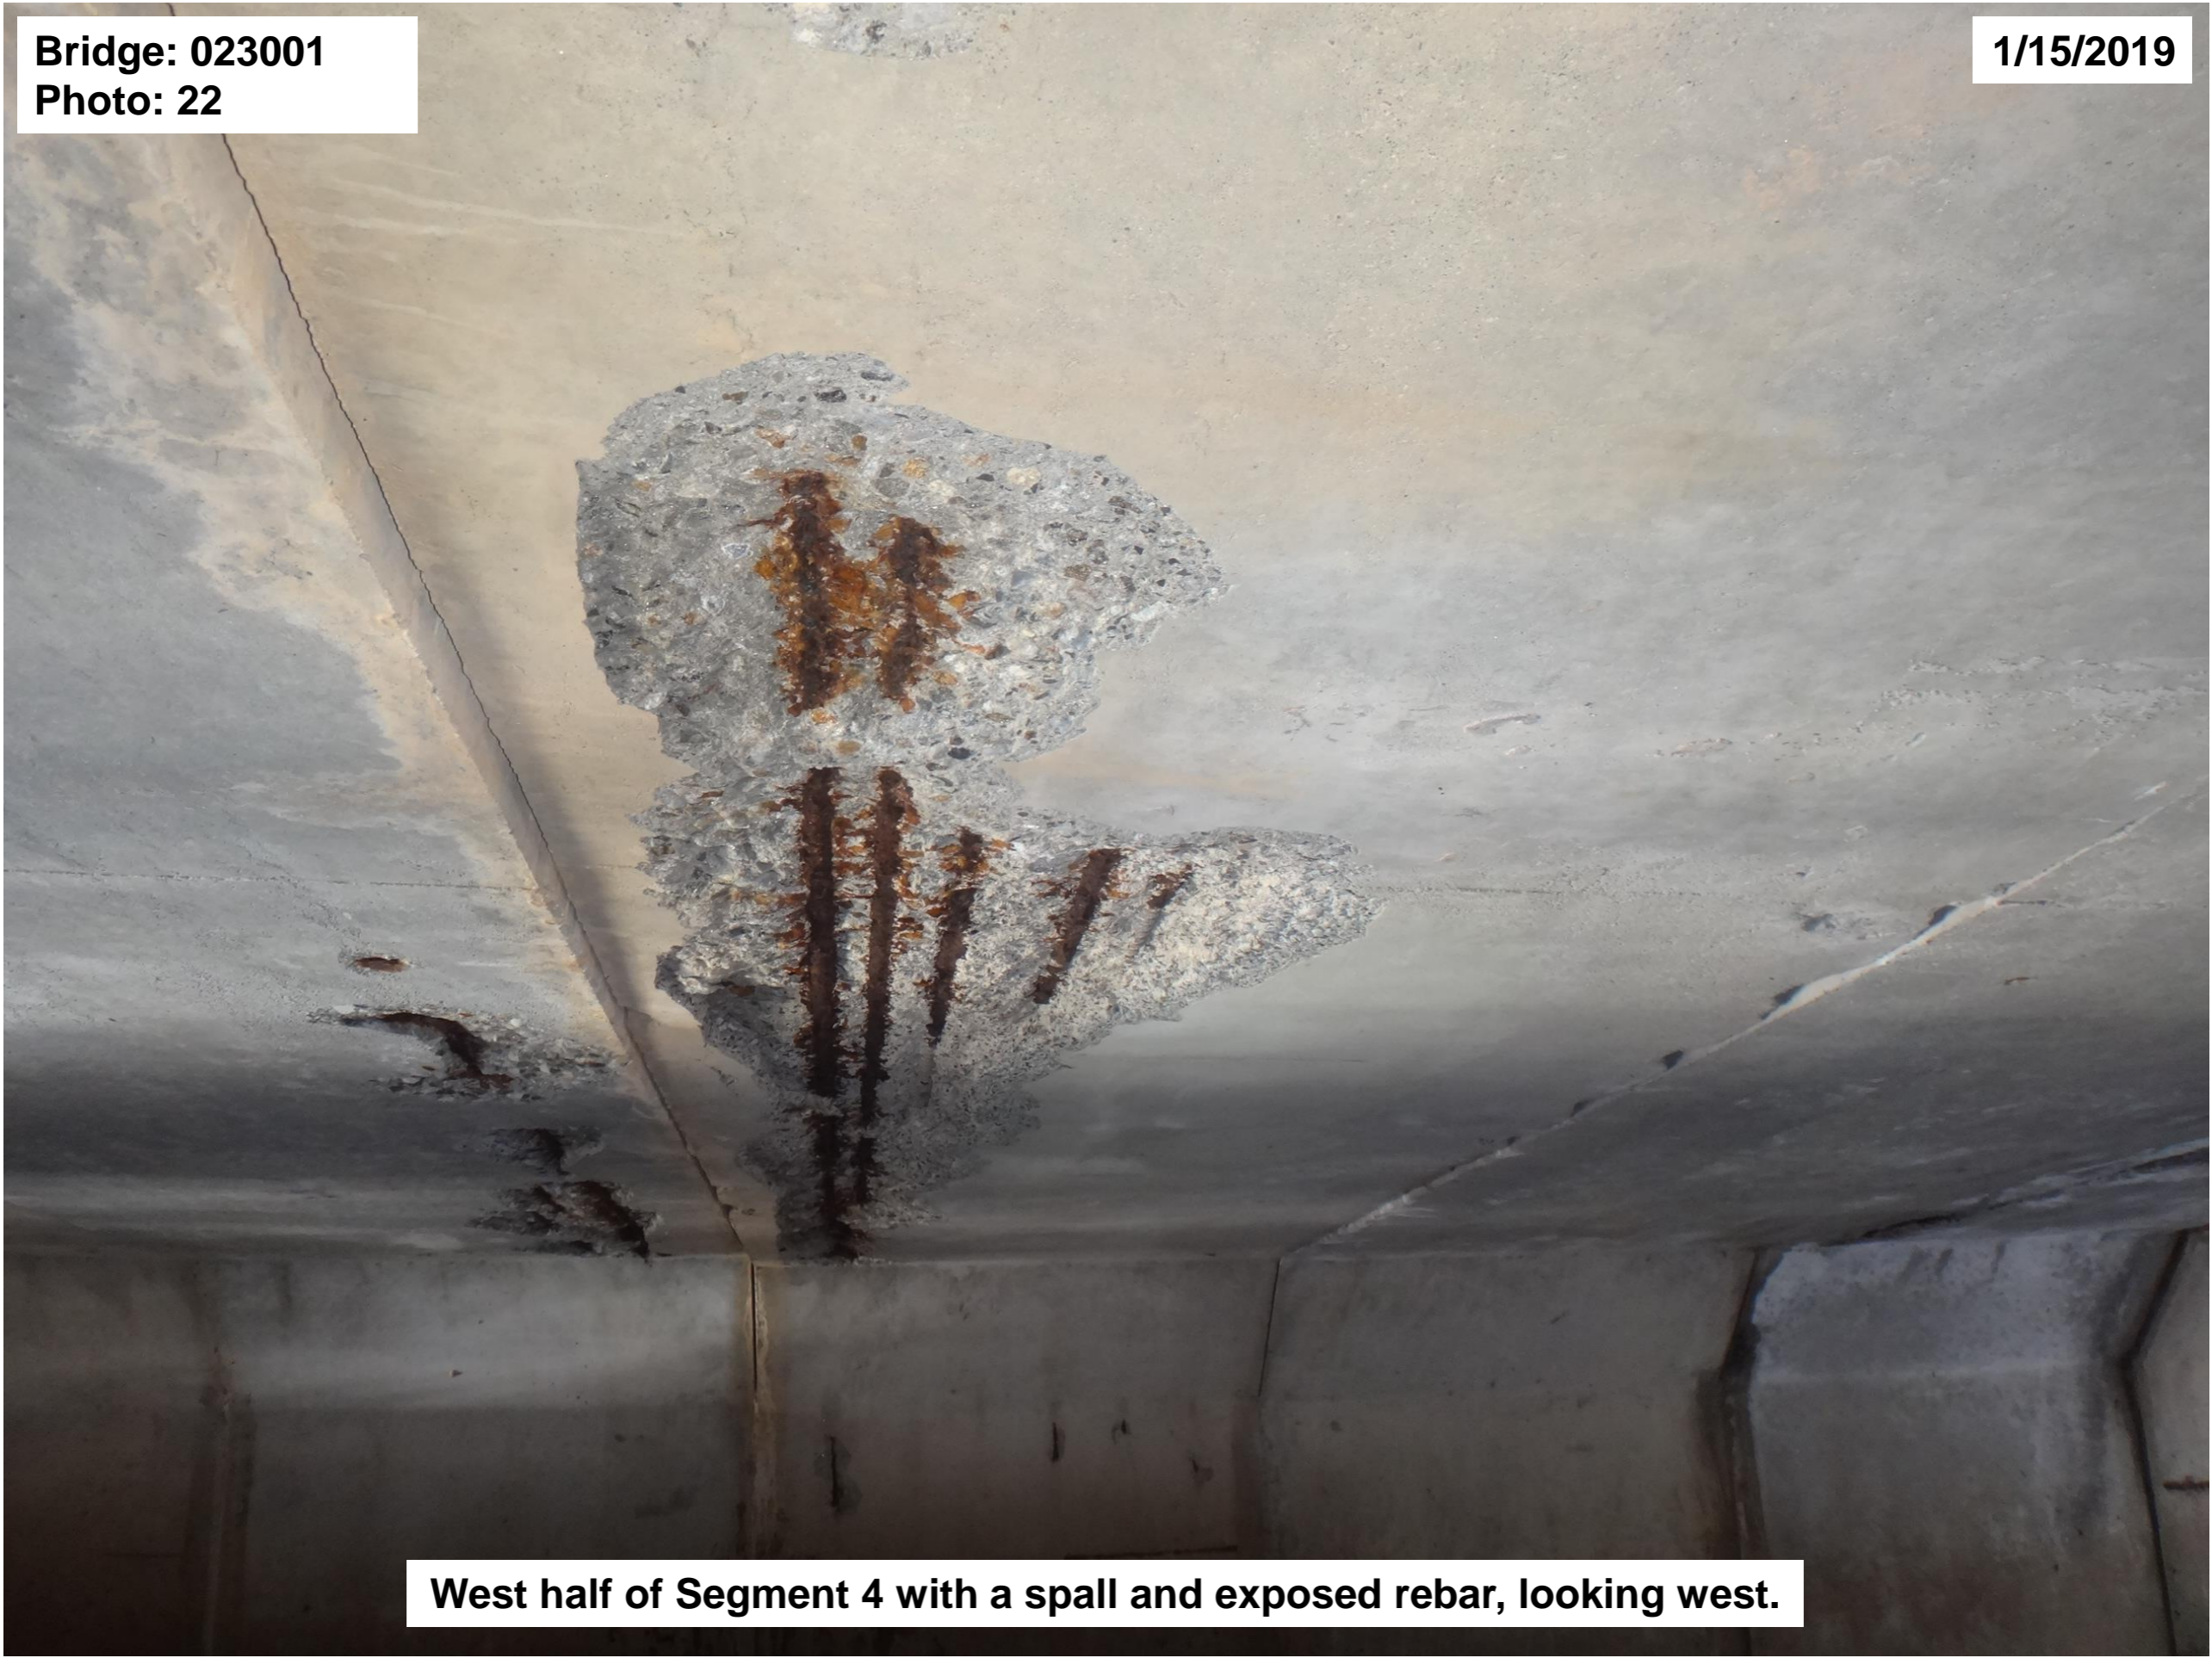
Bridge: 023001  
Photo: 23

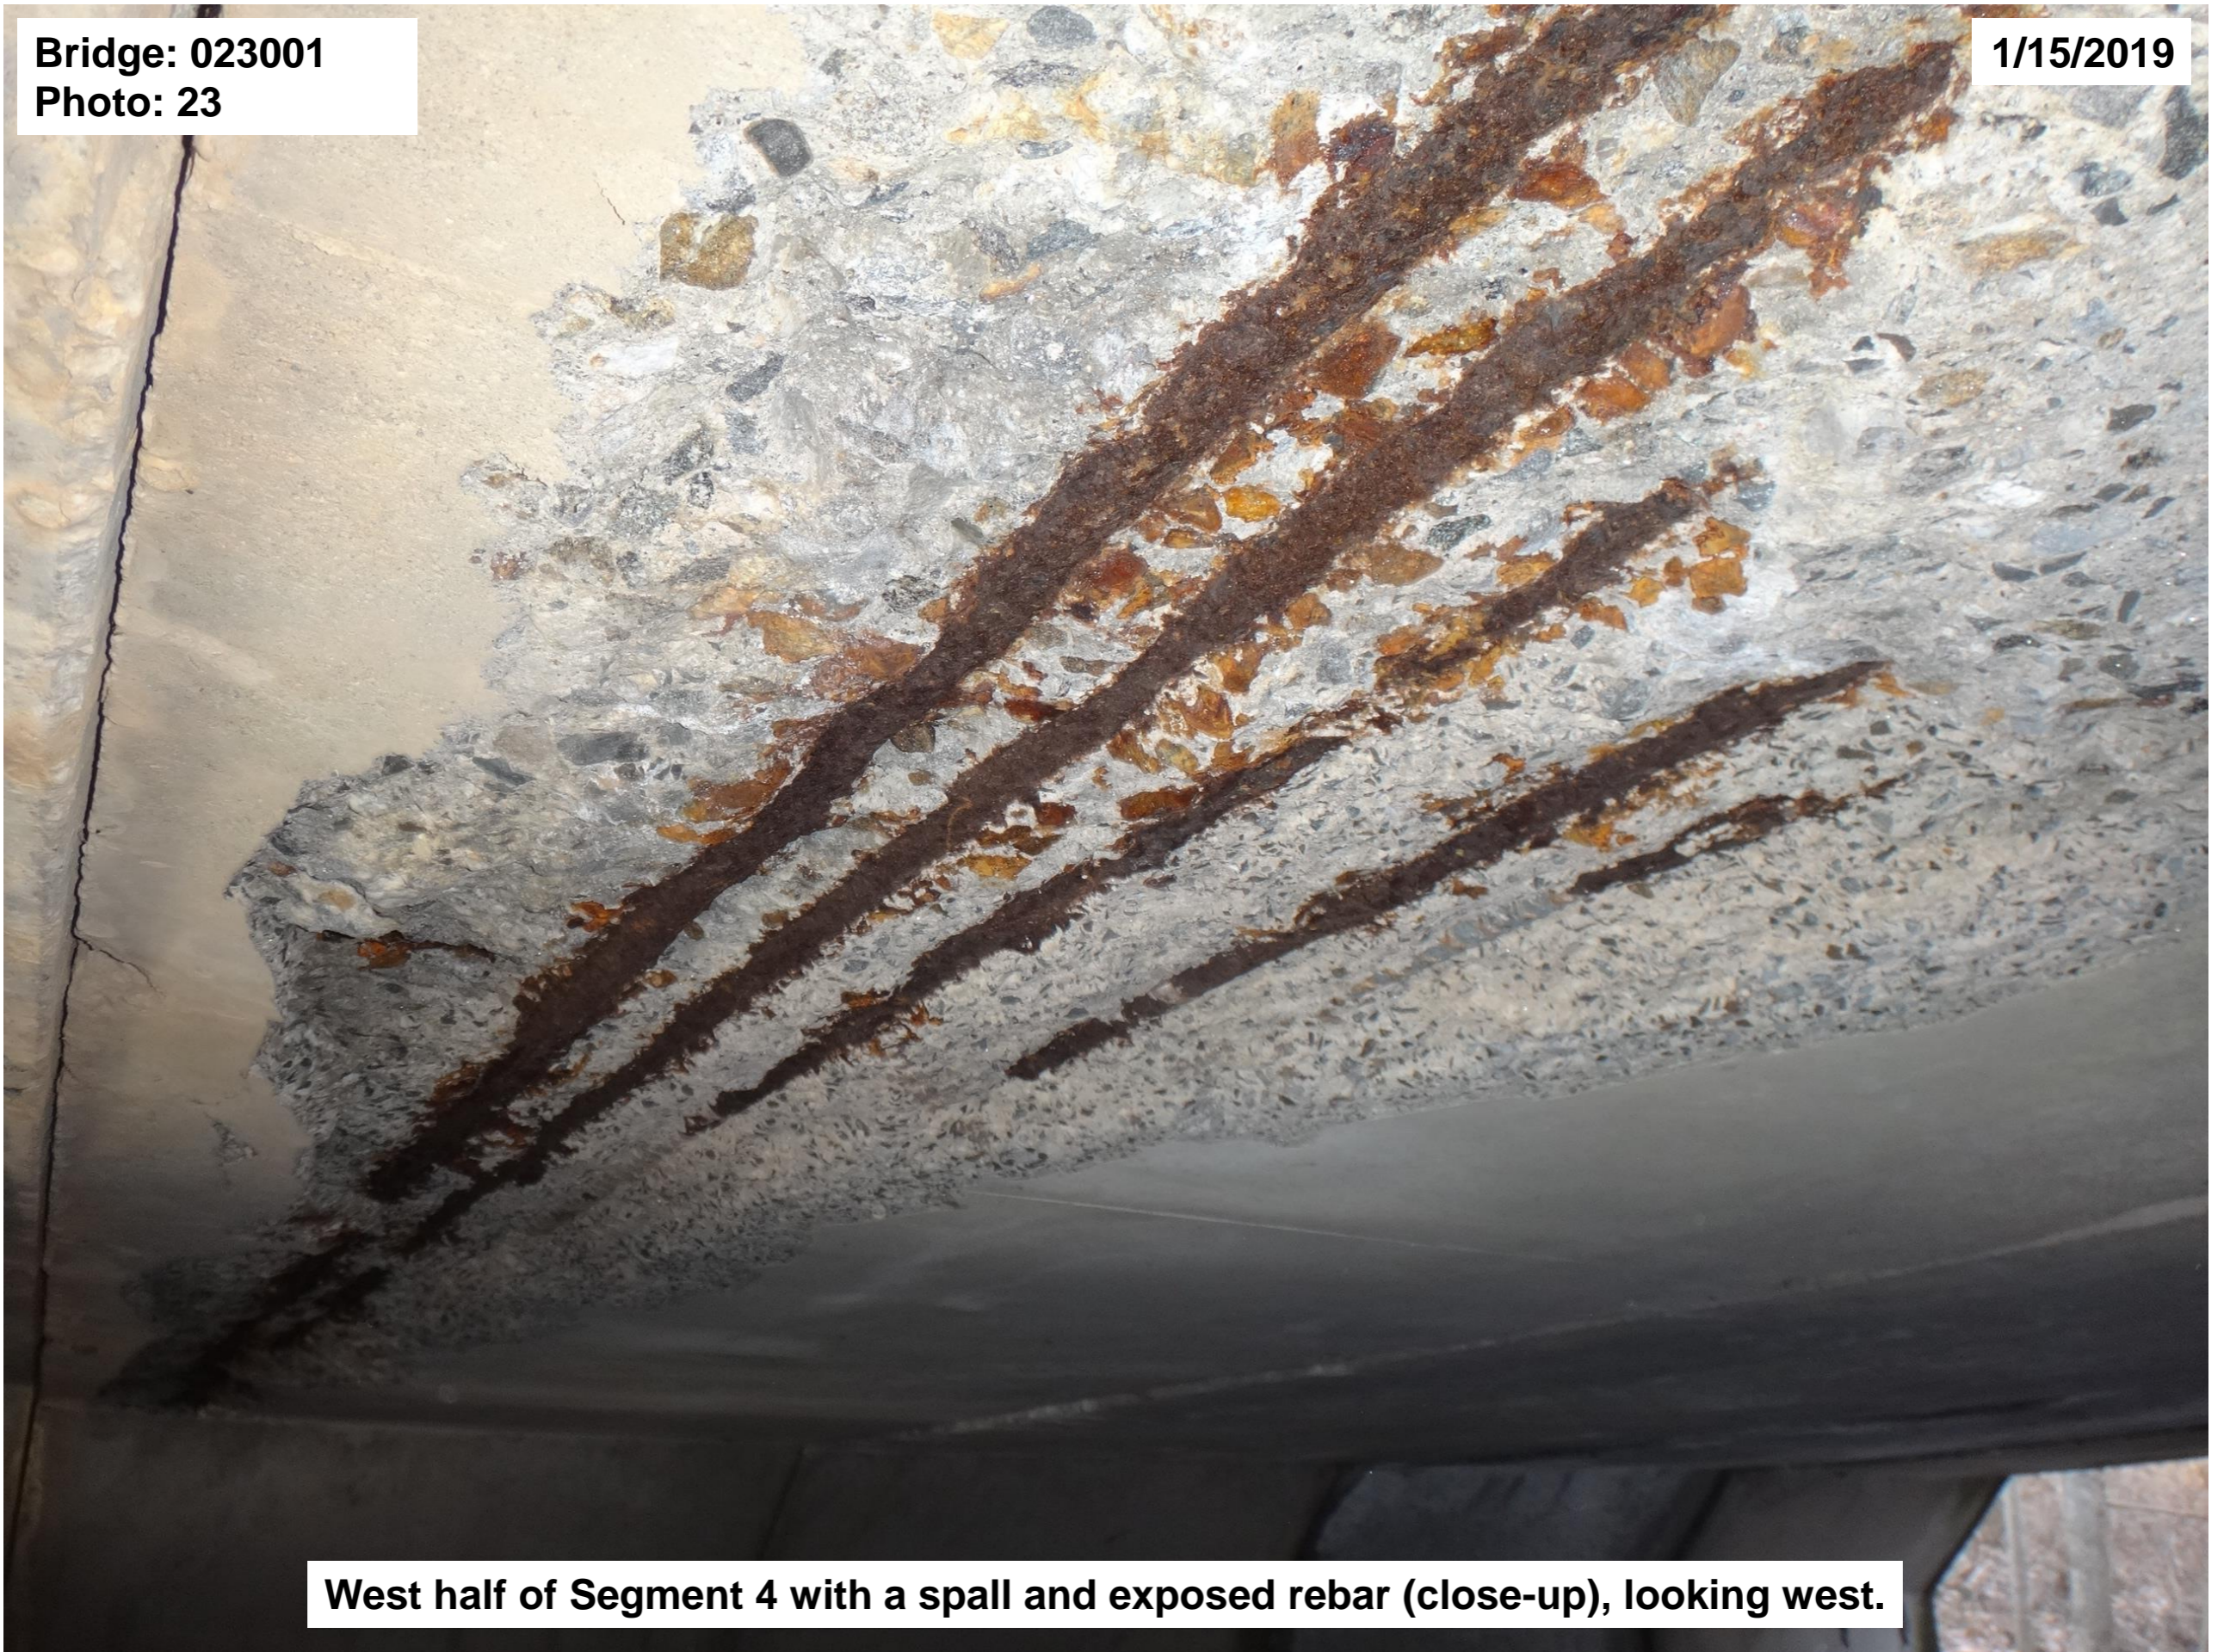
West half of Segment 4 with a spall and exposed rebar (close-up), looking west.

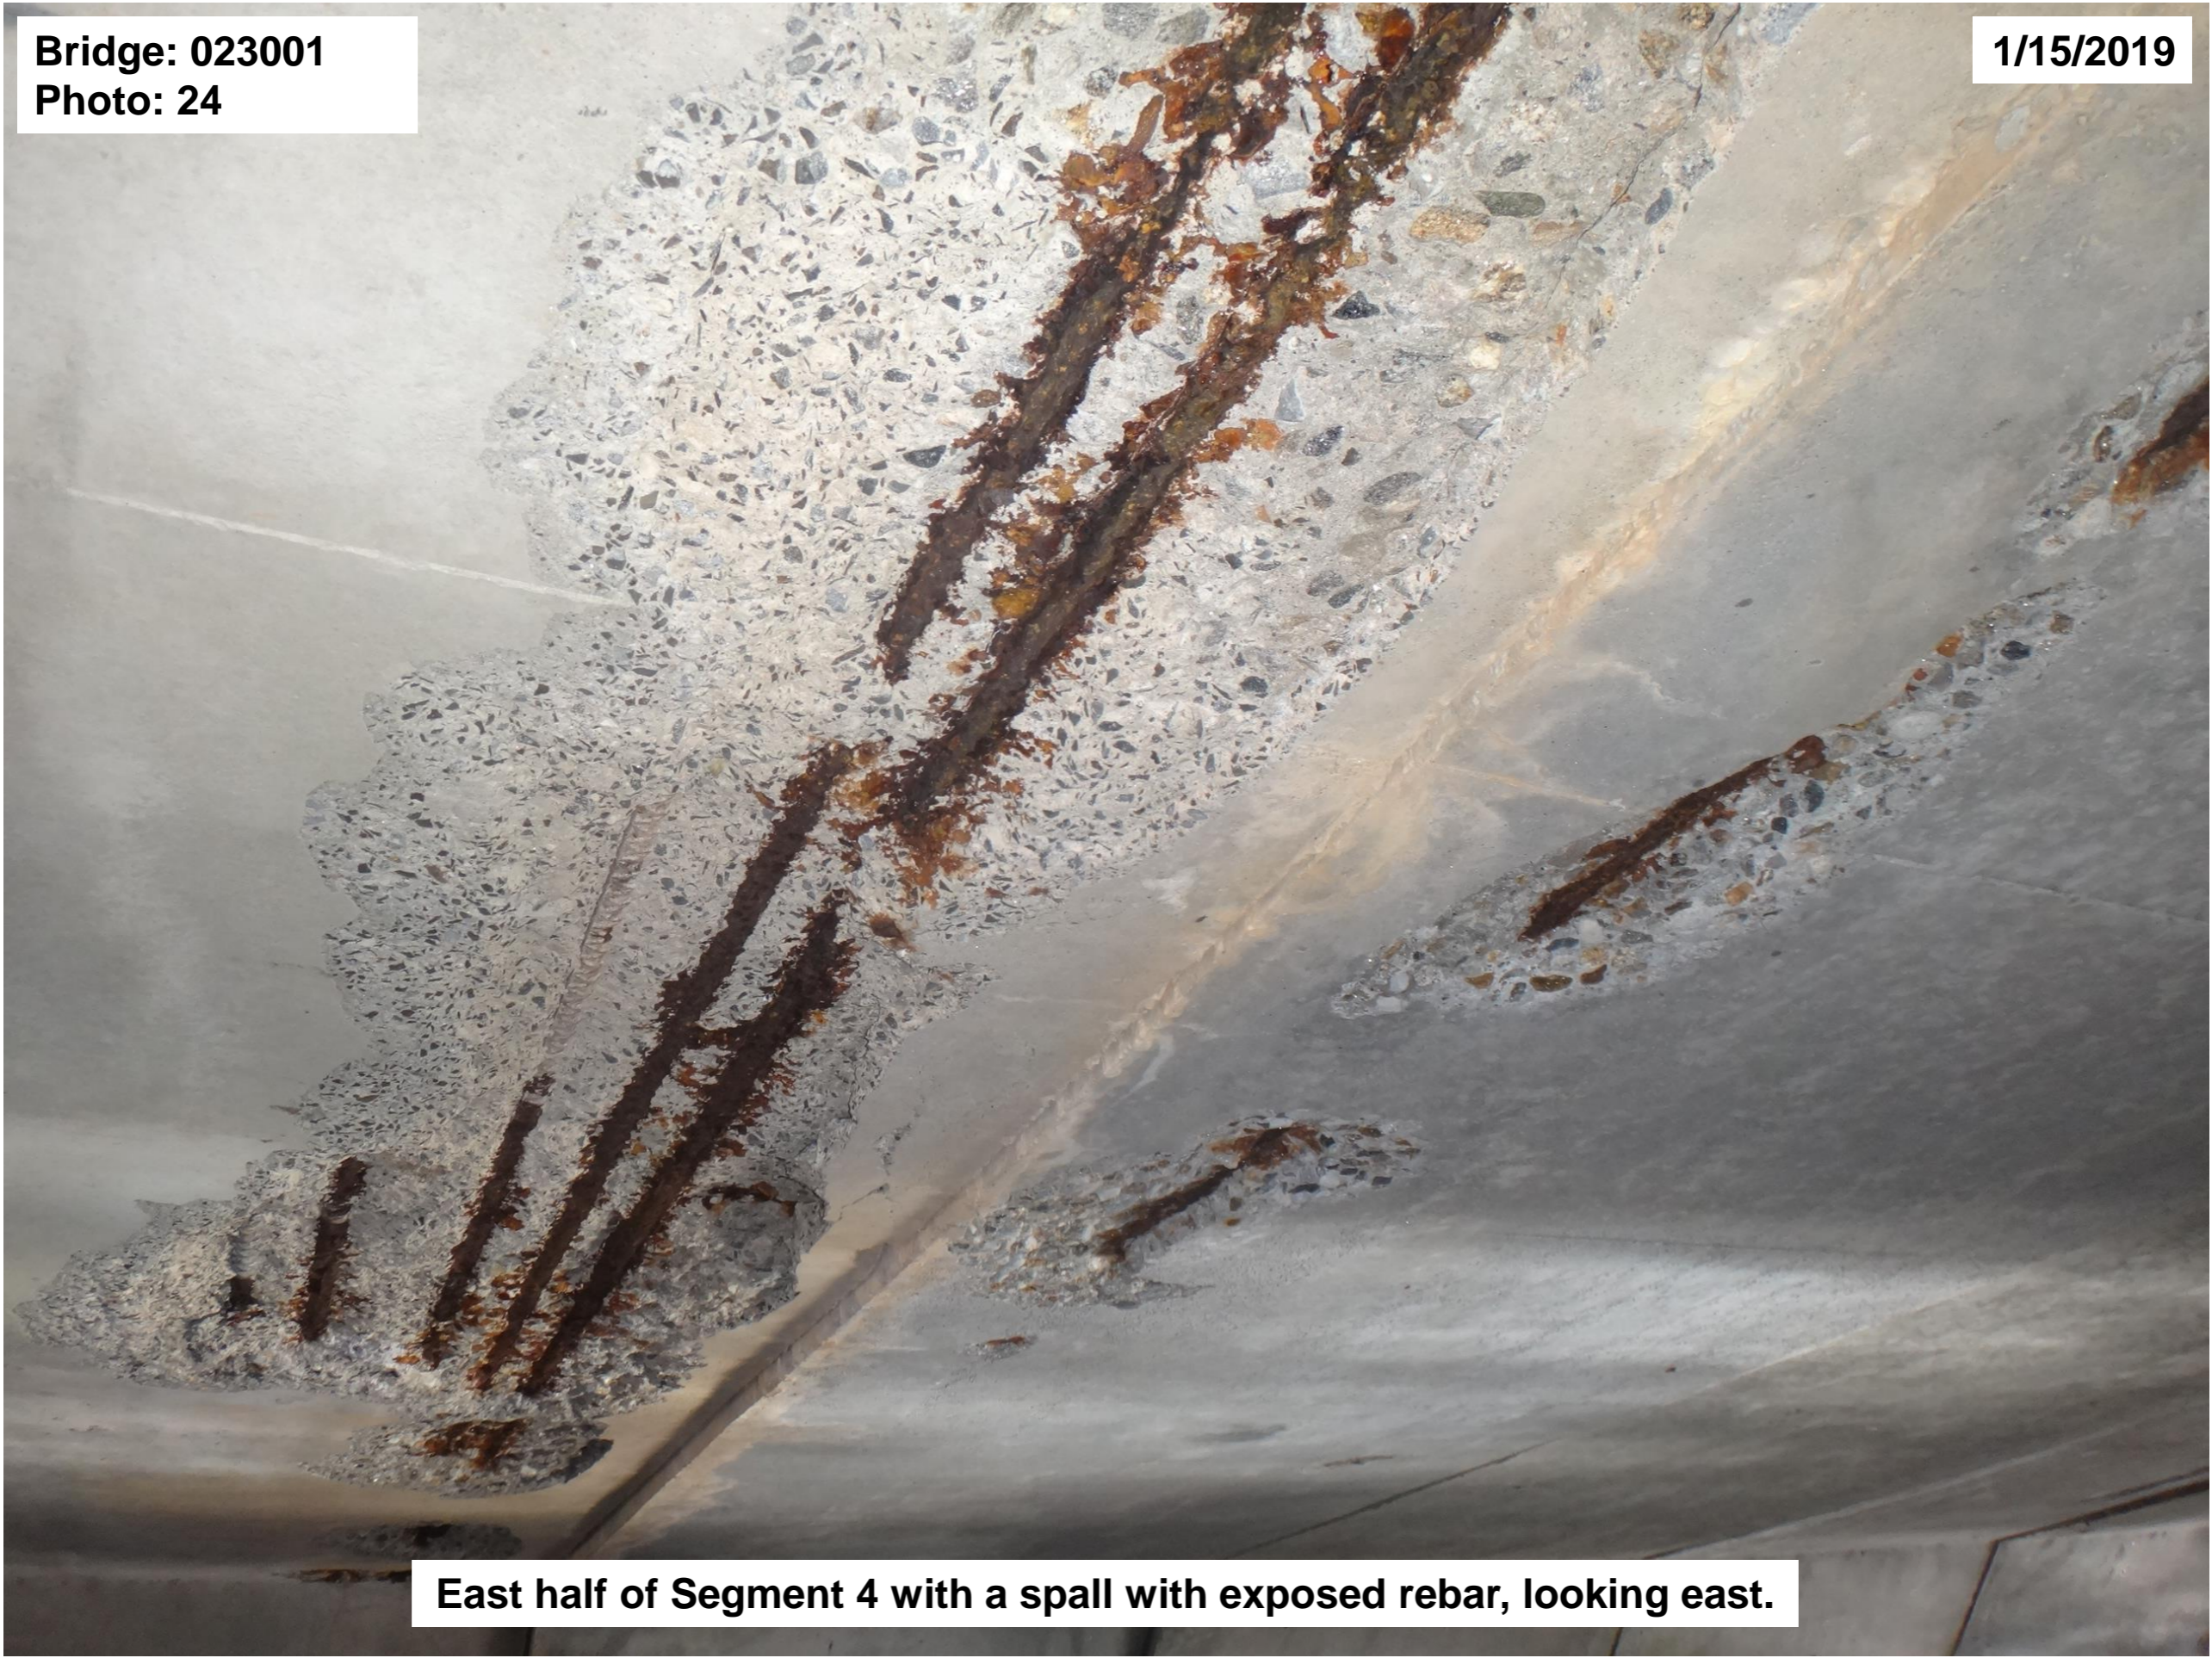
Bridge: 023001  
Photo: 25

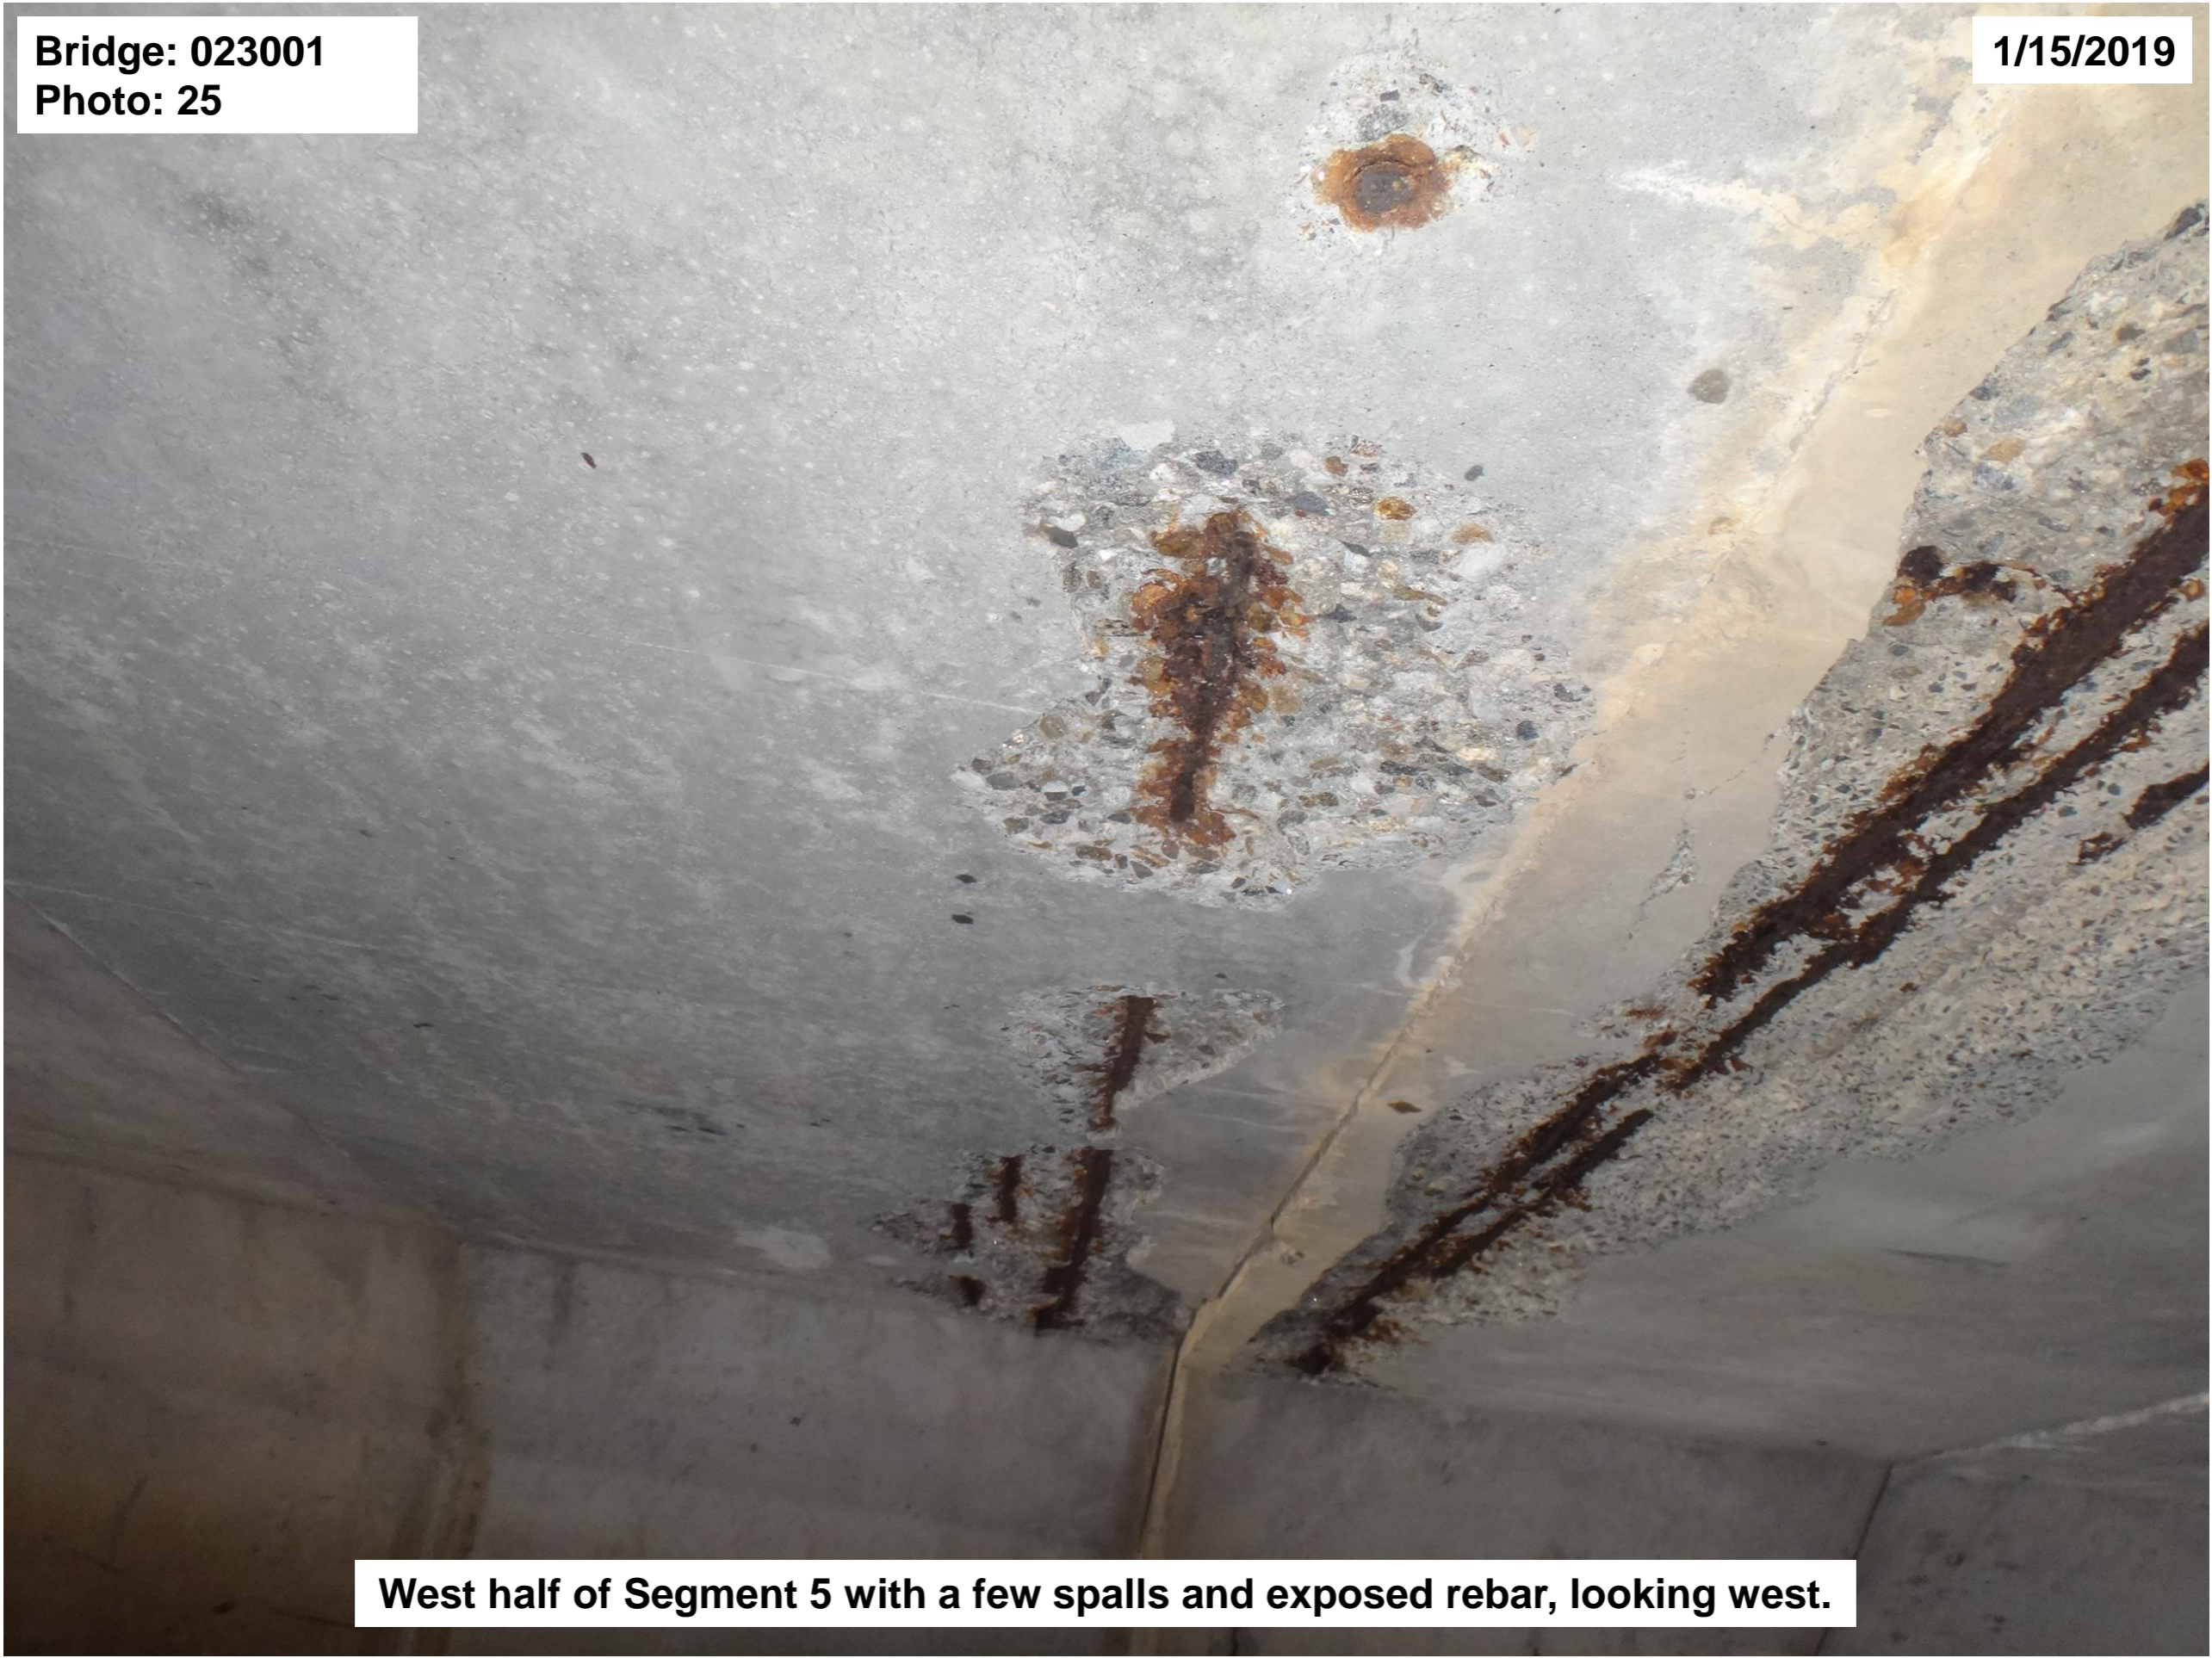
**Bridge: 023001**  
**Photo: 26**
