# Table of Contents

OLD CANTON BRIDGE SIGNED APPLICATION.pdf .....	104
WASHBURN BRIDGE SIGNED APPLICATION.pdf .....	106

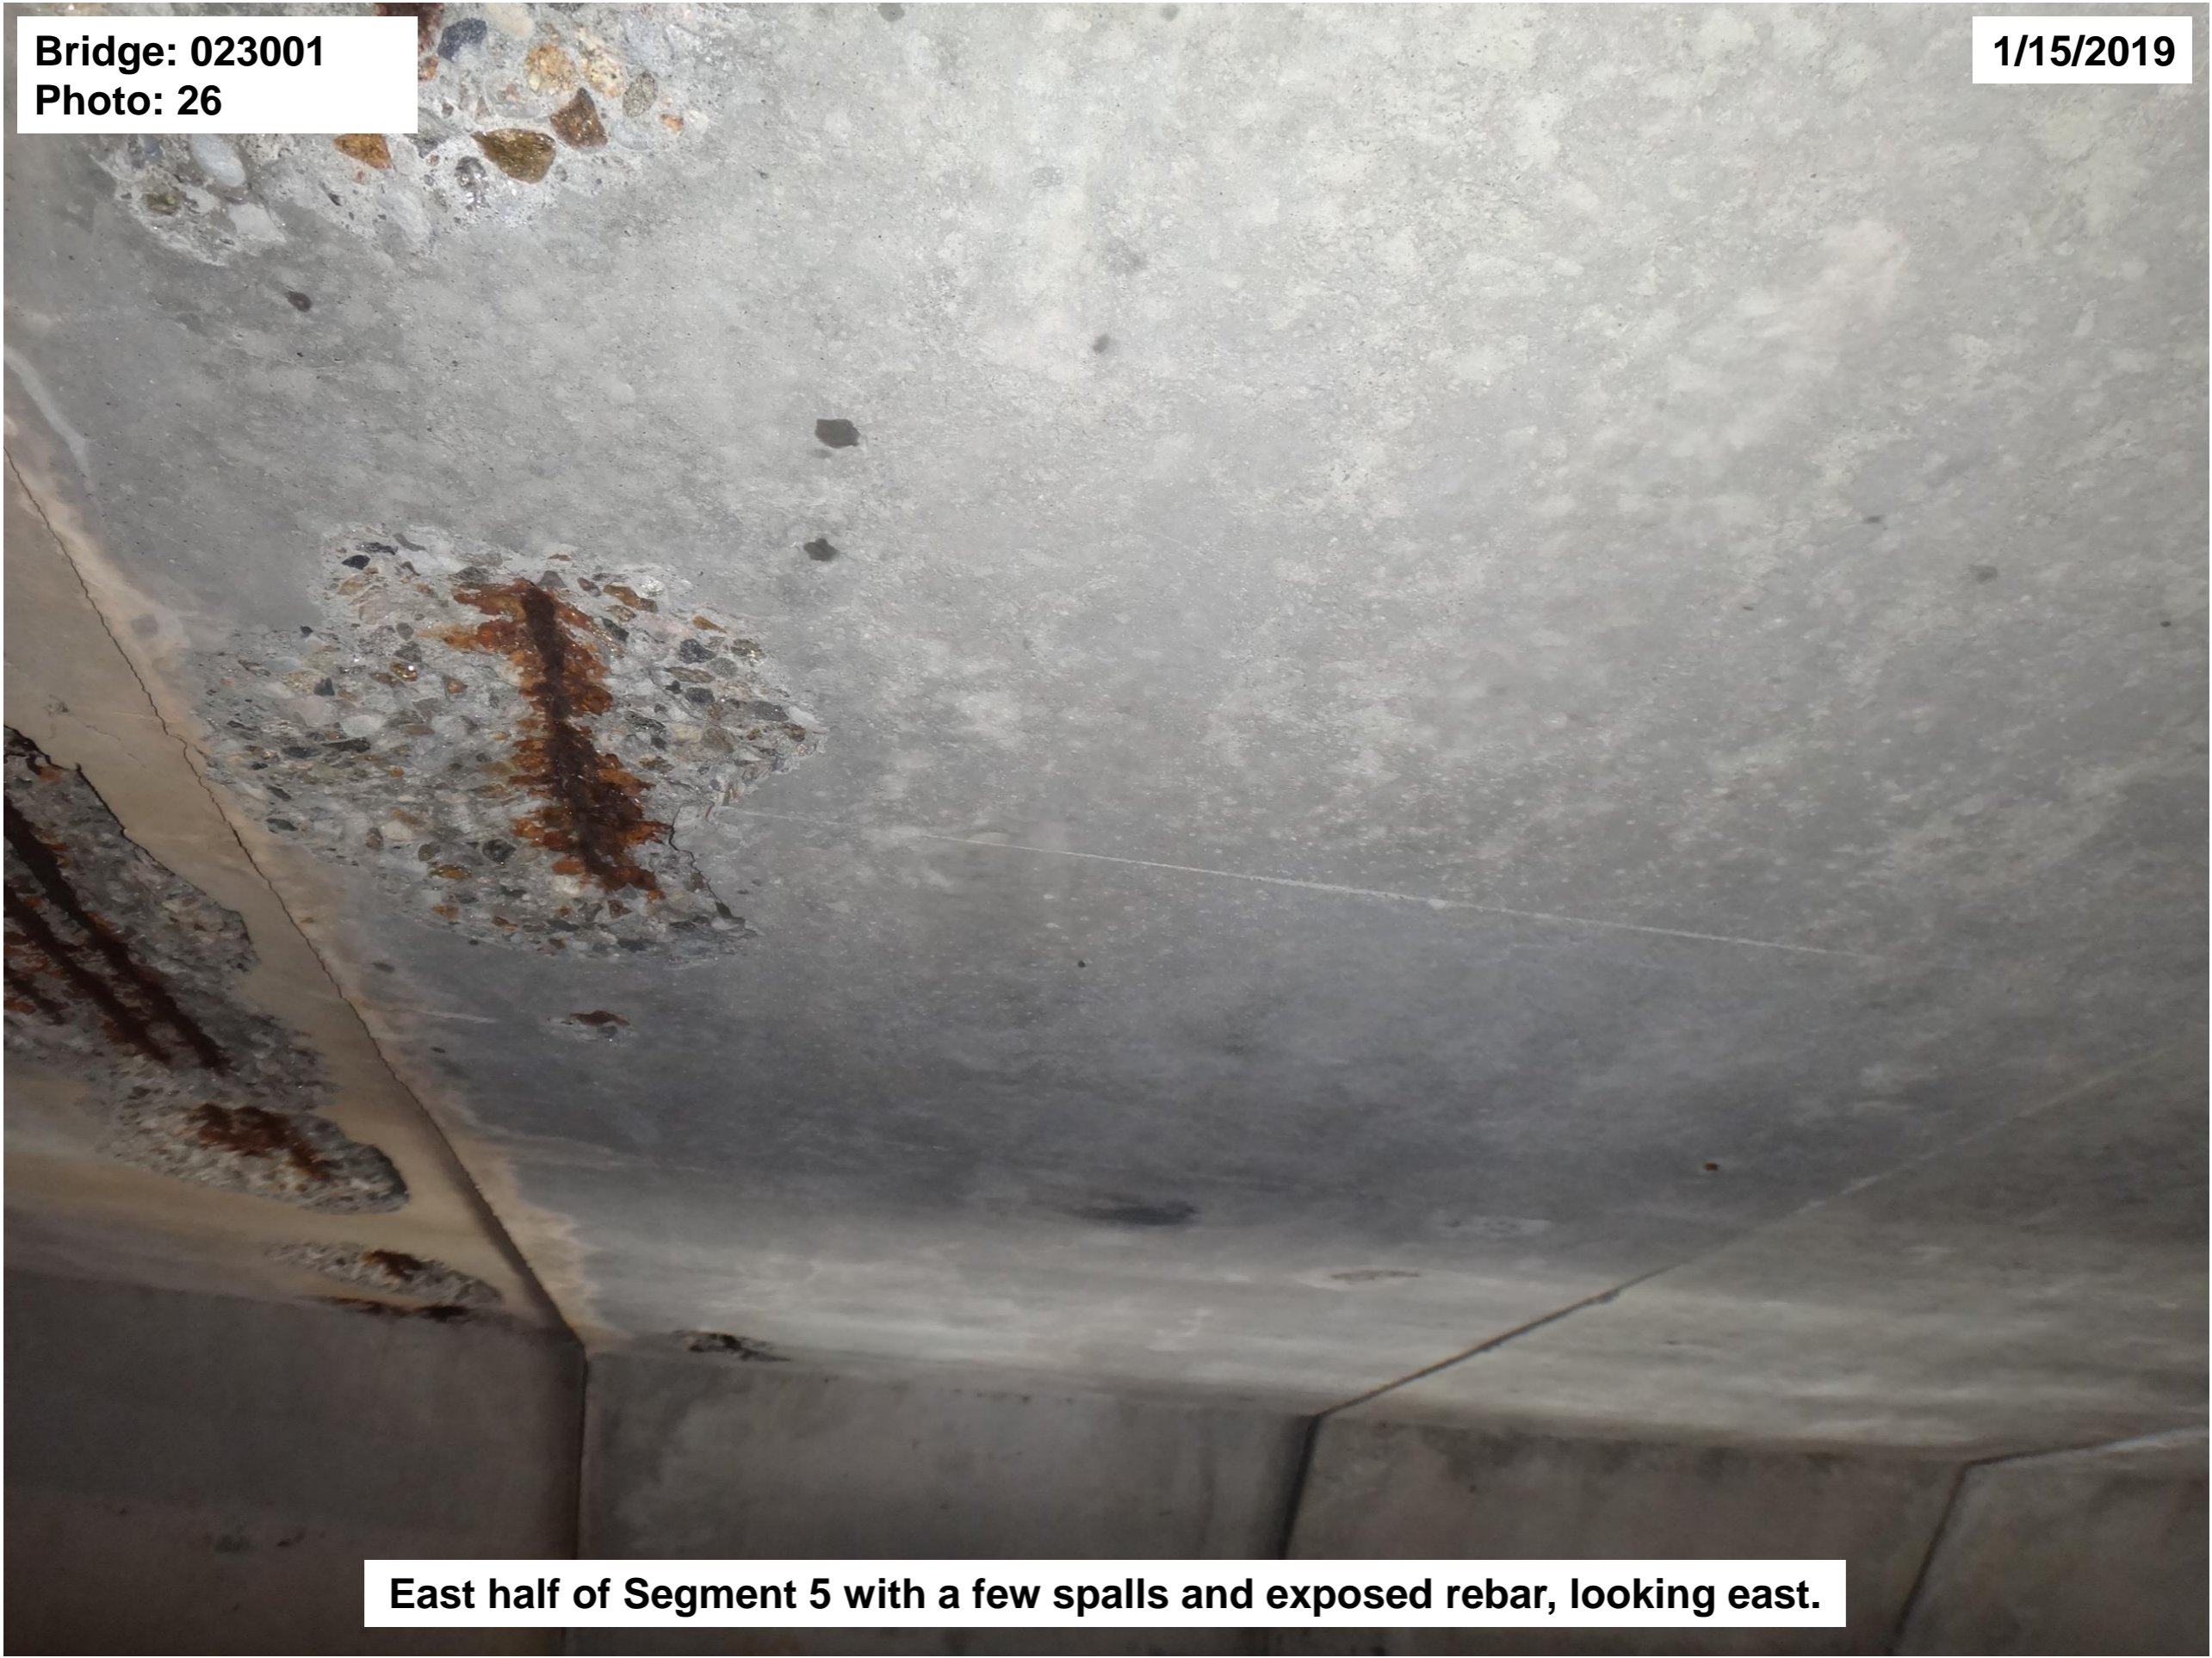
Bridge: 023001  
Photo: 27

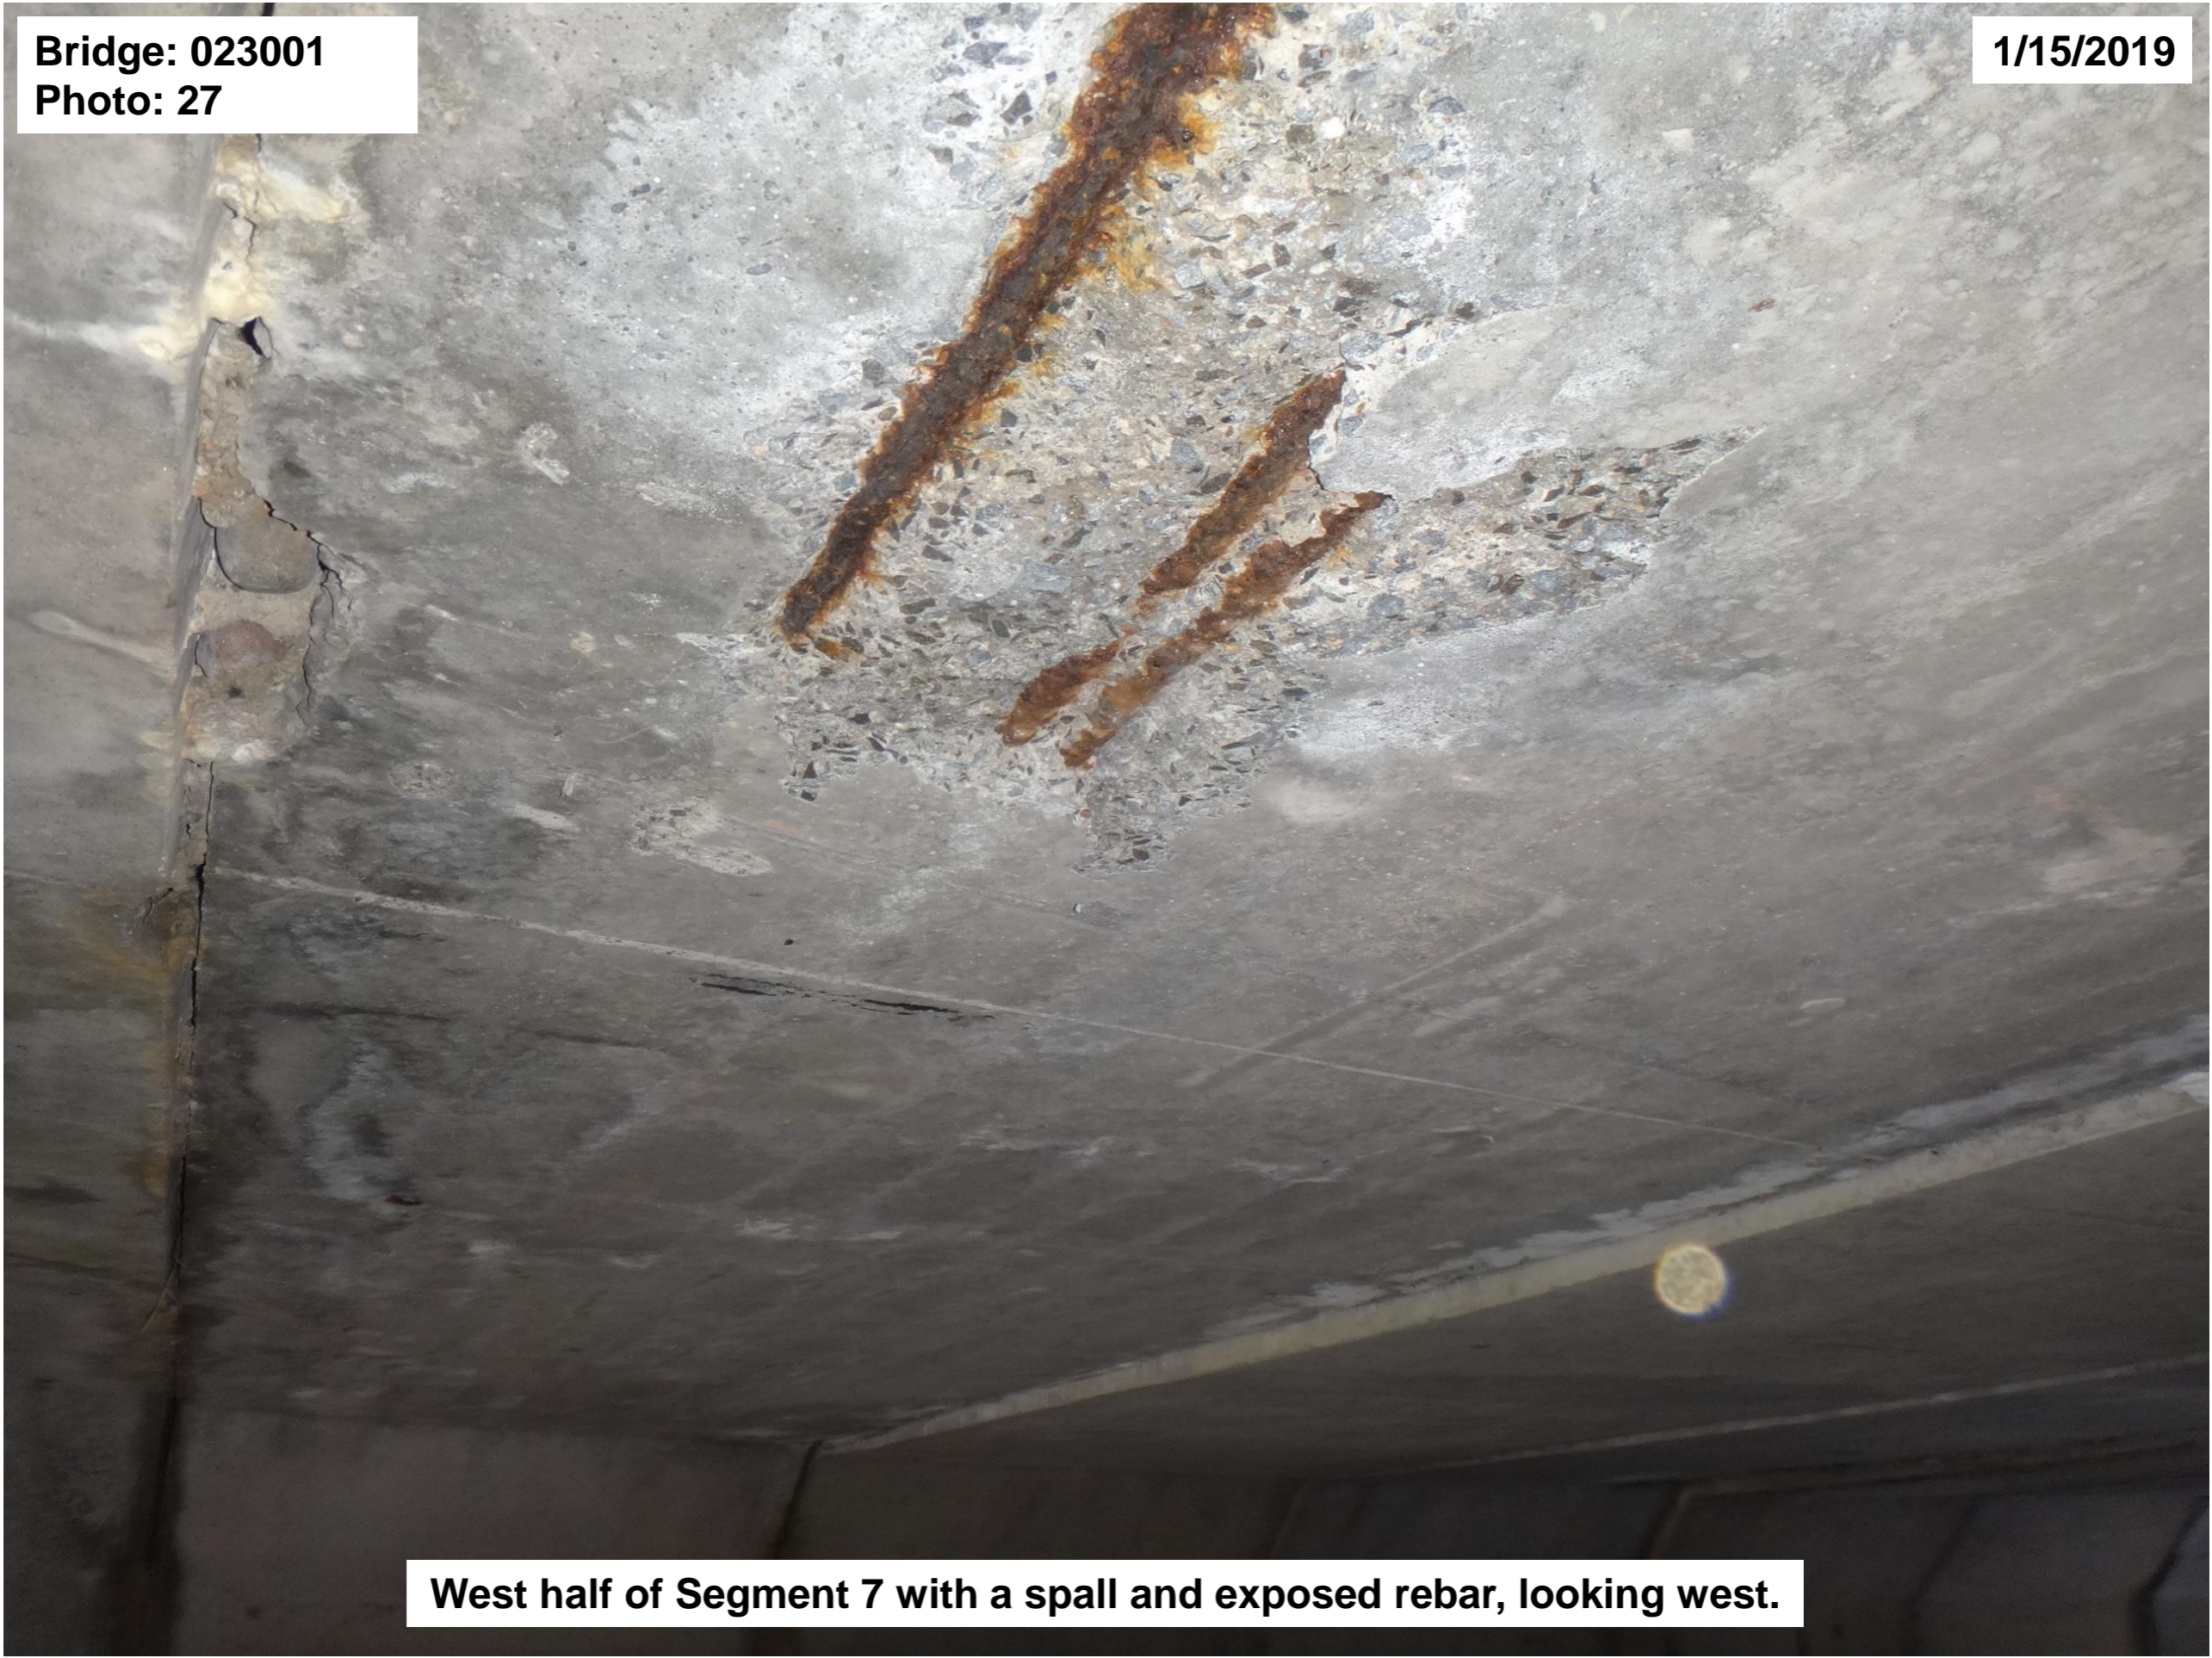
Bridge: 023001  
Photo: 28

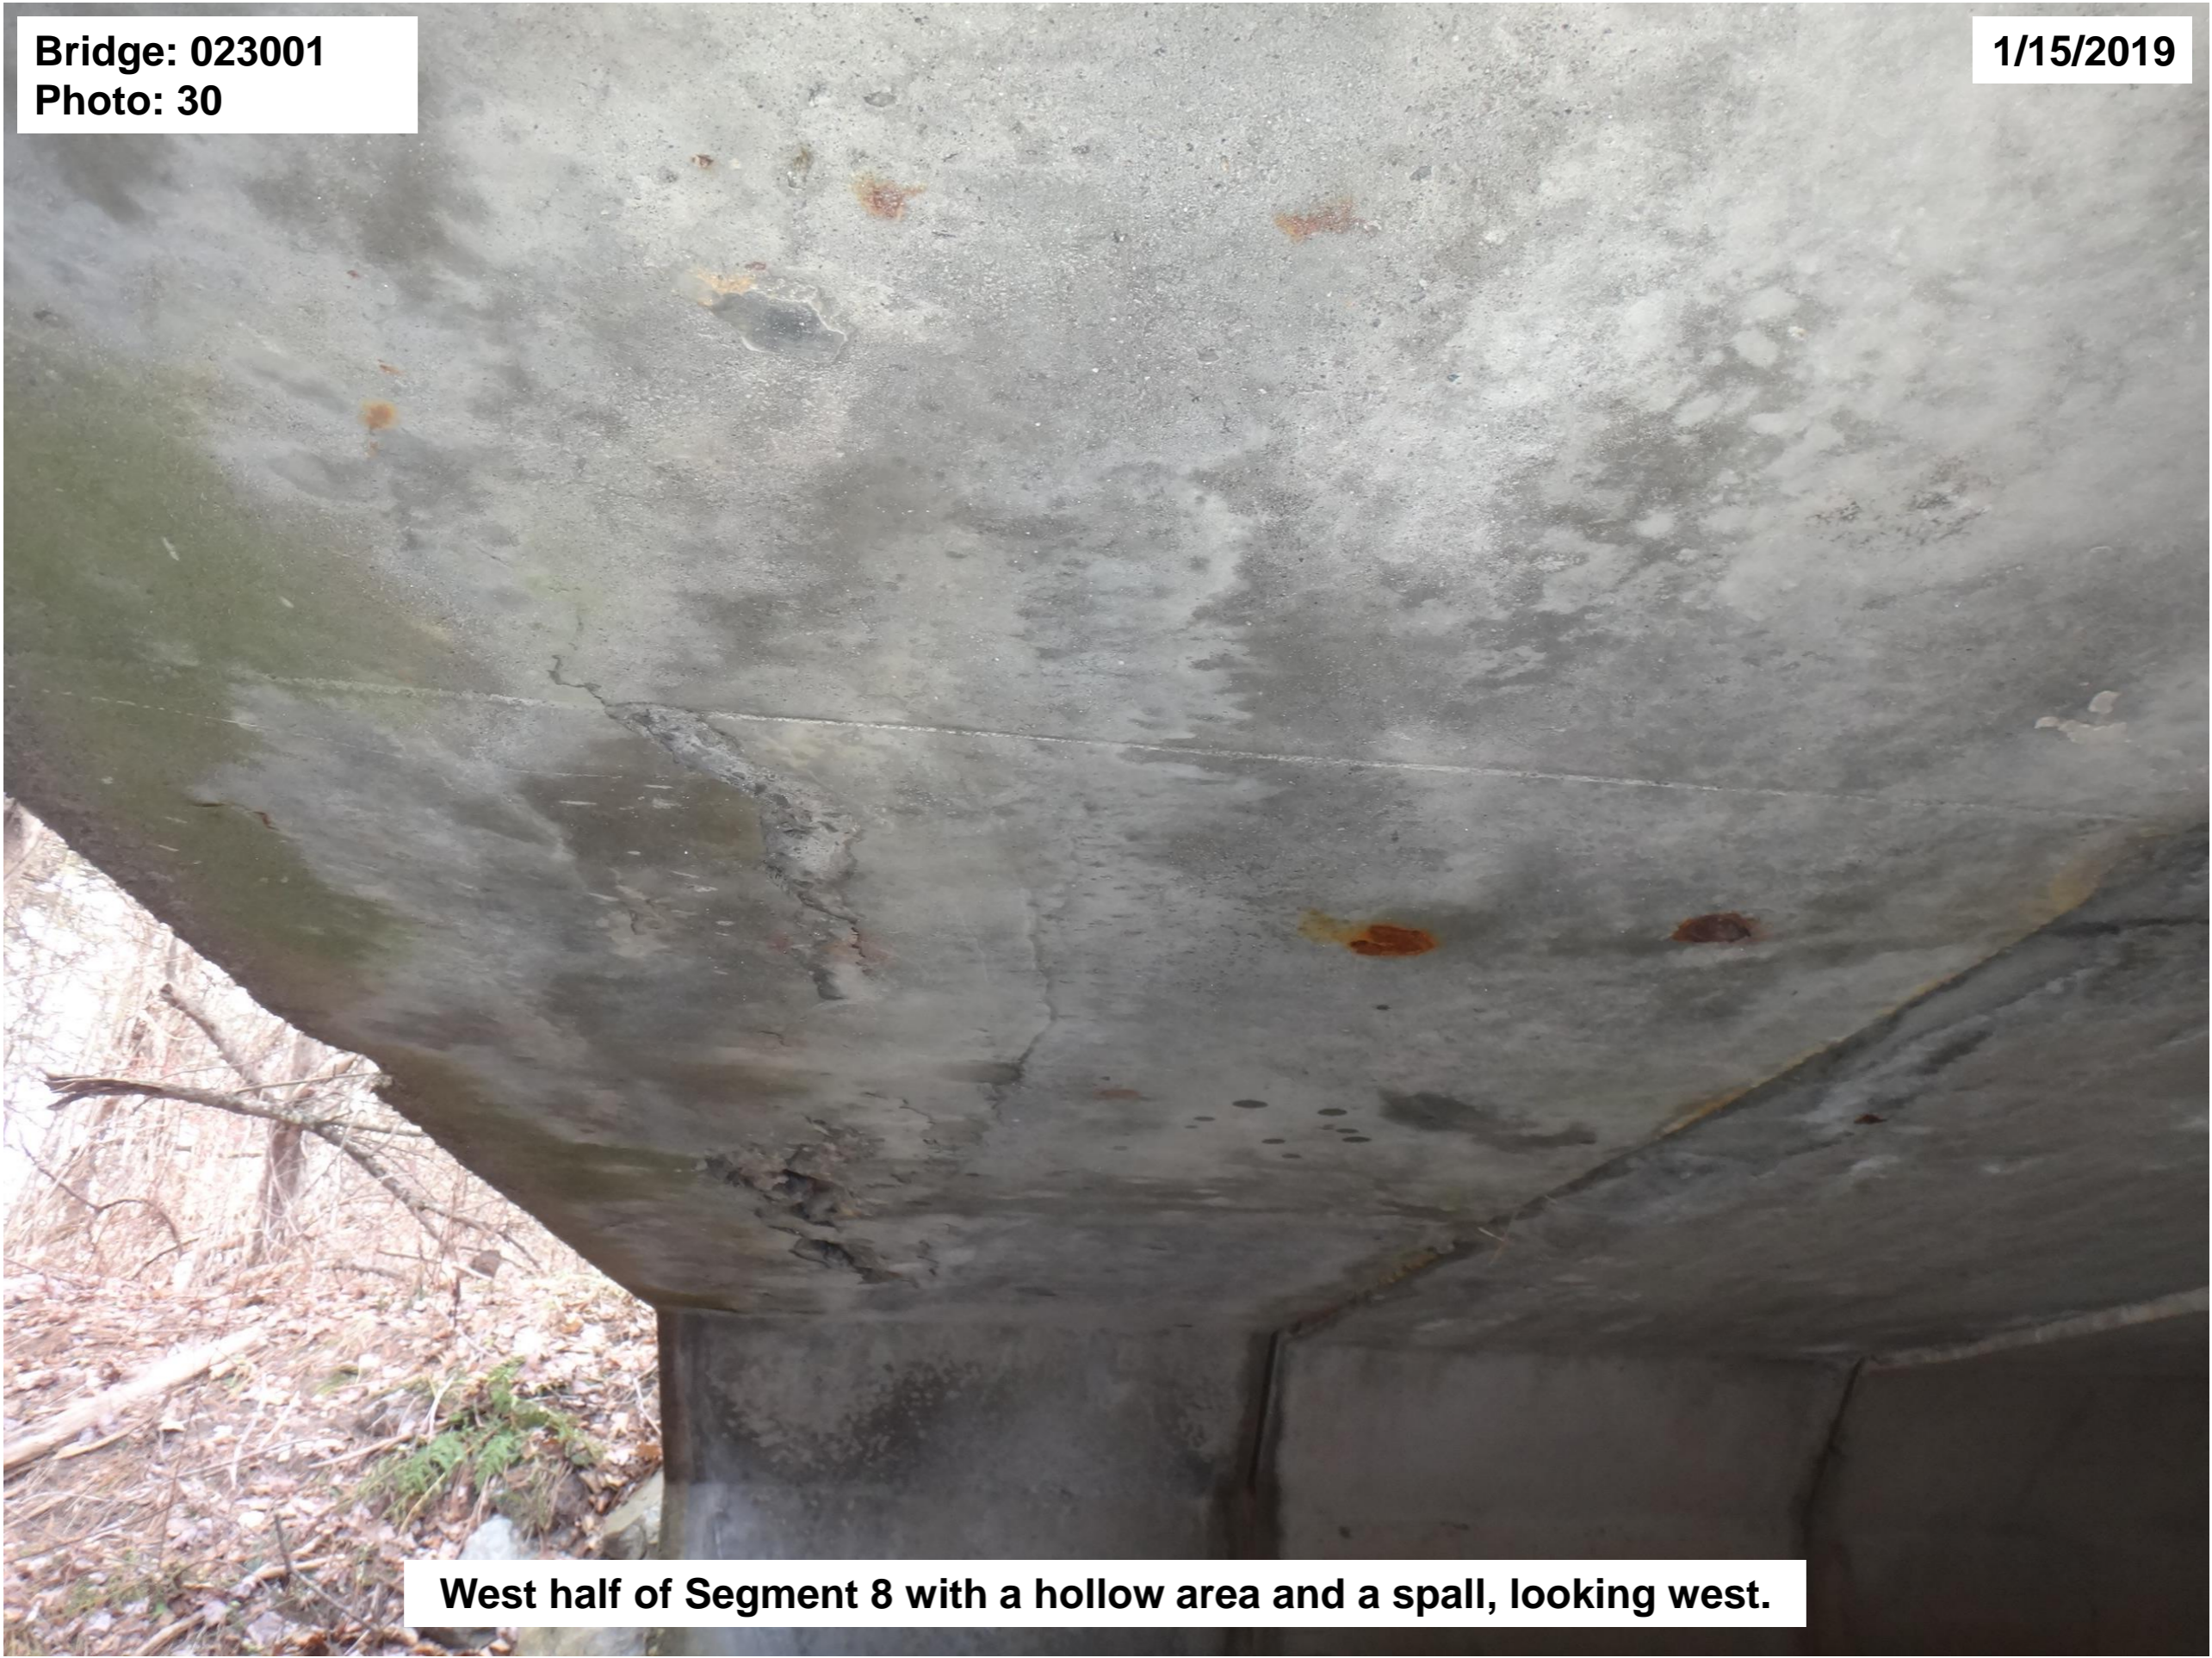
Bridge: 023001  
Photo: 31

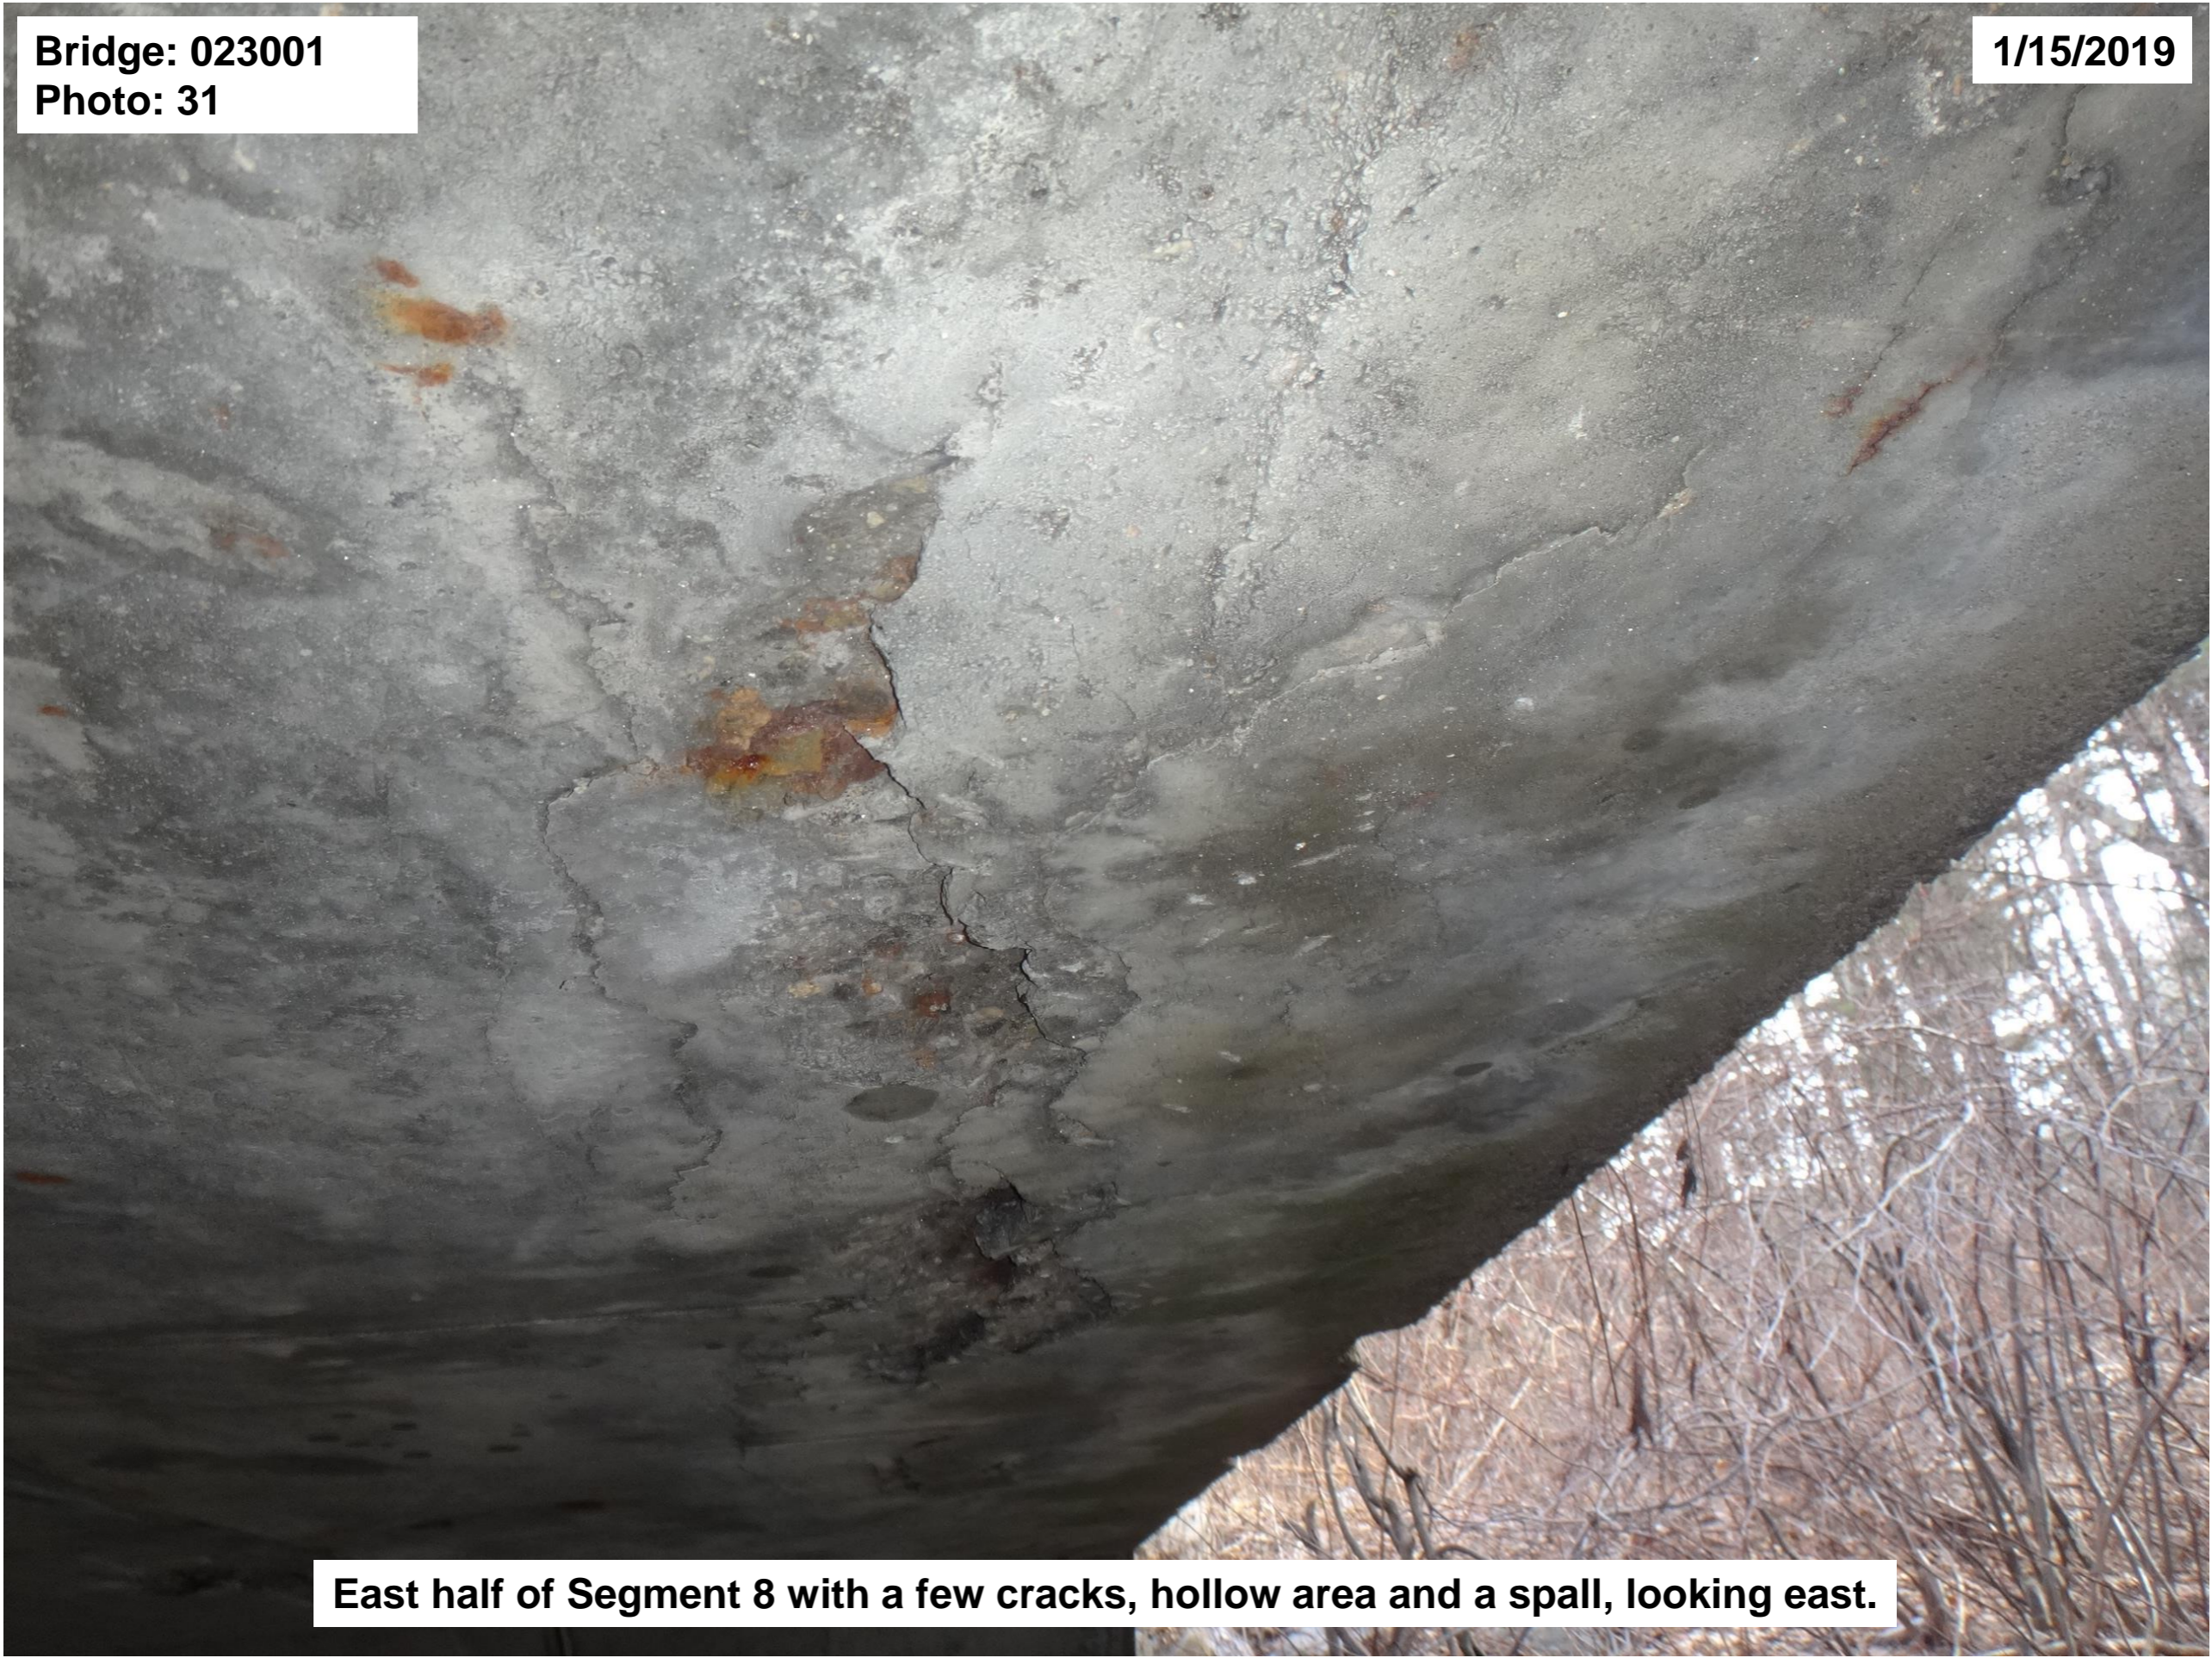
Bridge: 023001  
Photo: 32

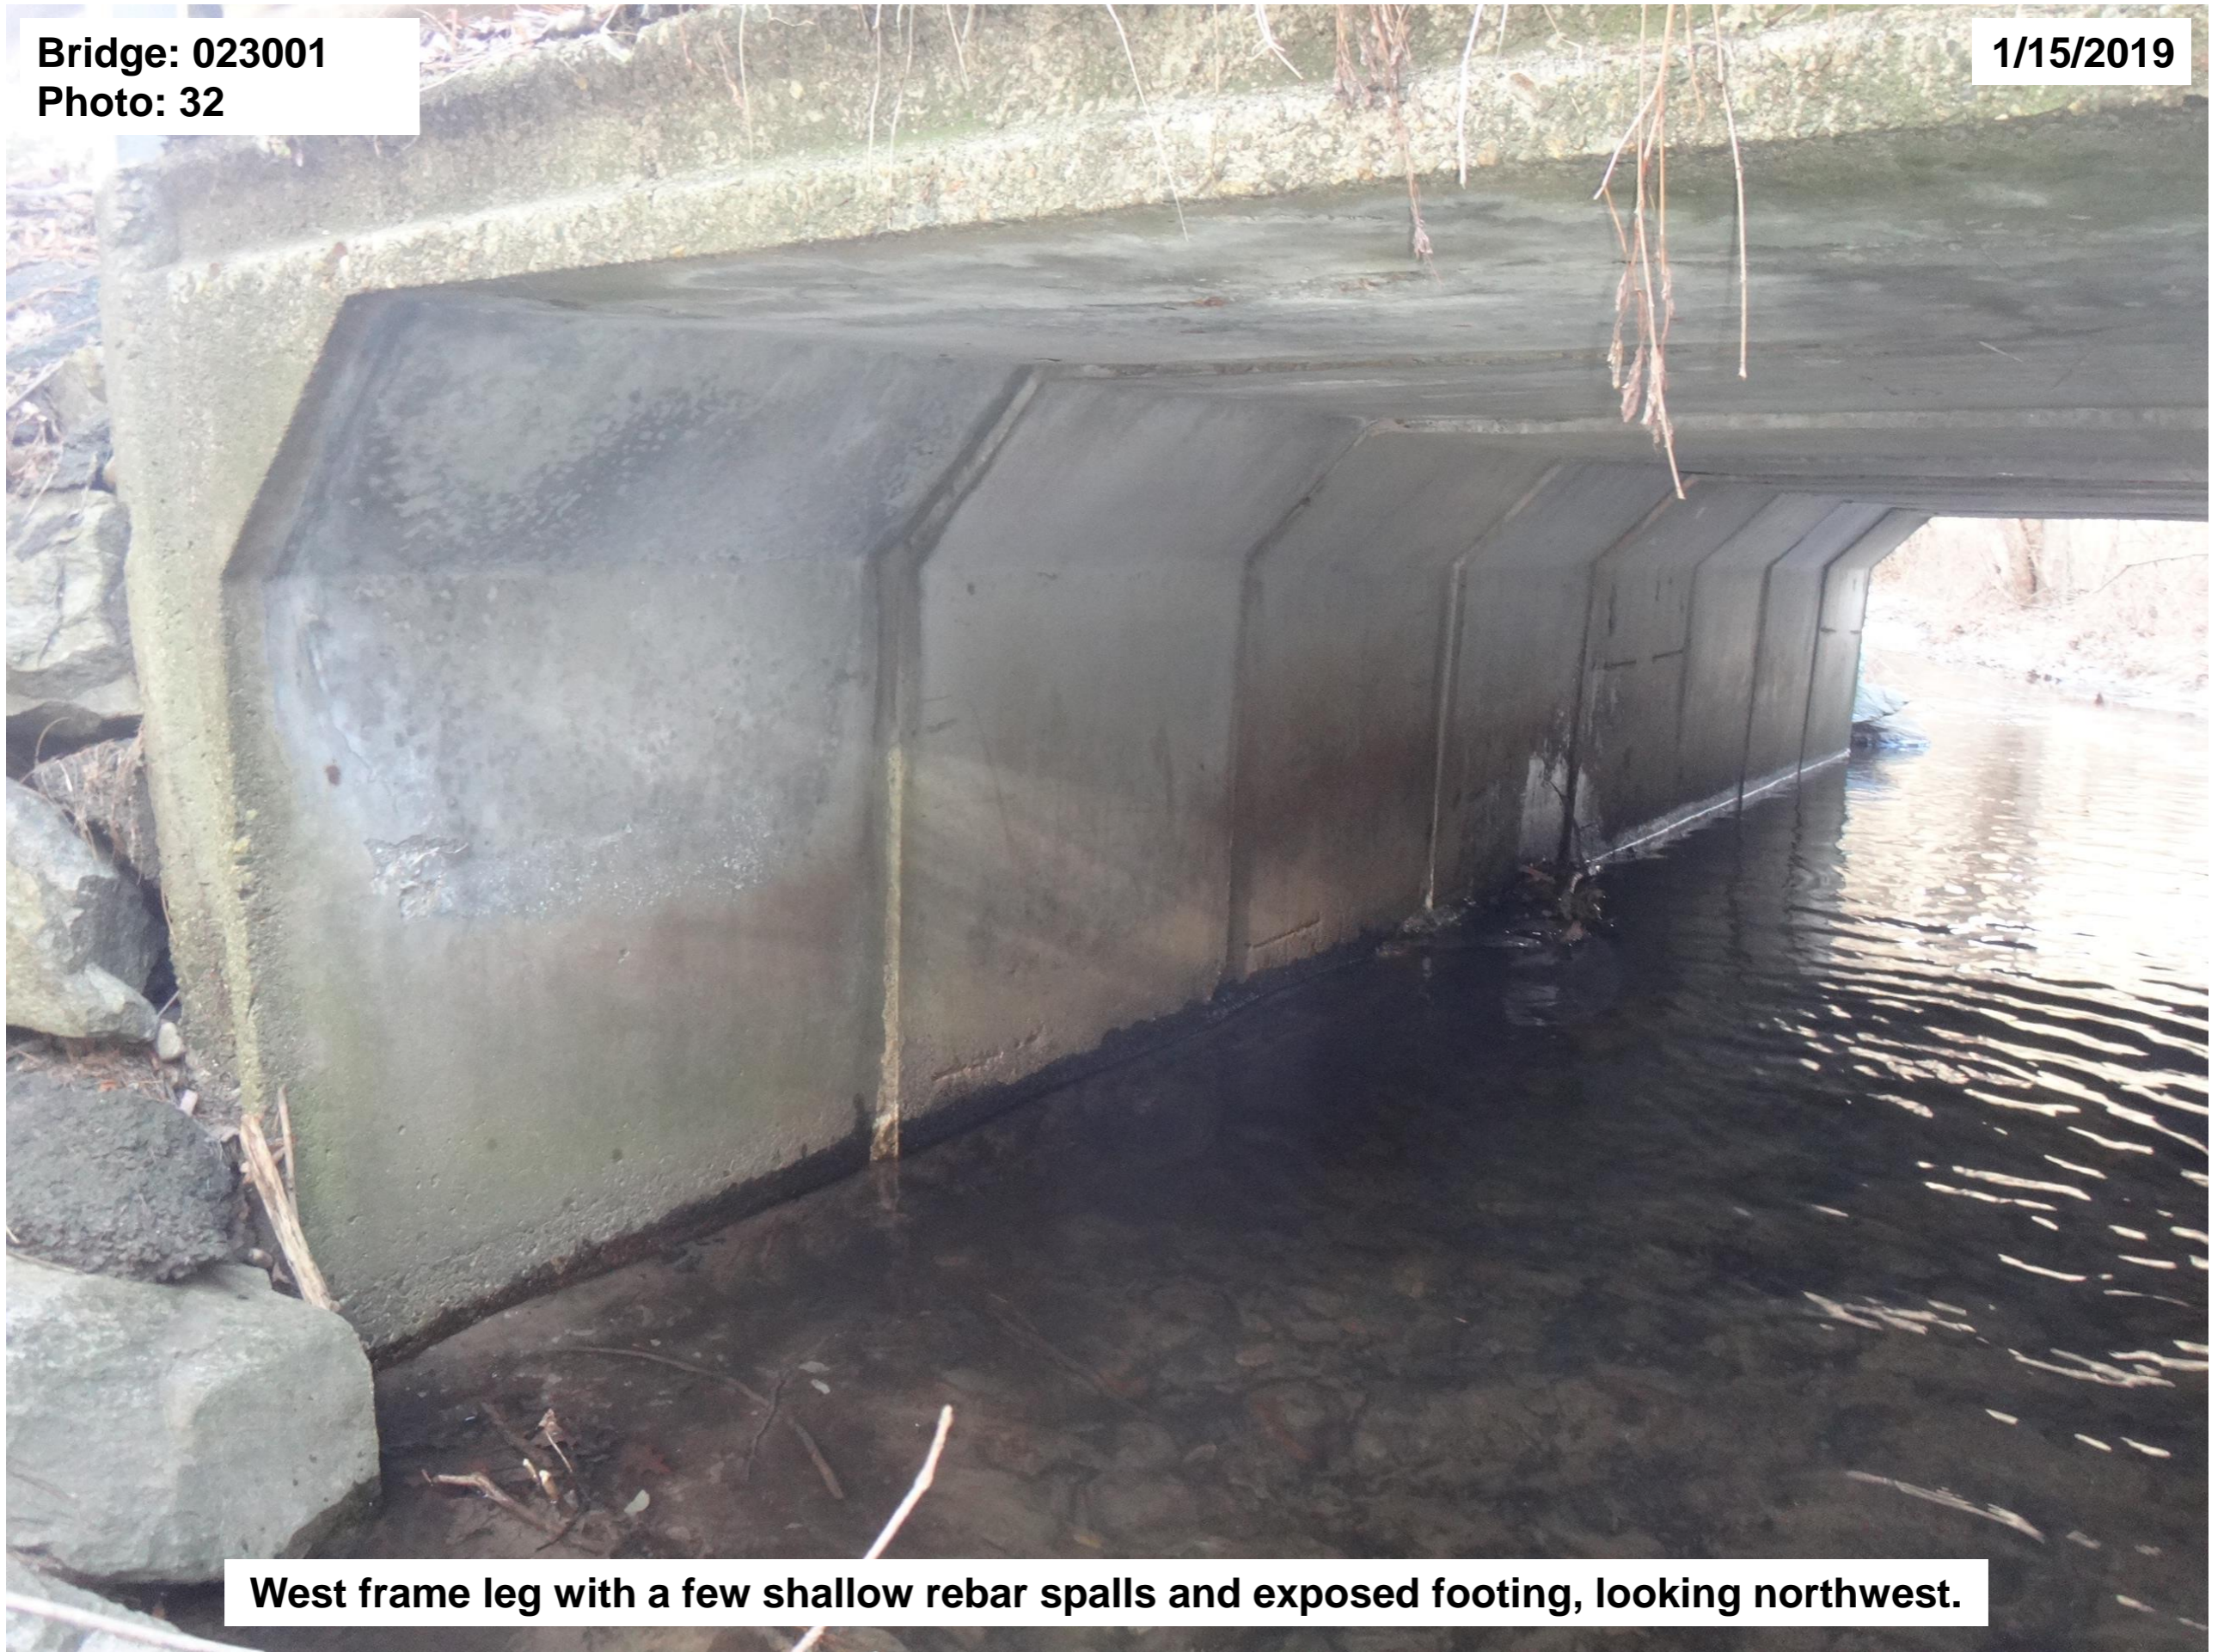
West frame leg with a few shallow rebar spalls and exposed footing, looking northwest.

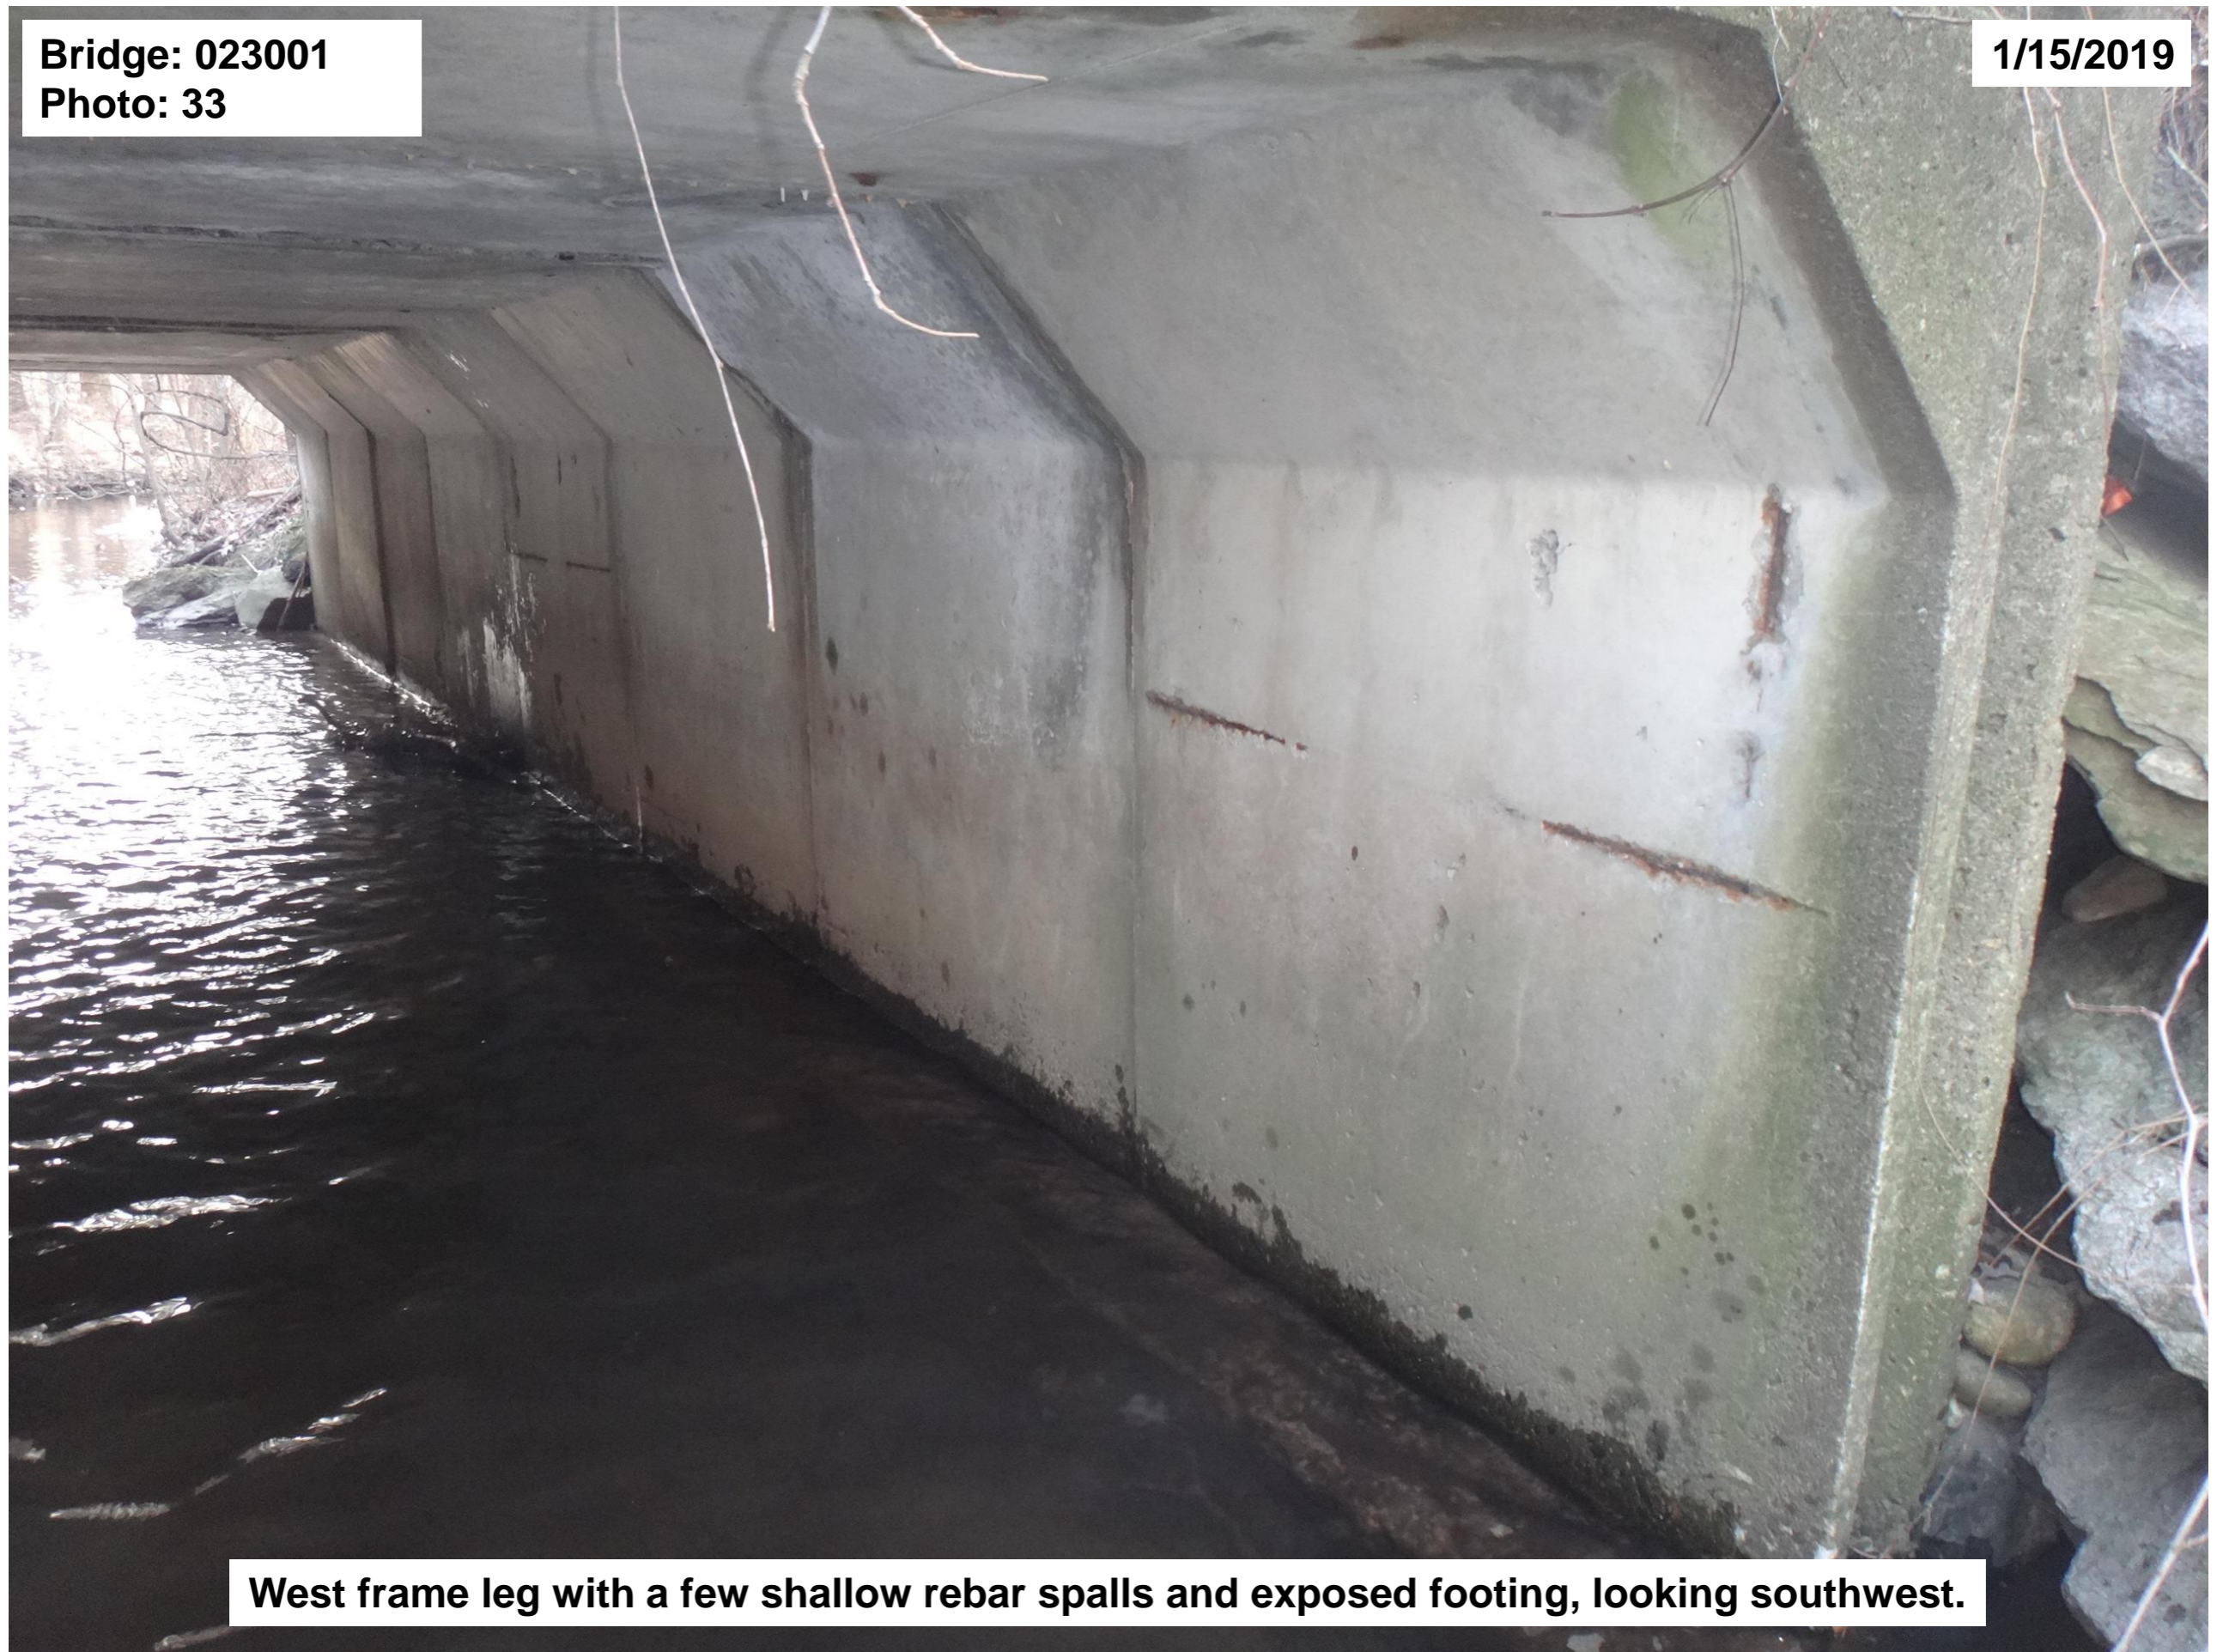
West frame leg with a few shallow rebar spalls and exposed footing, looking southwest.
