# Table of Contents

OLD CANTON BRIDGE SIGNED APPLICATION.pdf .....	104
WASHBURN BRIDGE SIGNED APPLICATION.pdf .....	106

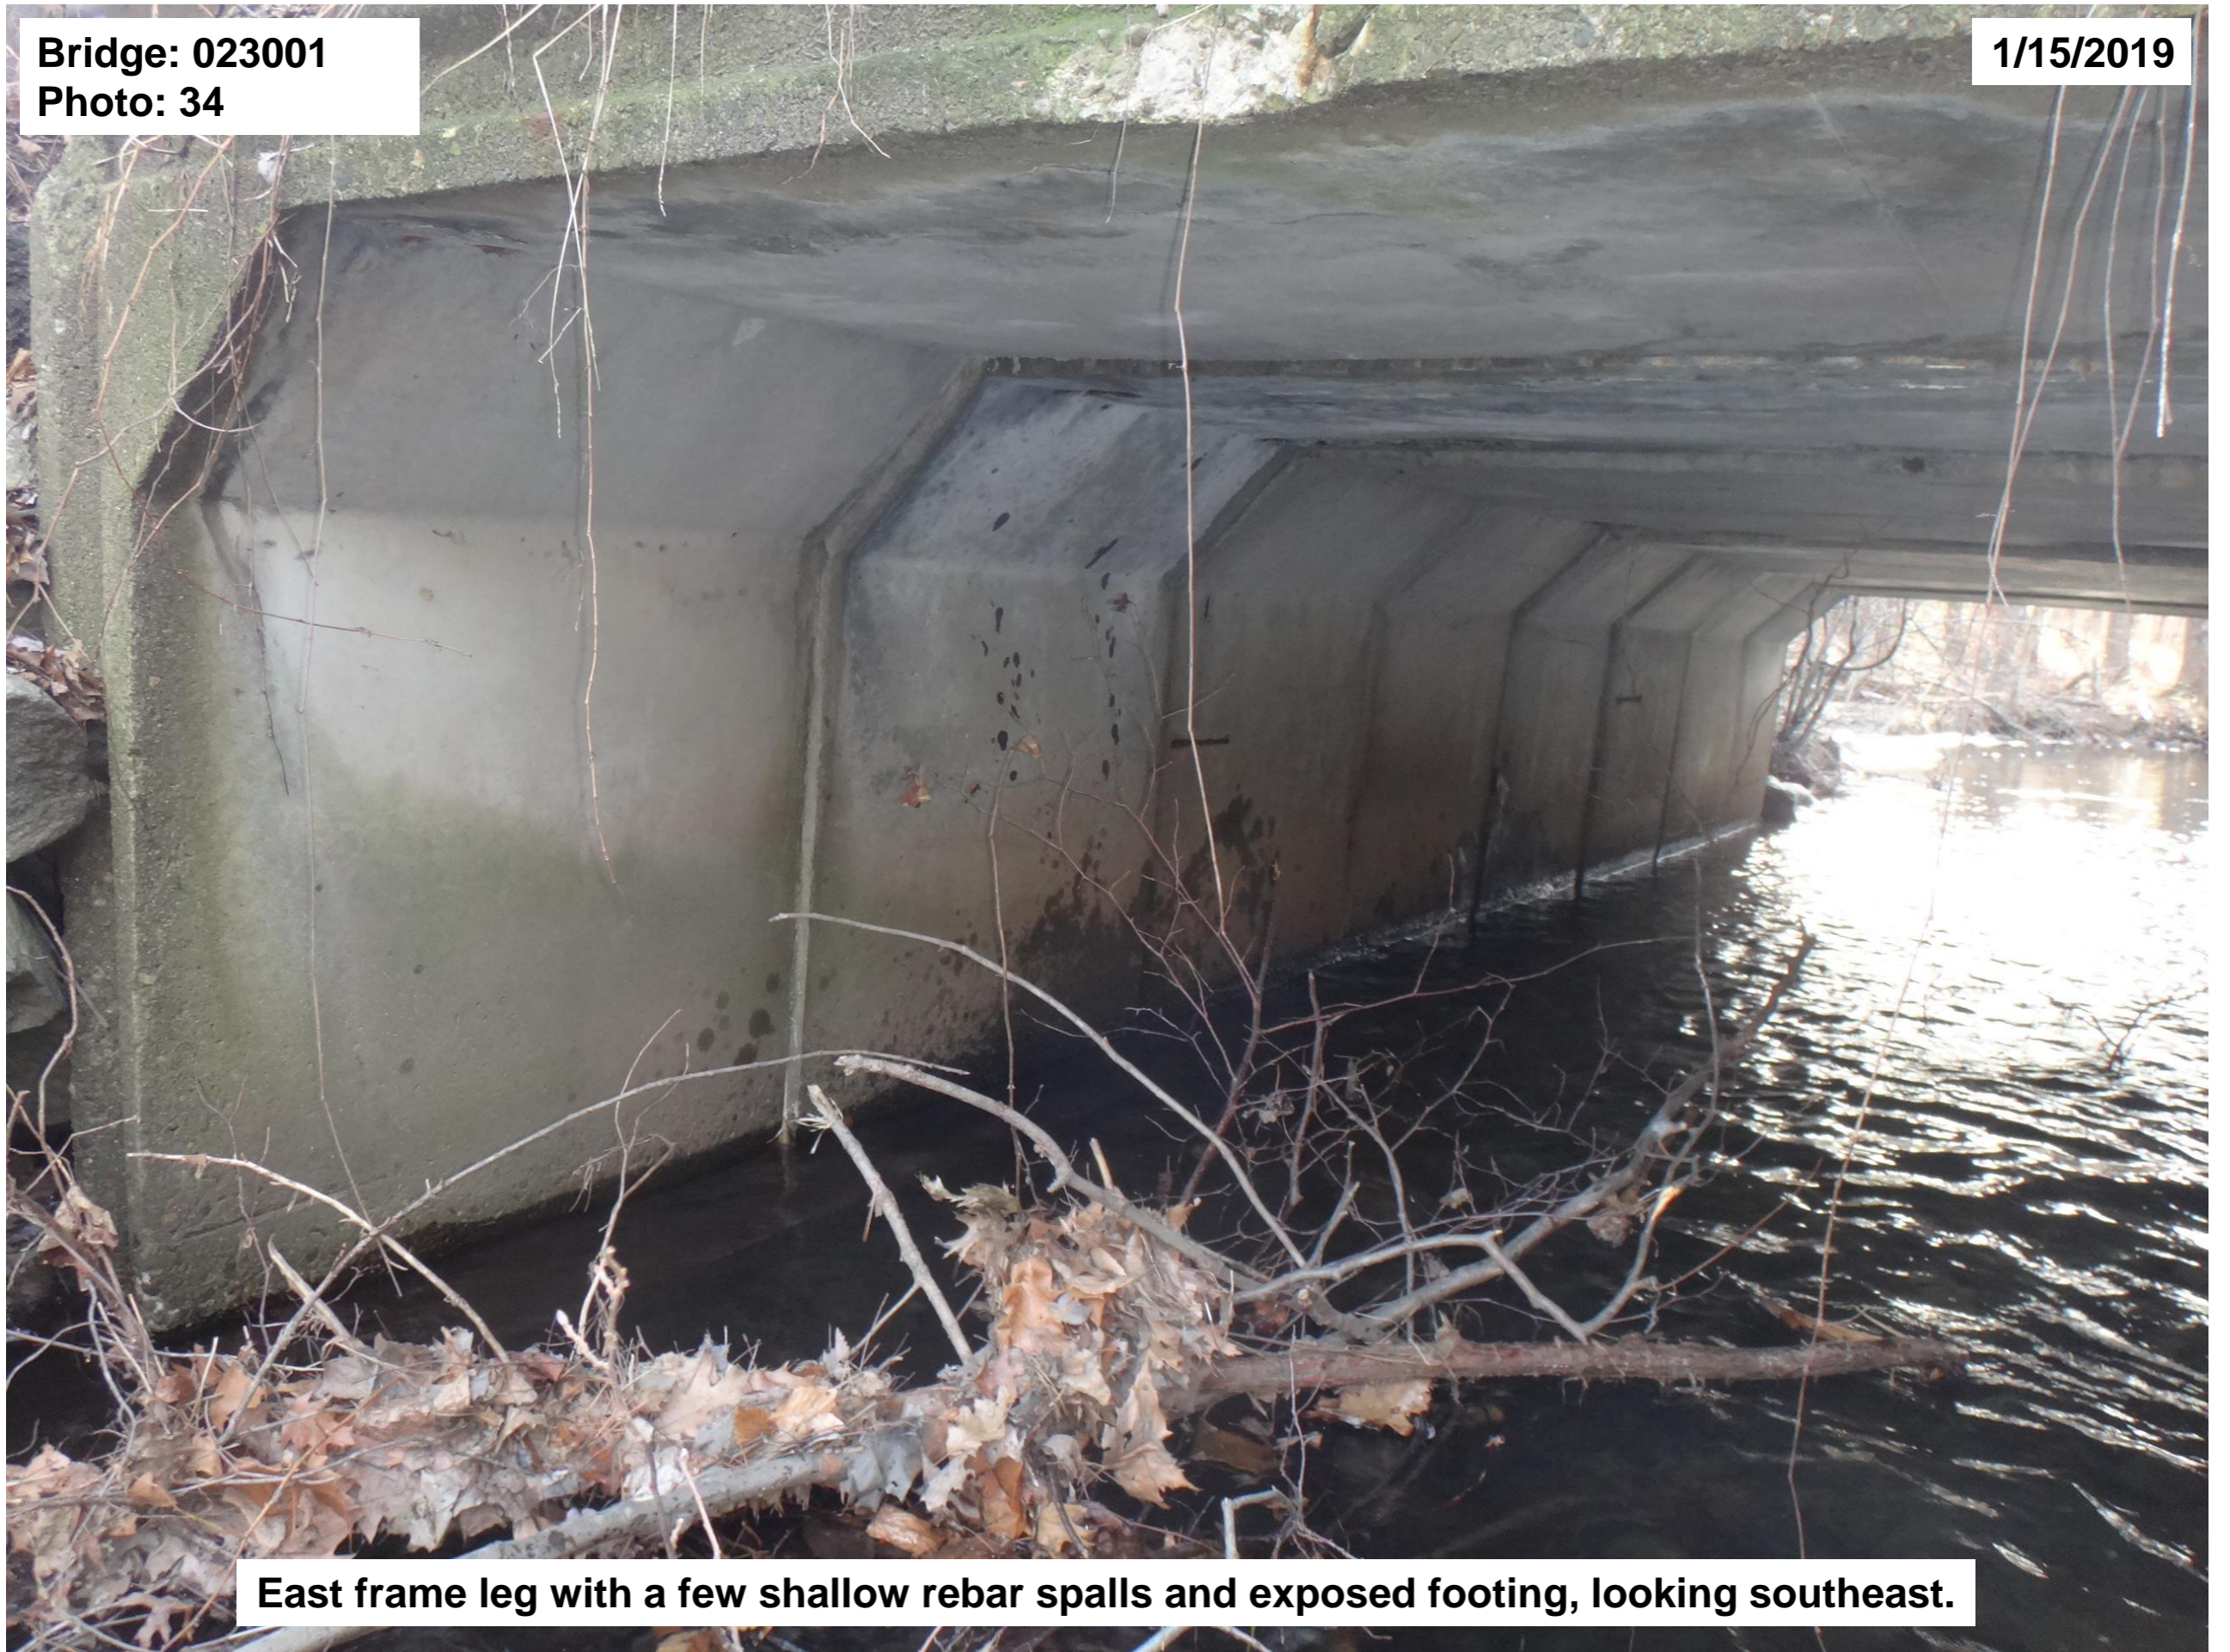
**East frame leg with a few shallow rebar spalls and exposed footing, looking southeast.**

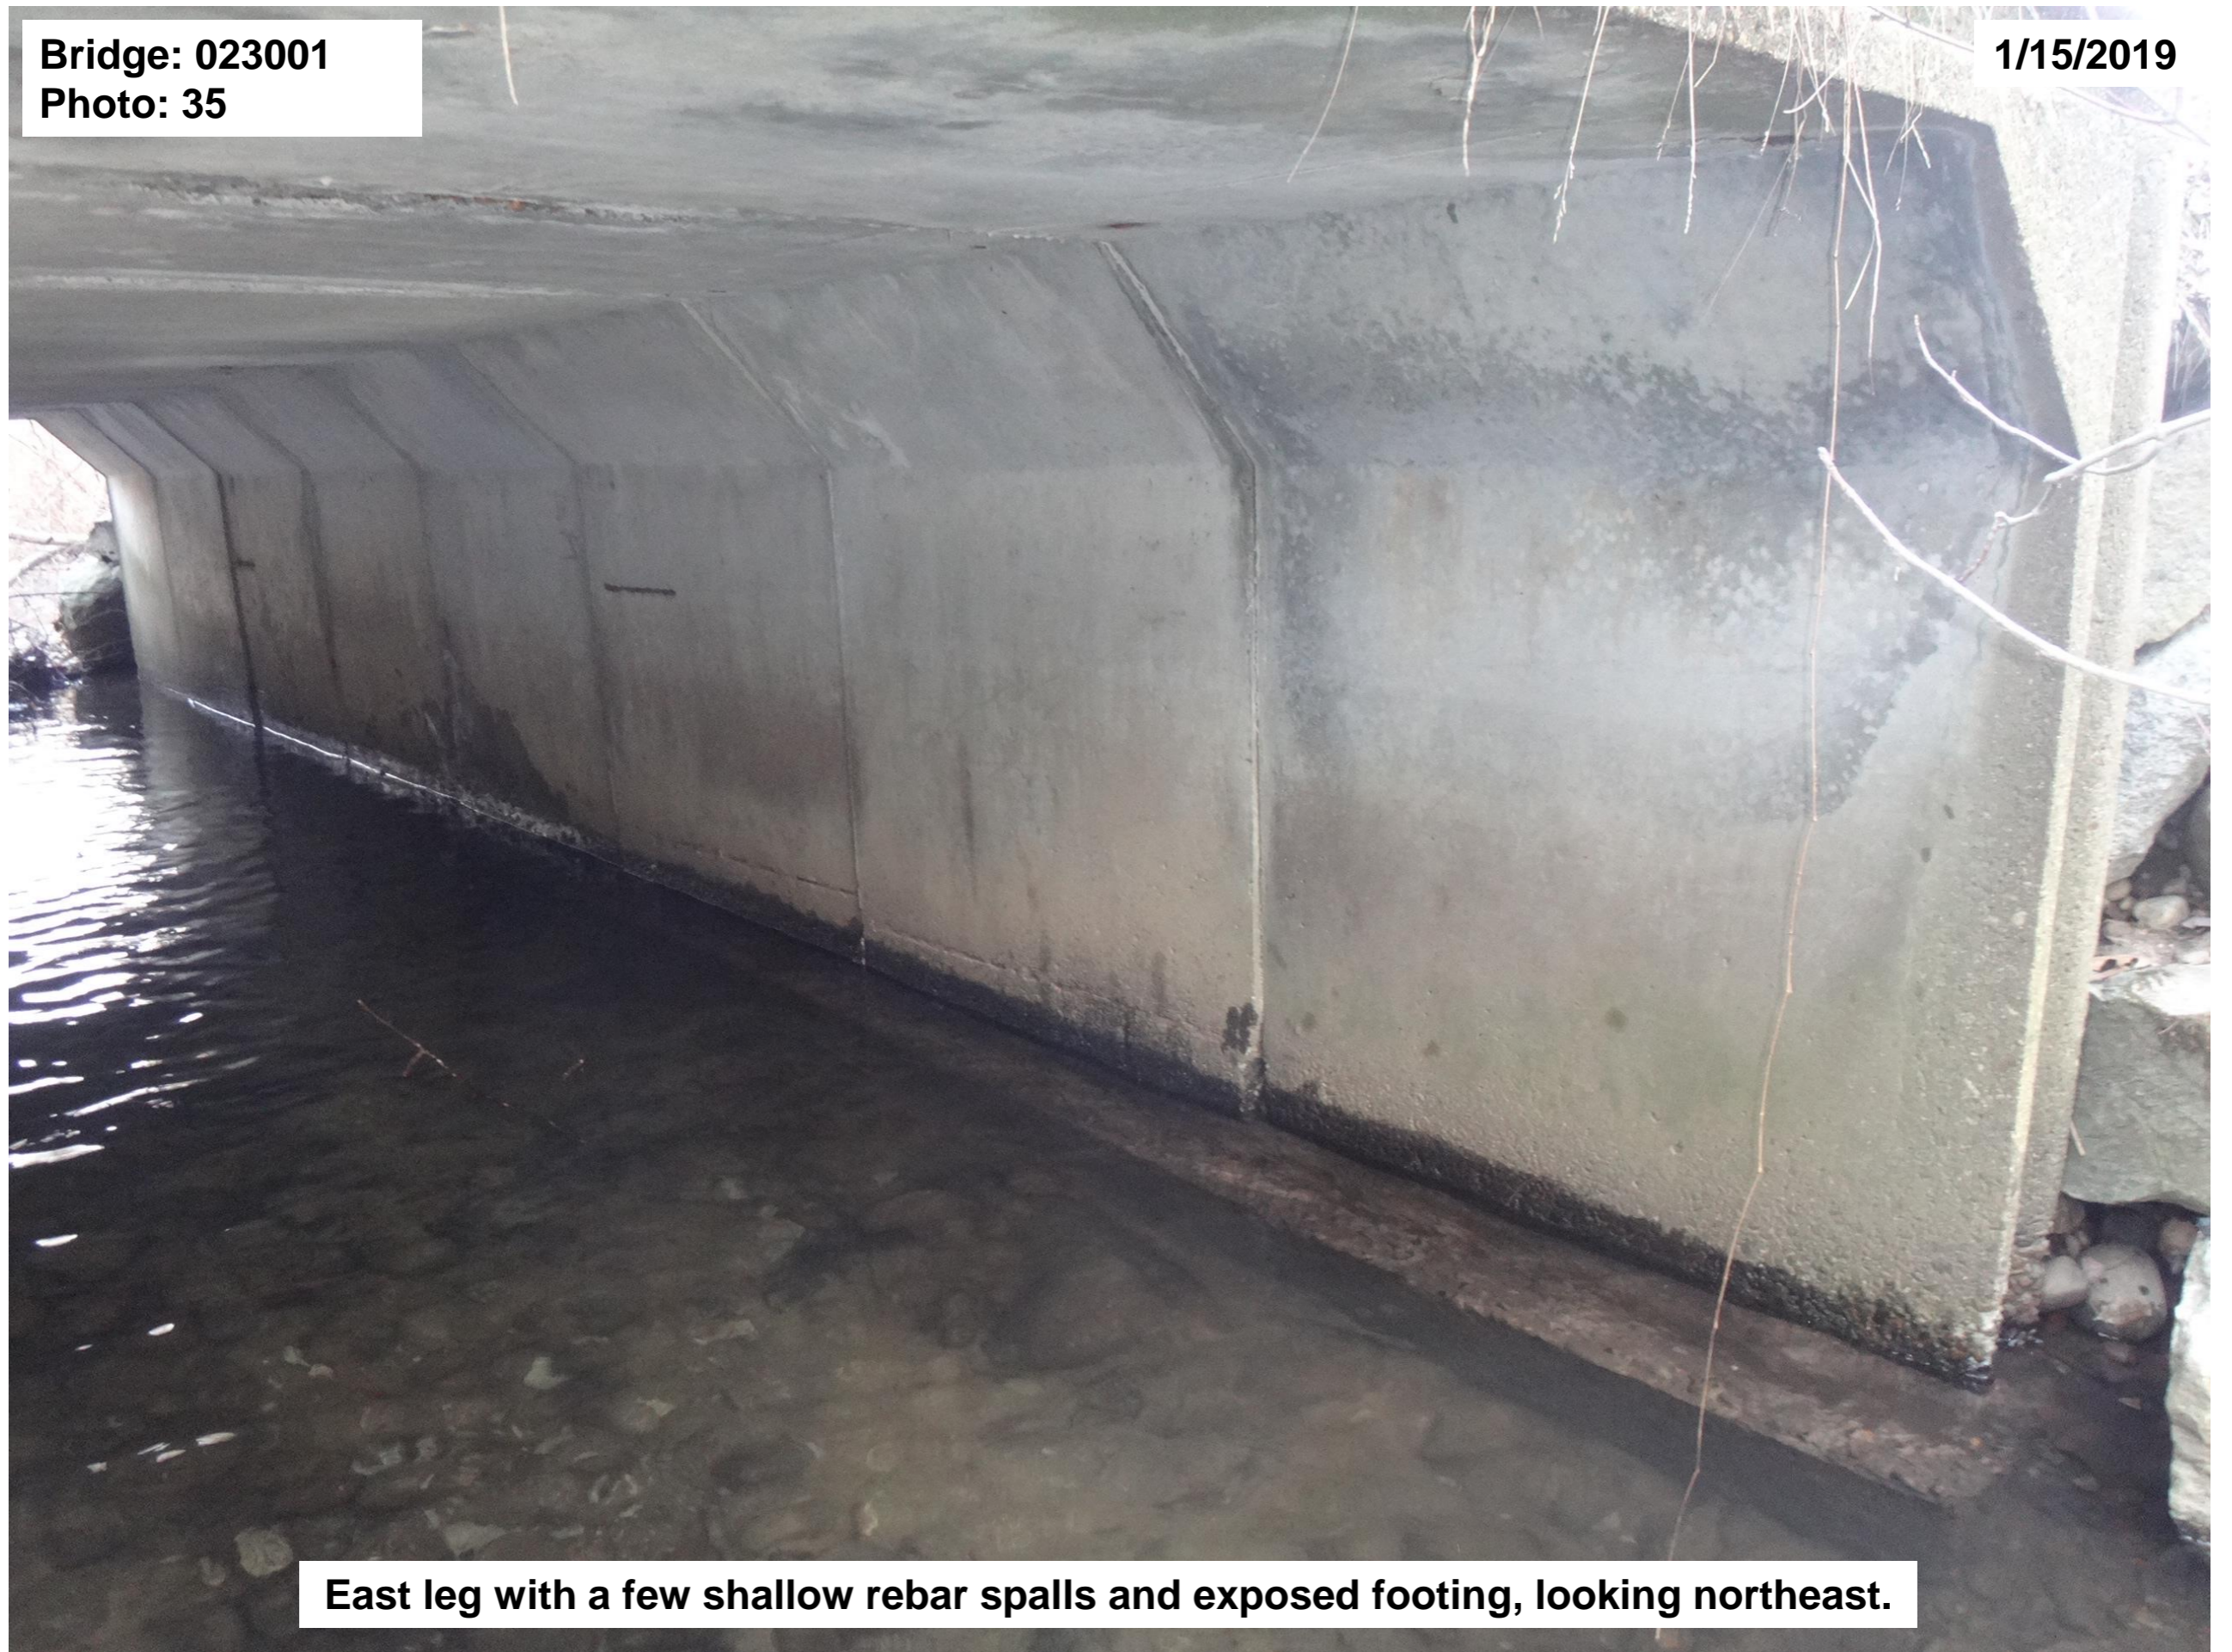
**East leg with a few shallow rebar spalls and exposed footing, looking northeast.**

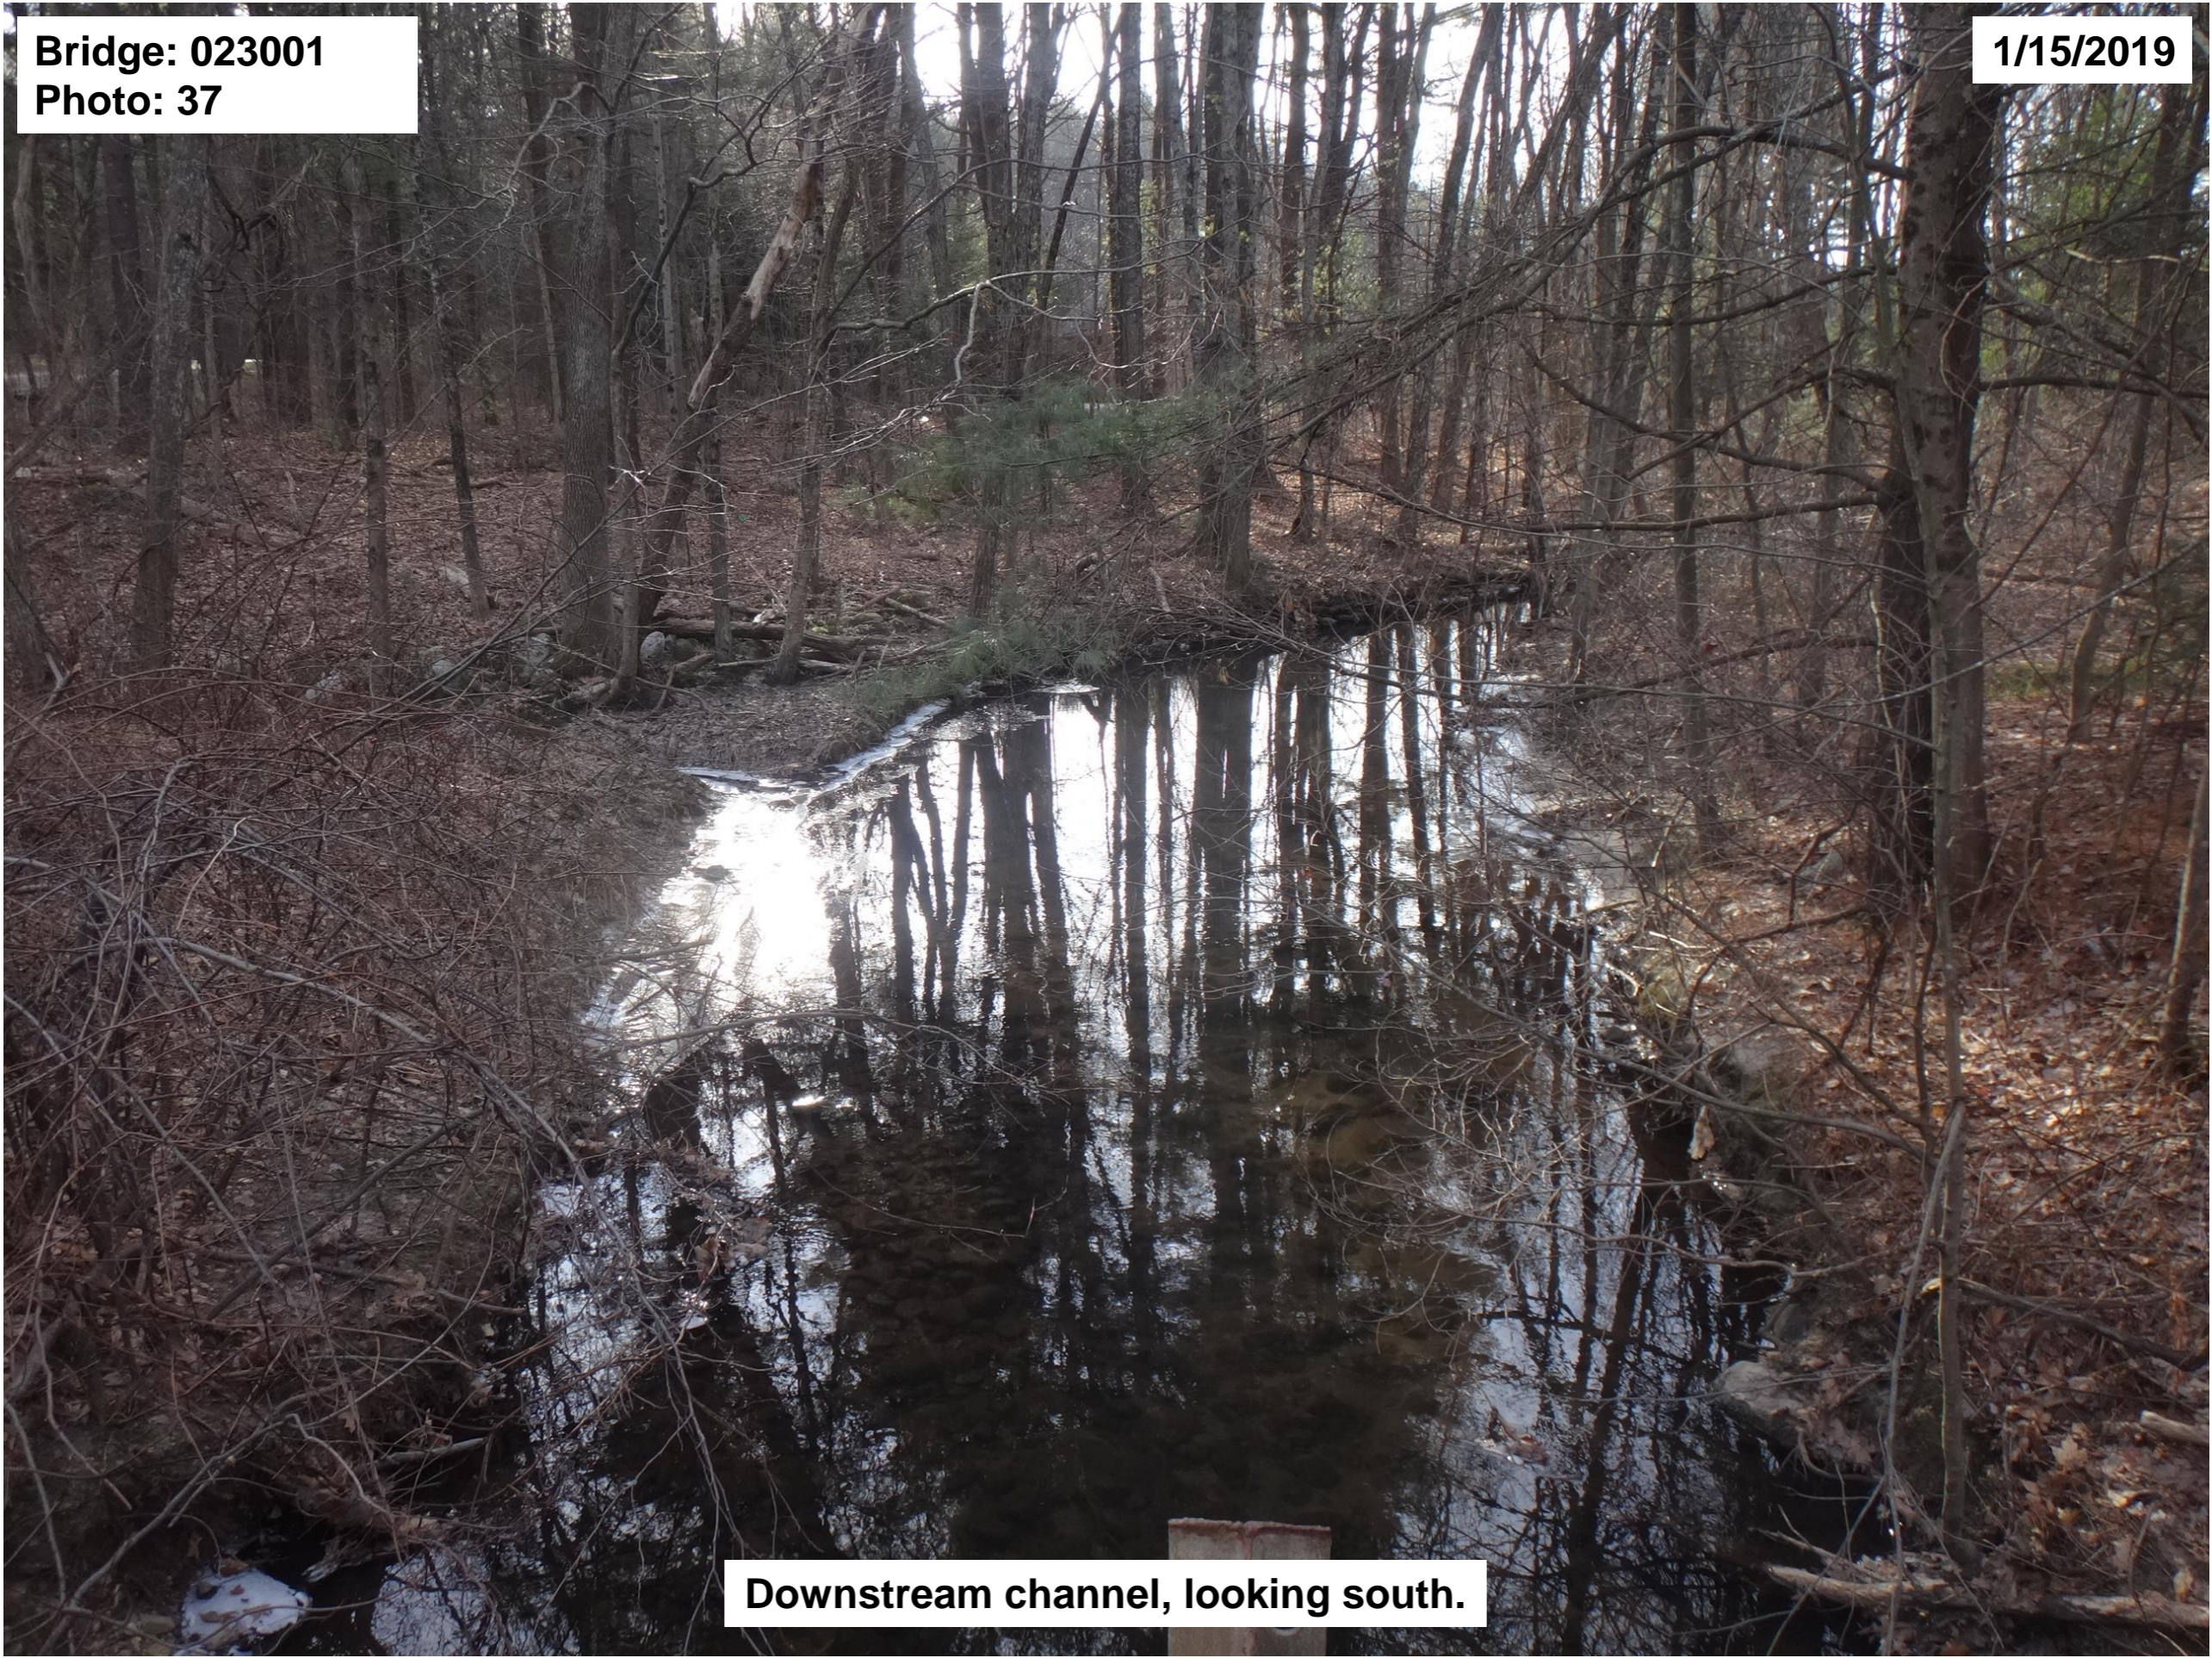
**TOWN OF CANTON  
BRIDGE NO. 023001  
WASHBURN ROAD OVER JIM BROOK  
ROUTINE AND IN-DEPTH INSPECTION  
BRIDGE REPLACEMENT ESTIMATE  
February 2019**

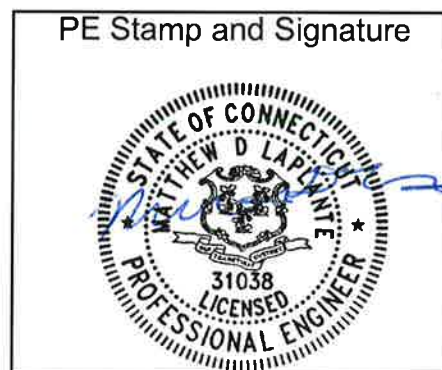
**INSPECTION REPORT**

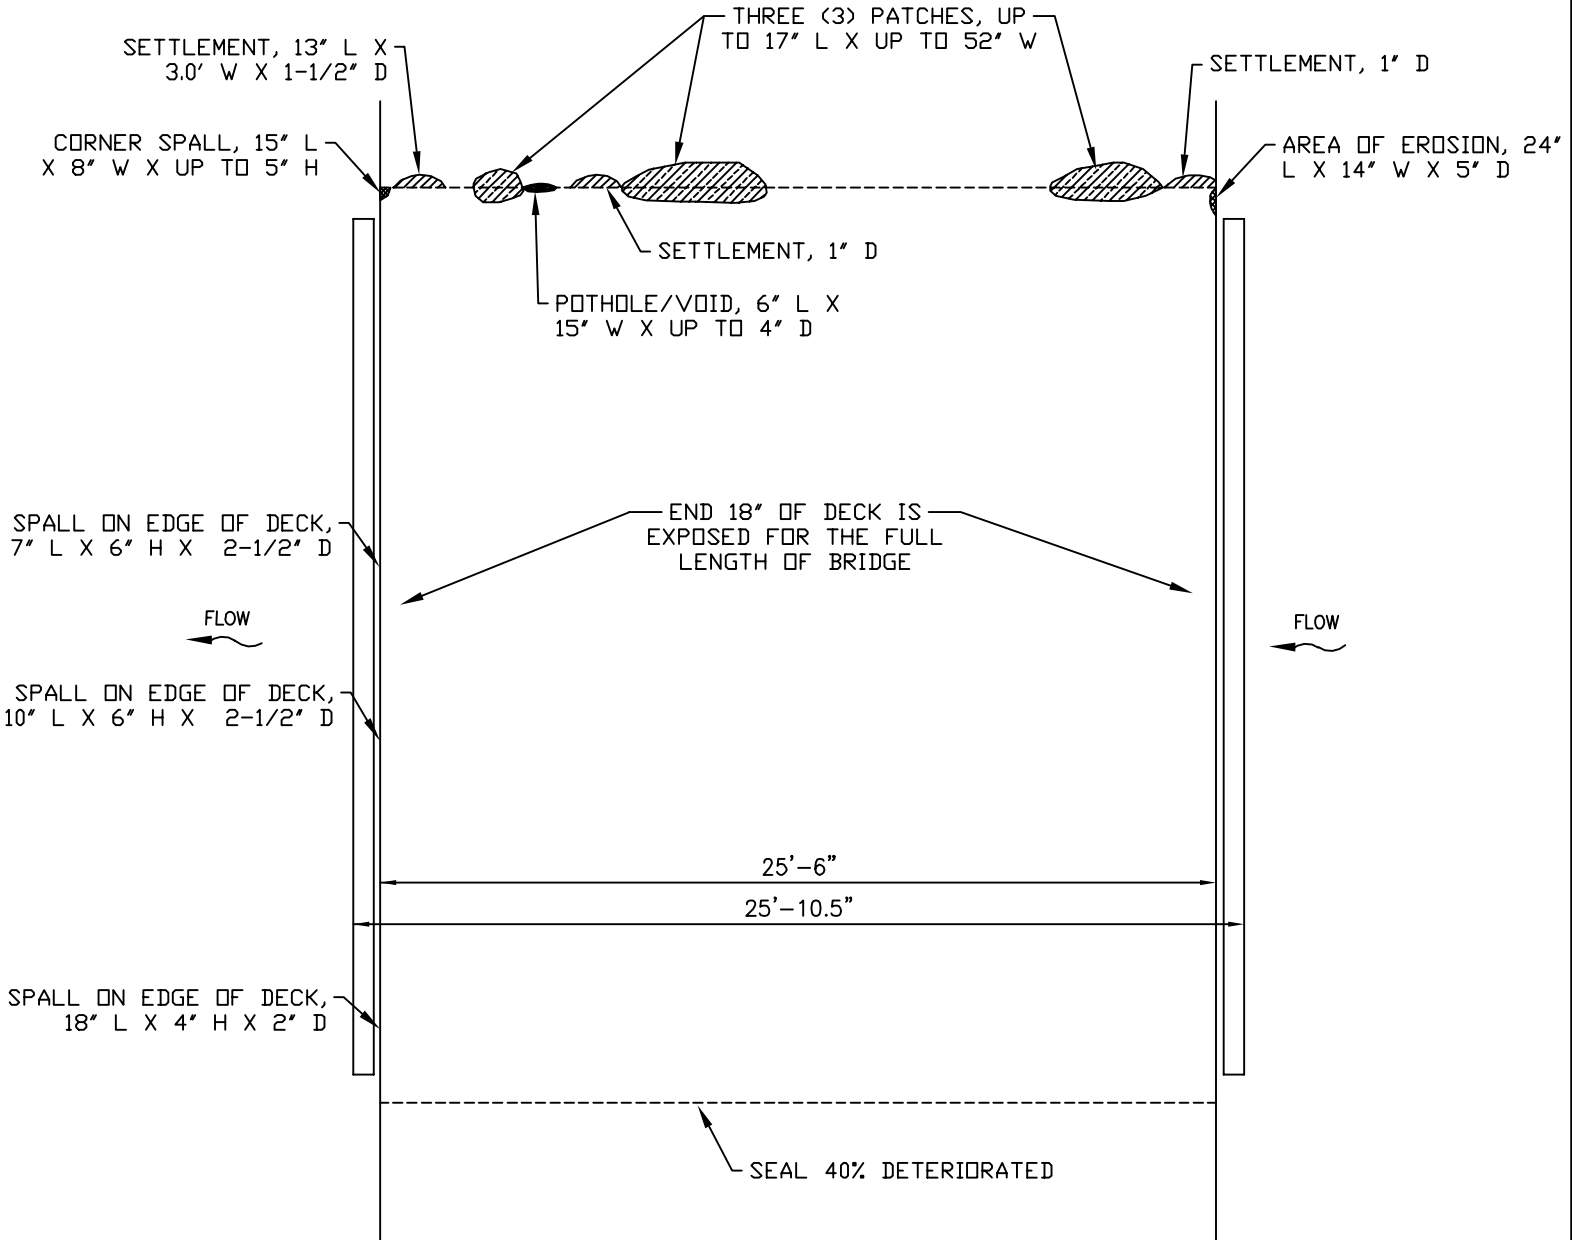
CREW: MATTHEW LAPLANTE AND ETHAN LACAIRE

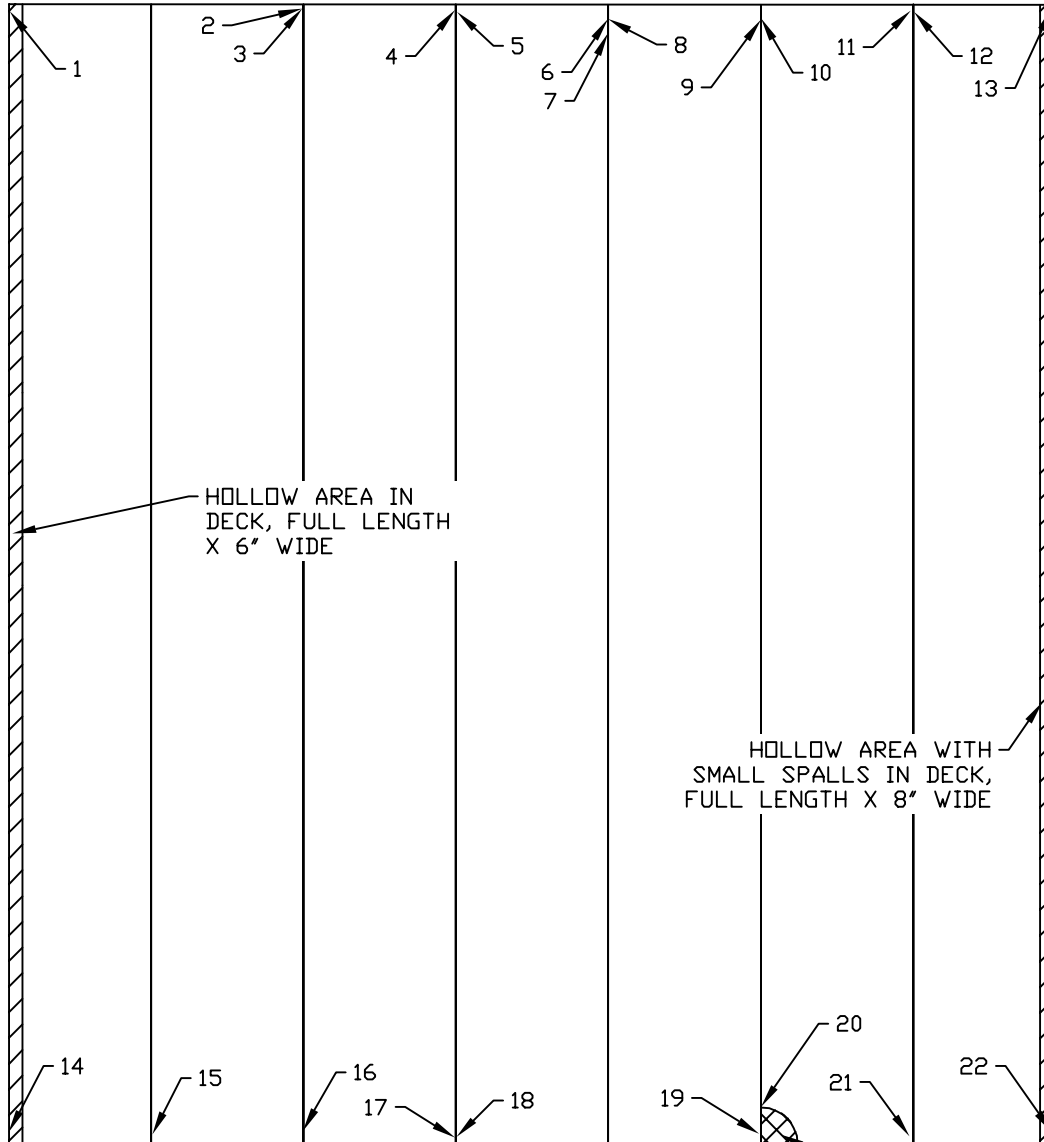
BEAM 8 BEAM 7 BEAM 6 BEAM 5 BEAM 4 BEAM 3 BEAM 2 BEAM 1

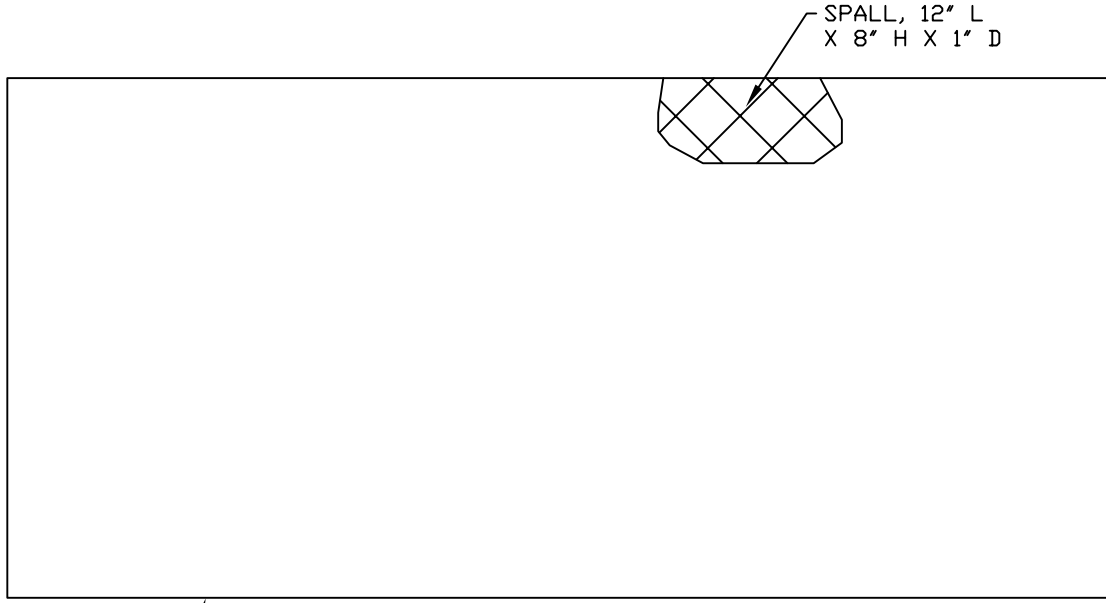
SPALL, 12" L  
X 8" H X 1" D

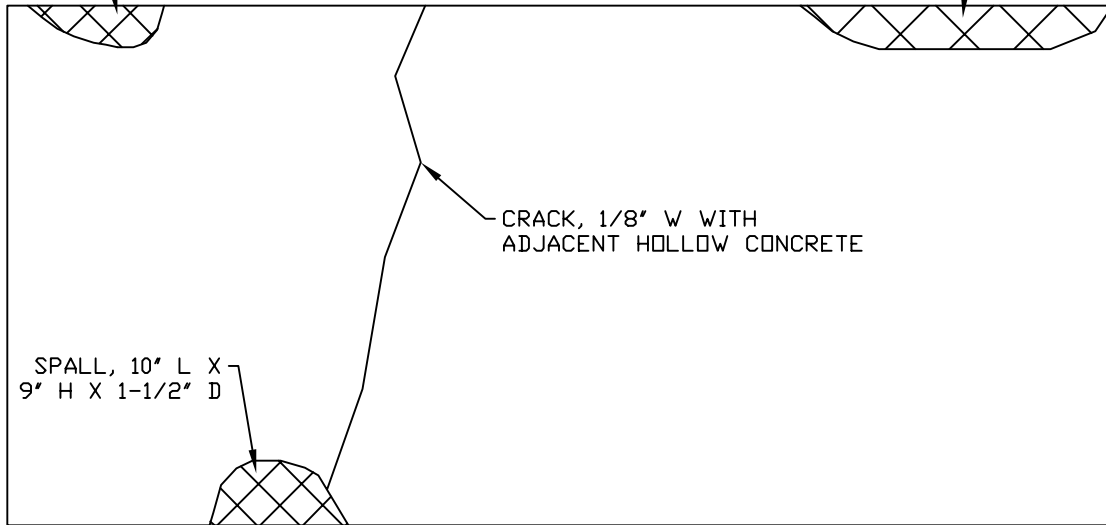
CRACK, 1/8" W WITH  
ADJACENT HOLLOW CONCRETE

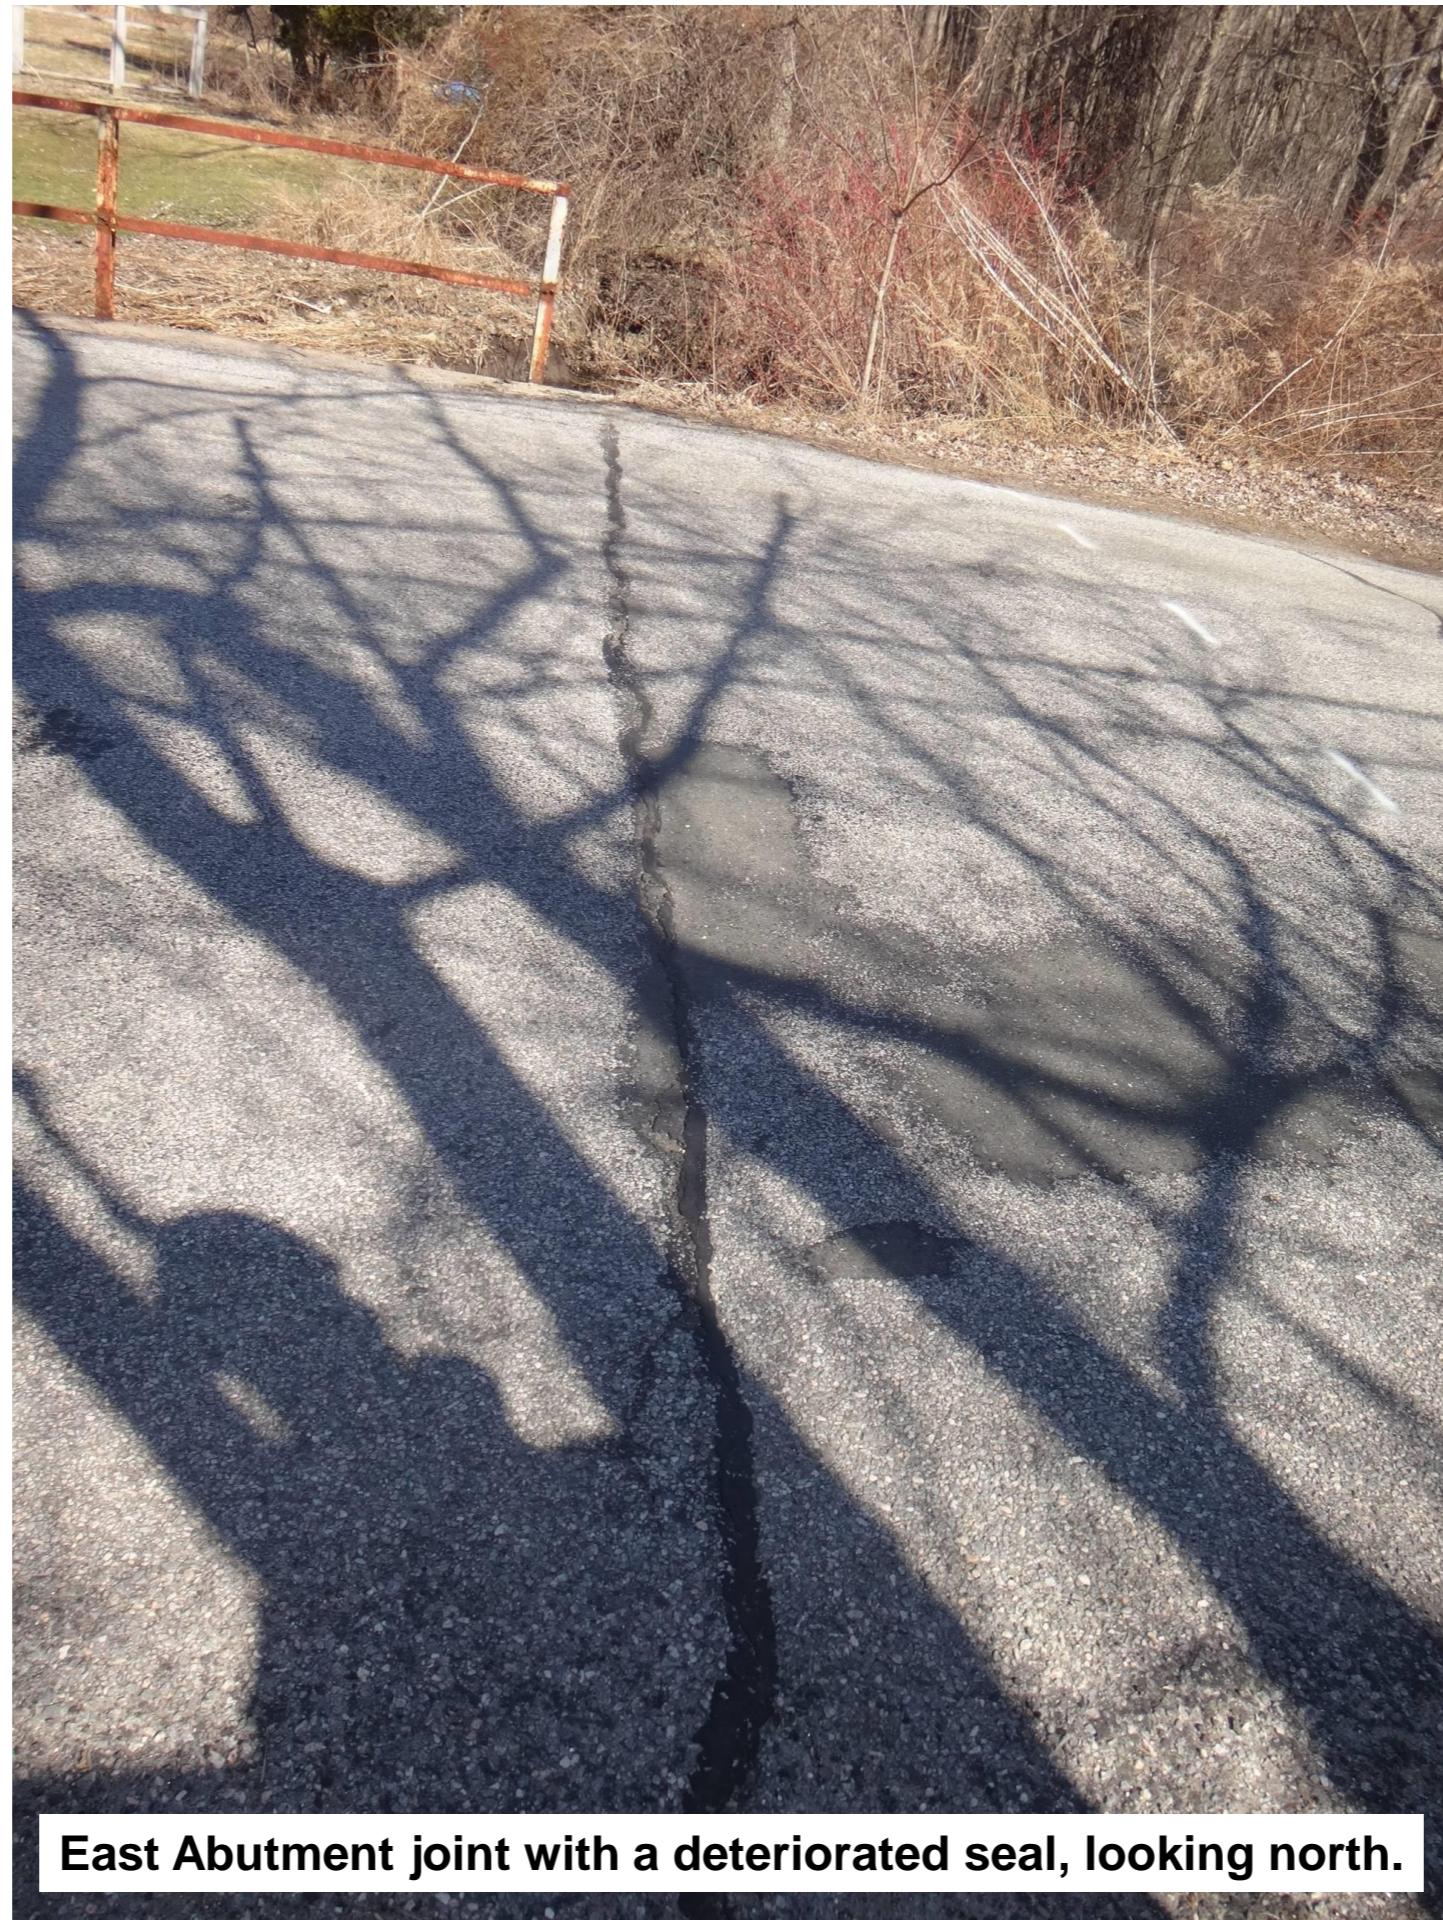
**East Abutment joint with a deteriorated seal, looking north.**

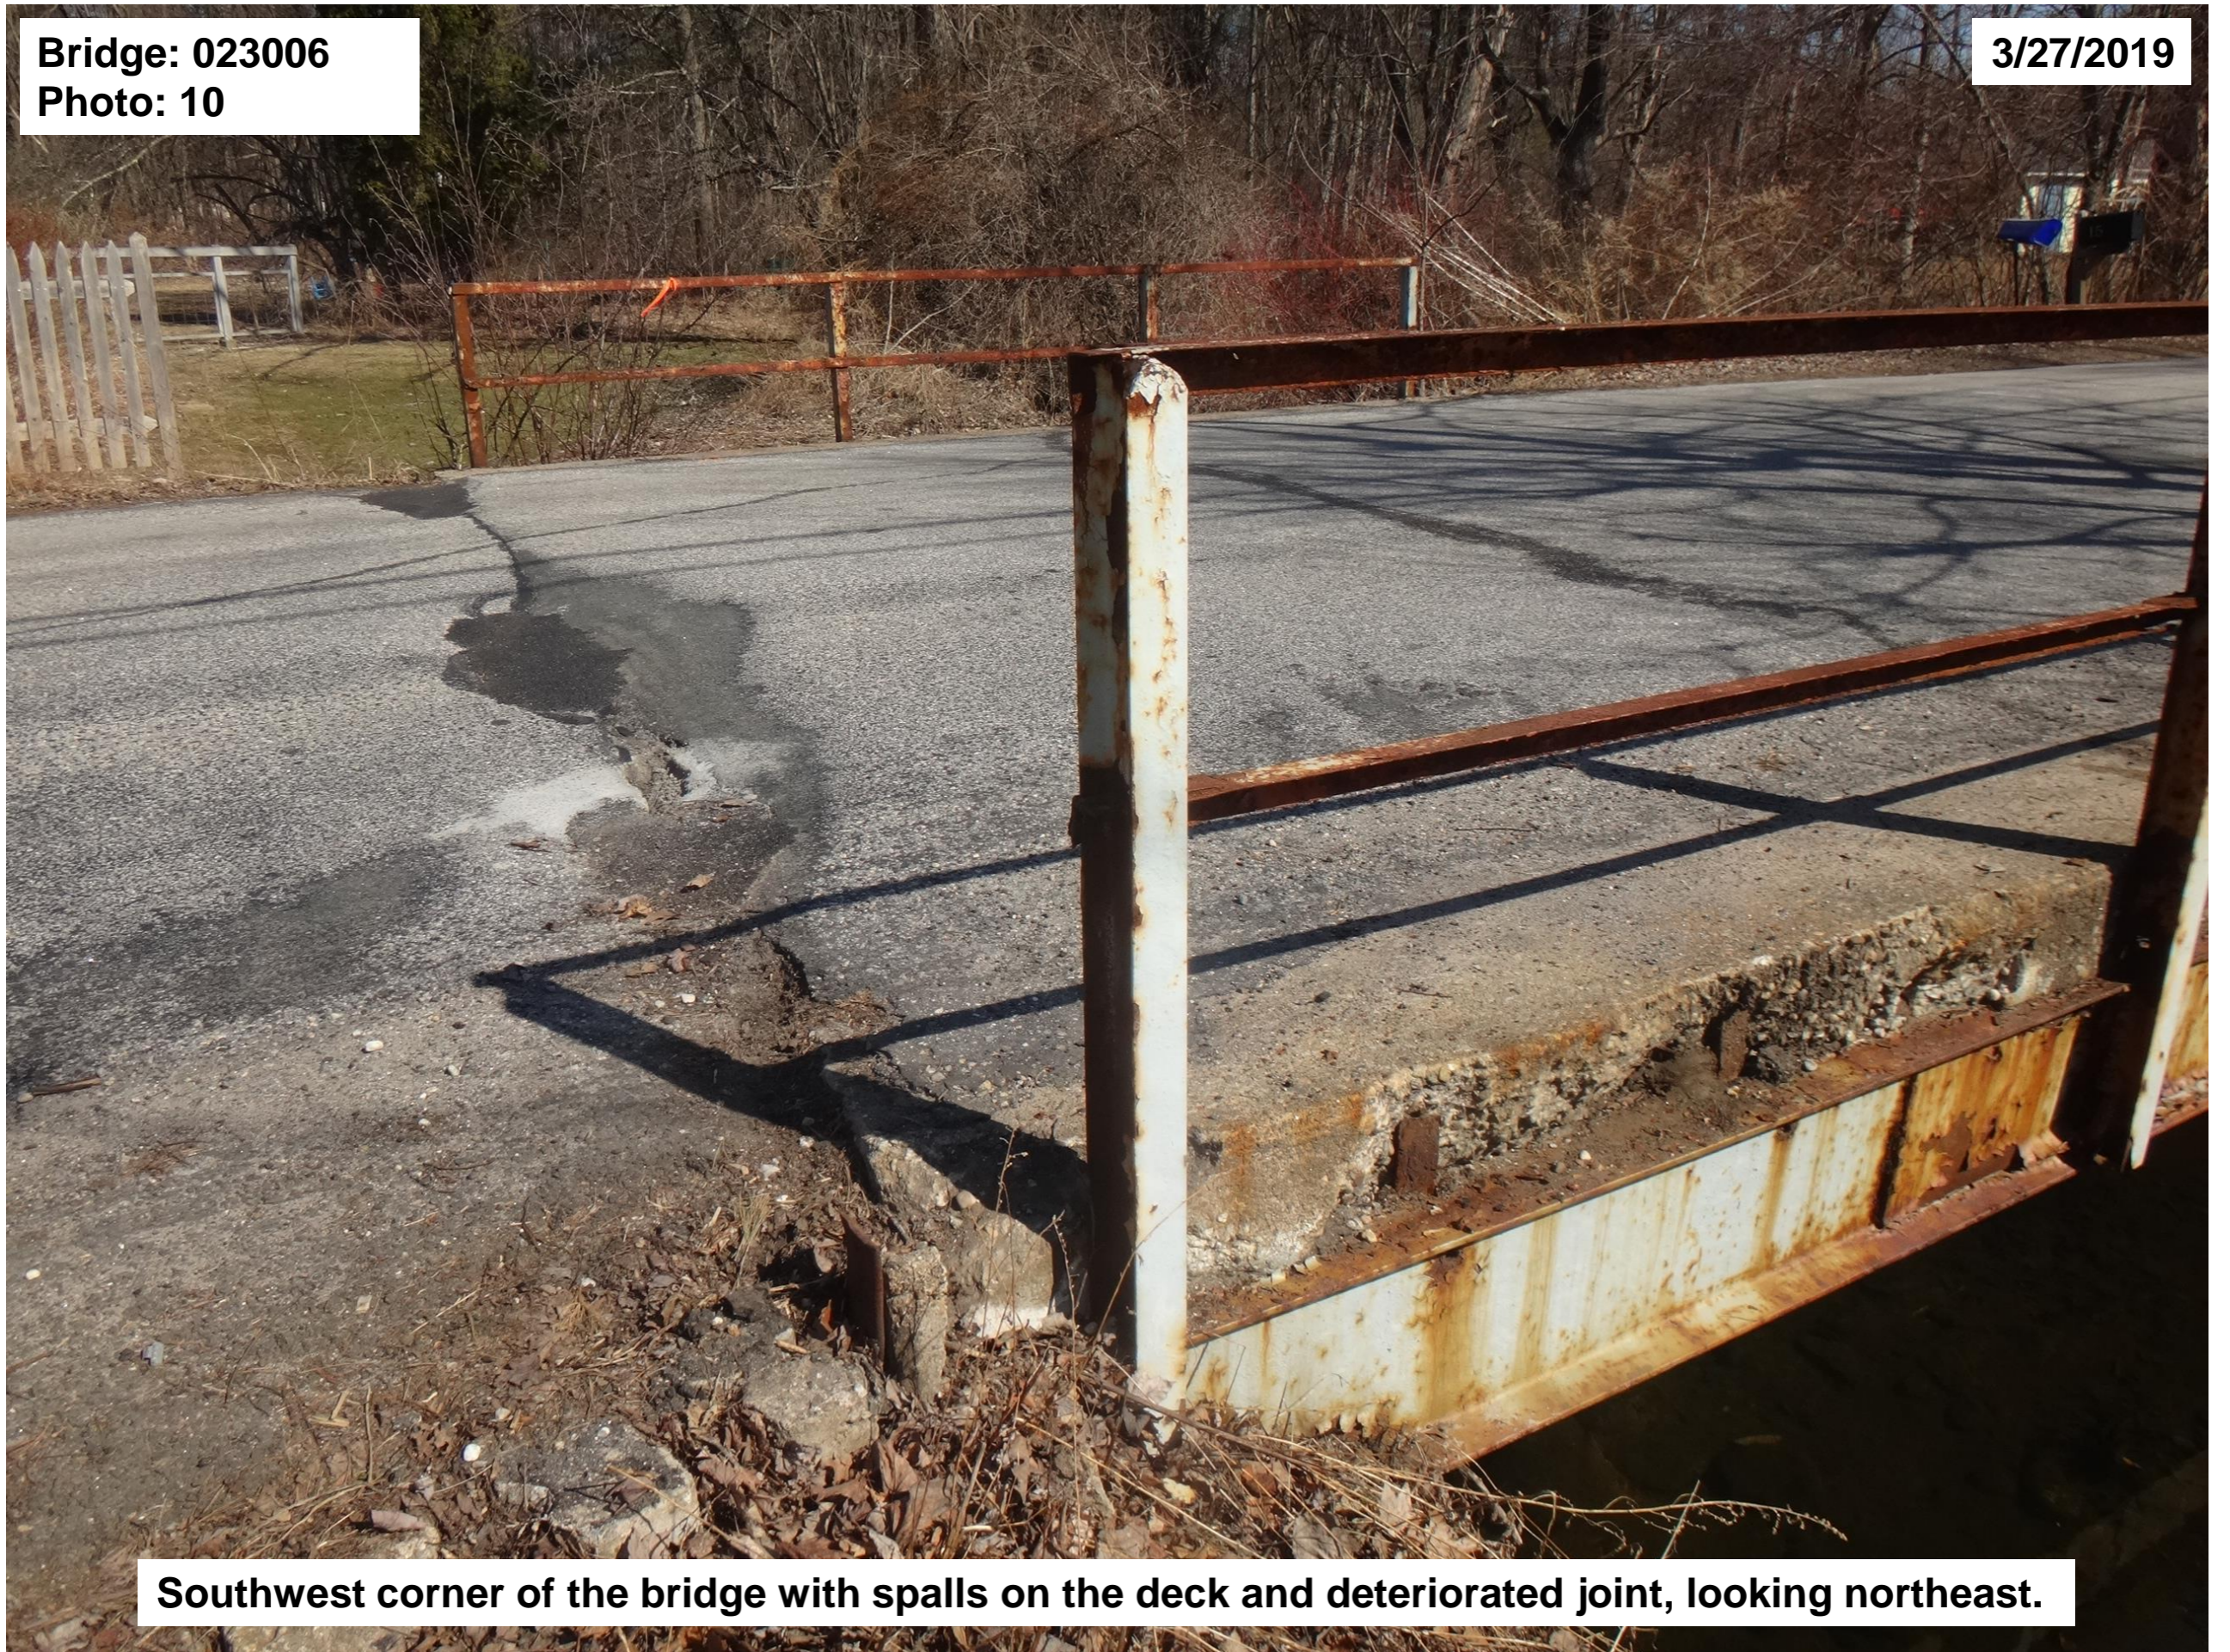
Southwest corner of the bridge with spalls on the deck and deteriorated joint, looking northeast.
