# Table of Contents

OLD CANTON BRIDGE SIGNED APPLICATION.pdf .....	104
WASHBURN BRIDGE SIGNED APPLICATION.pdf .....	106

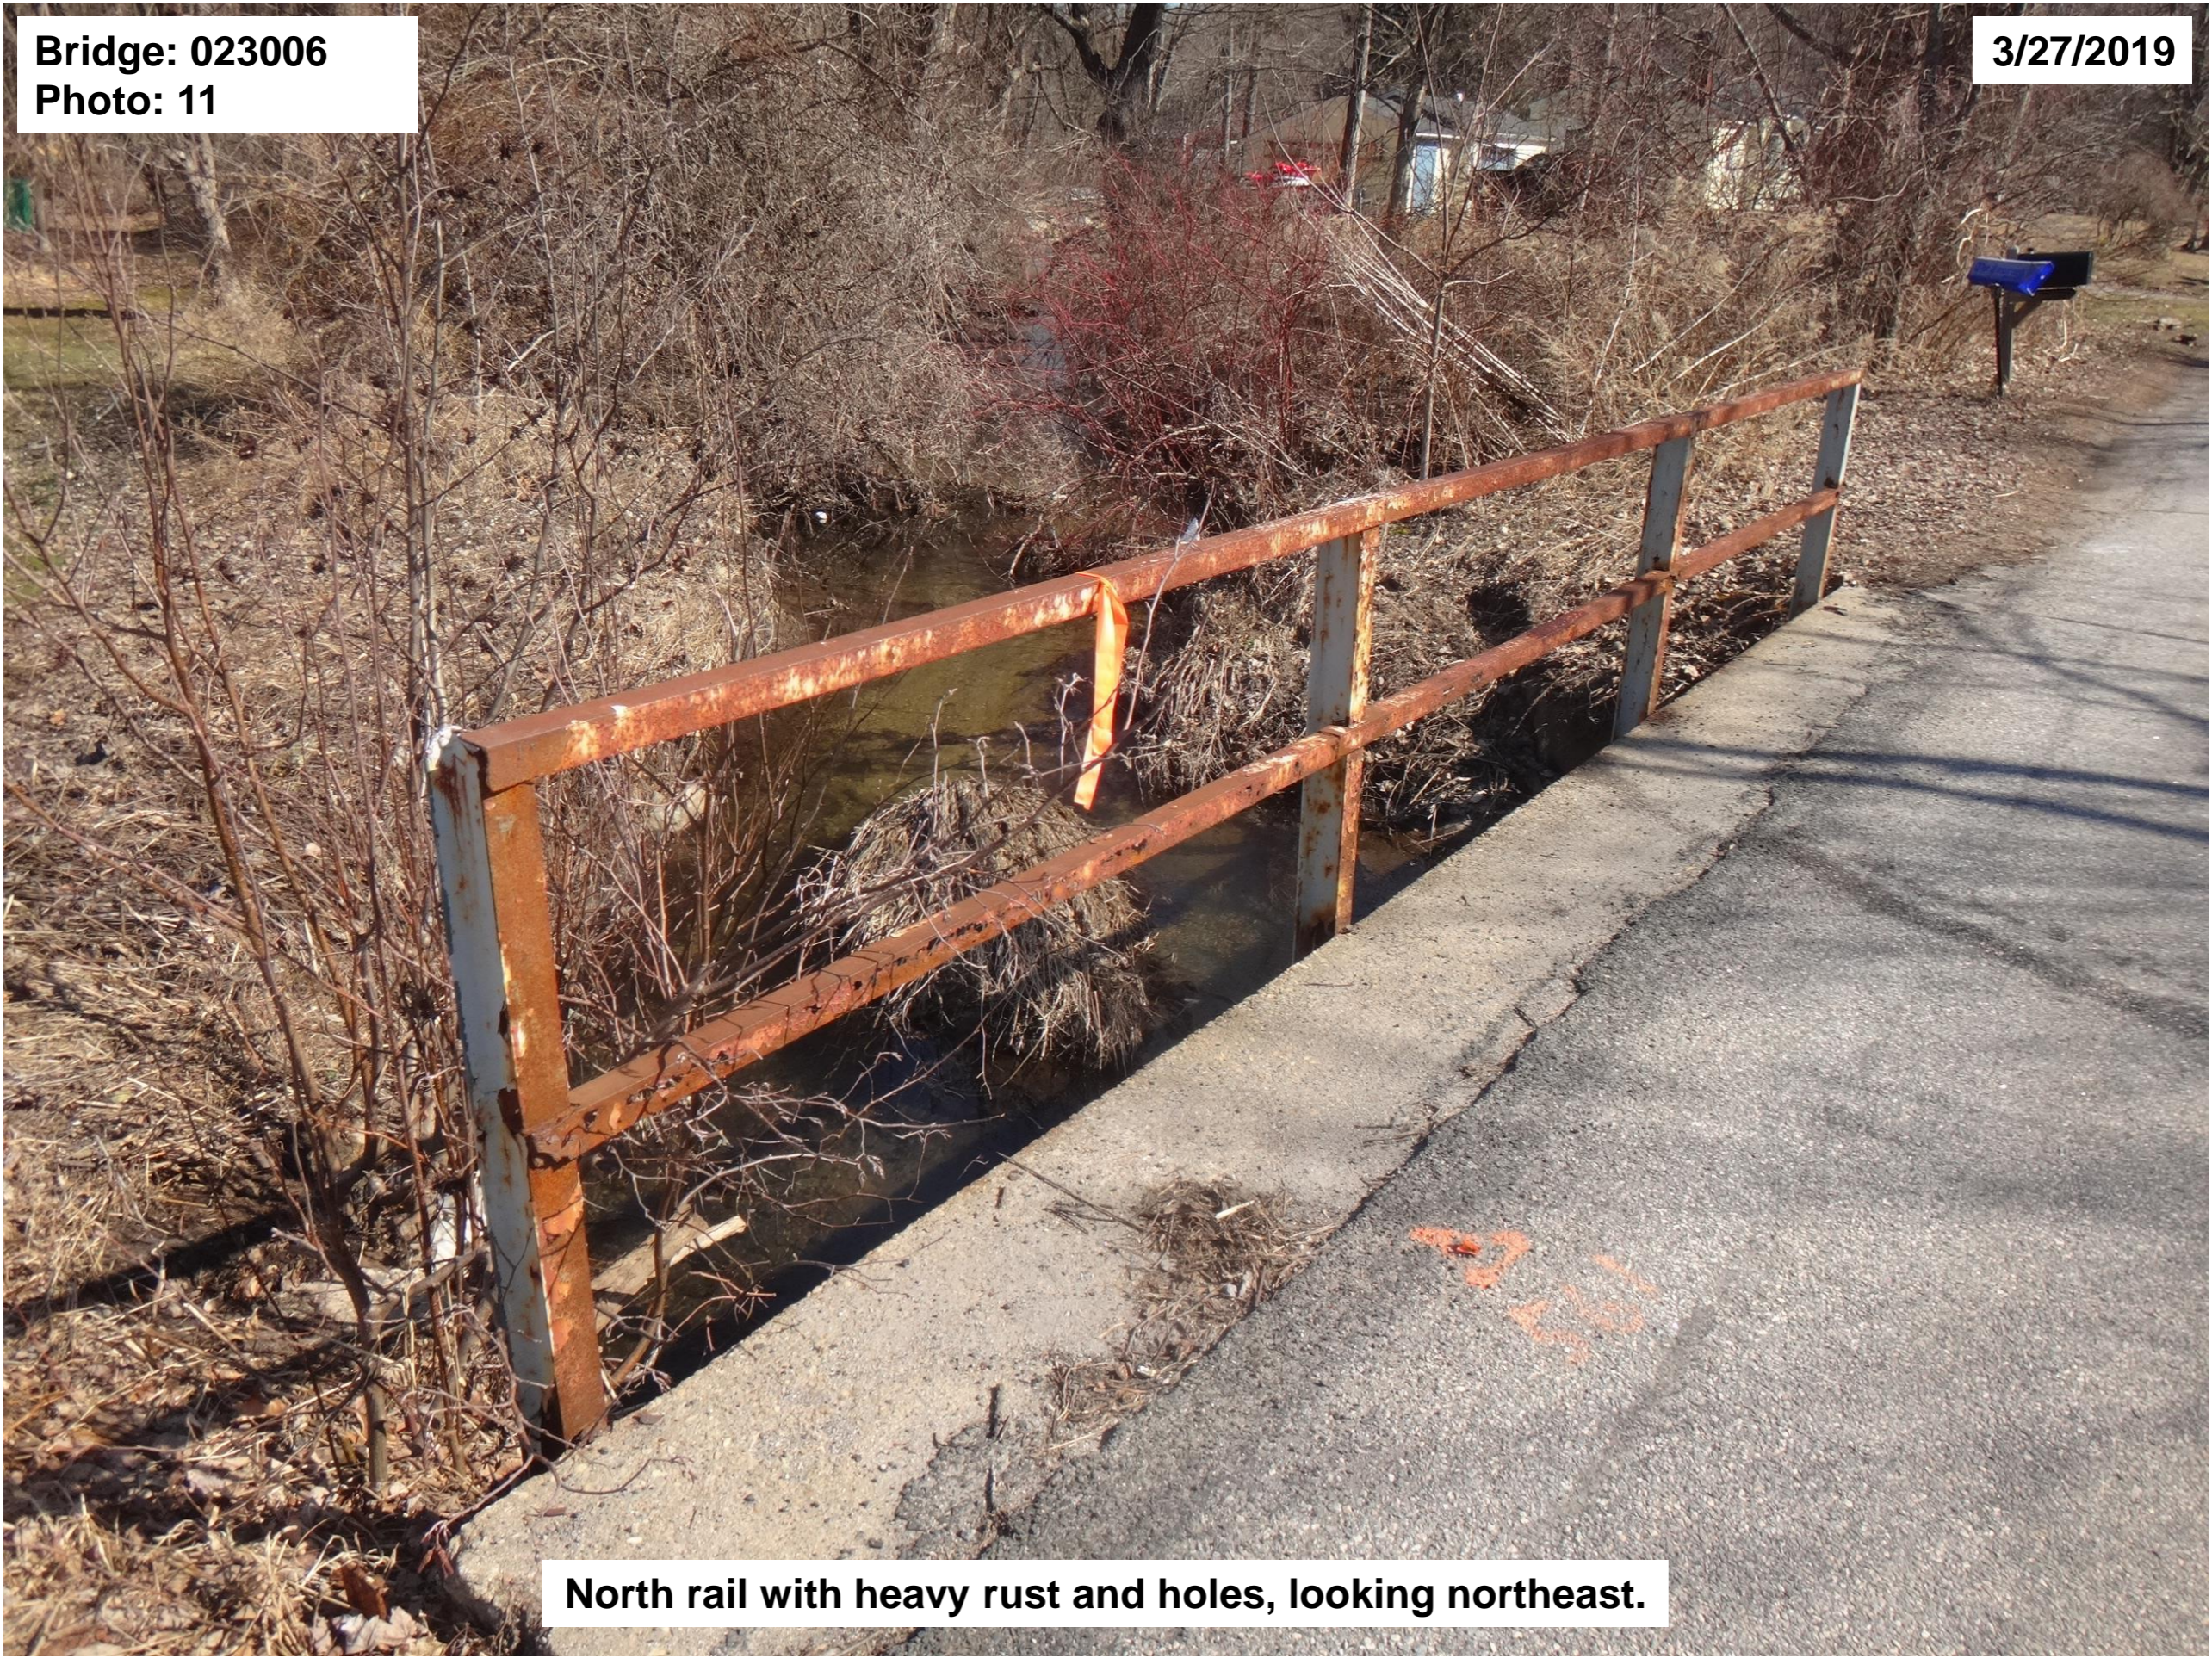
**Bridge: 023006**  
**Photo: 12**

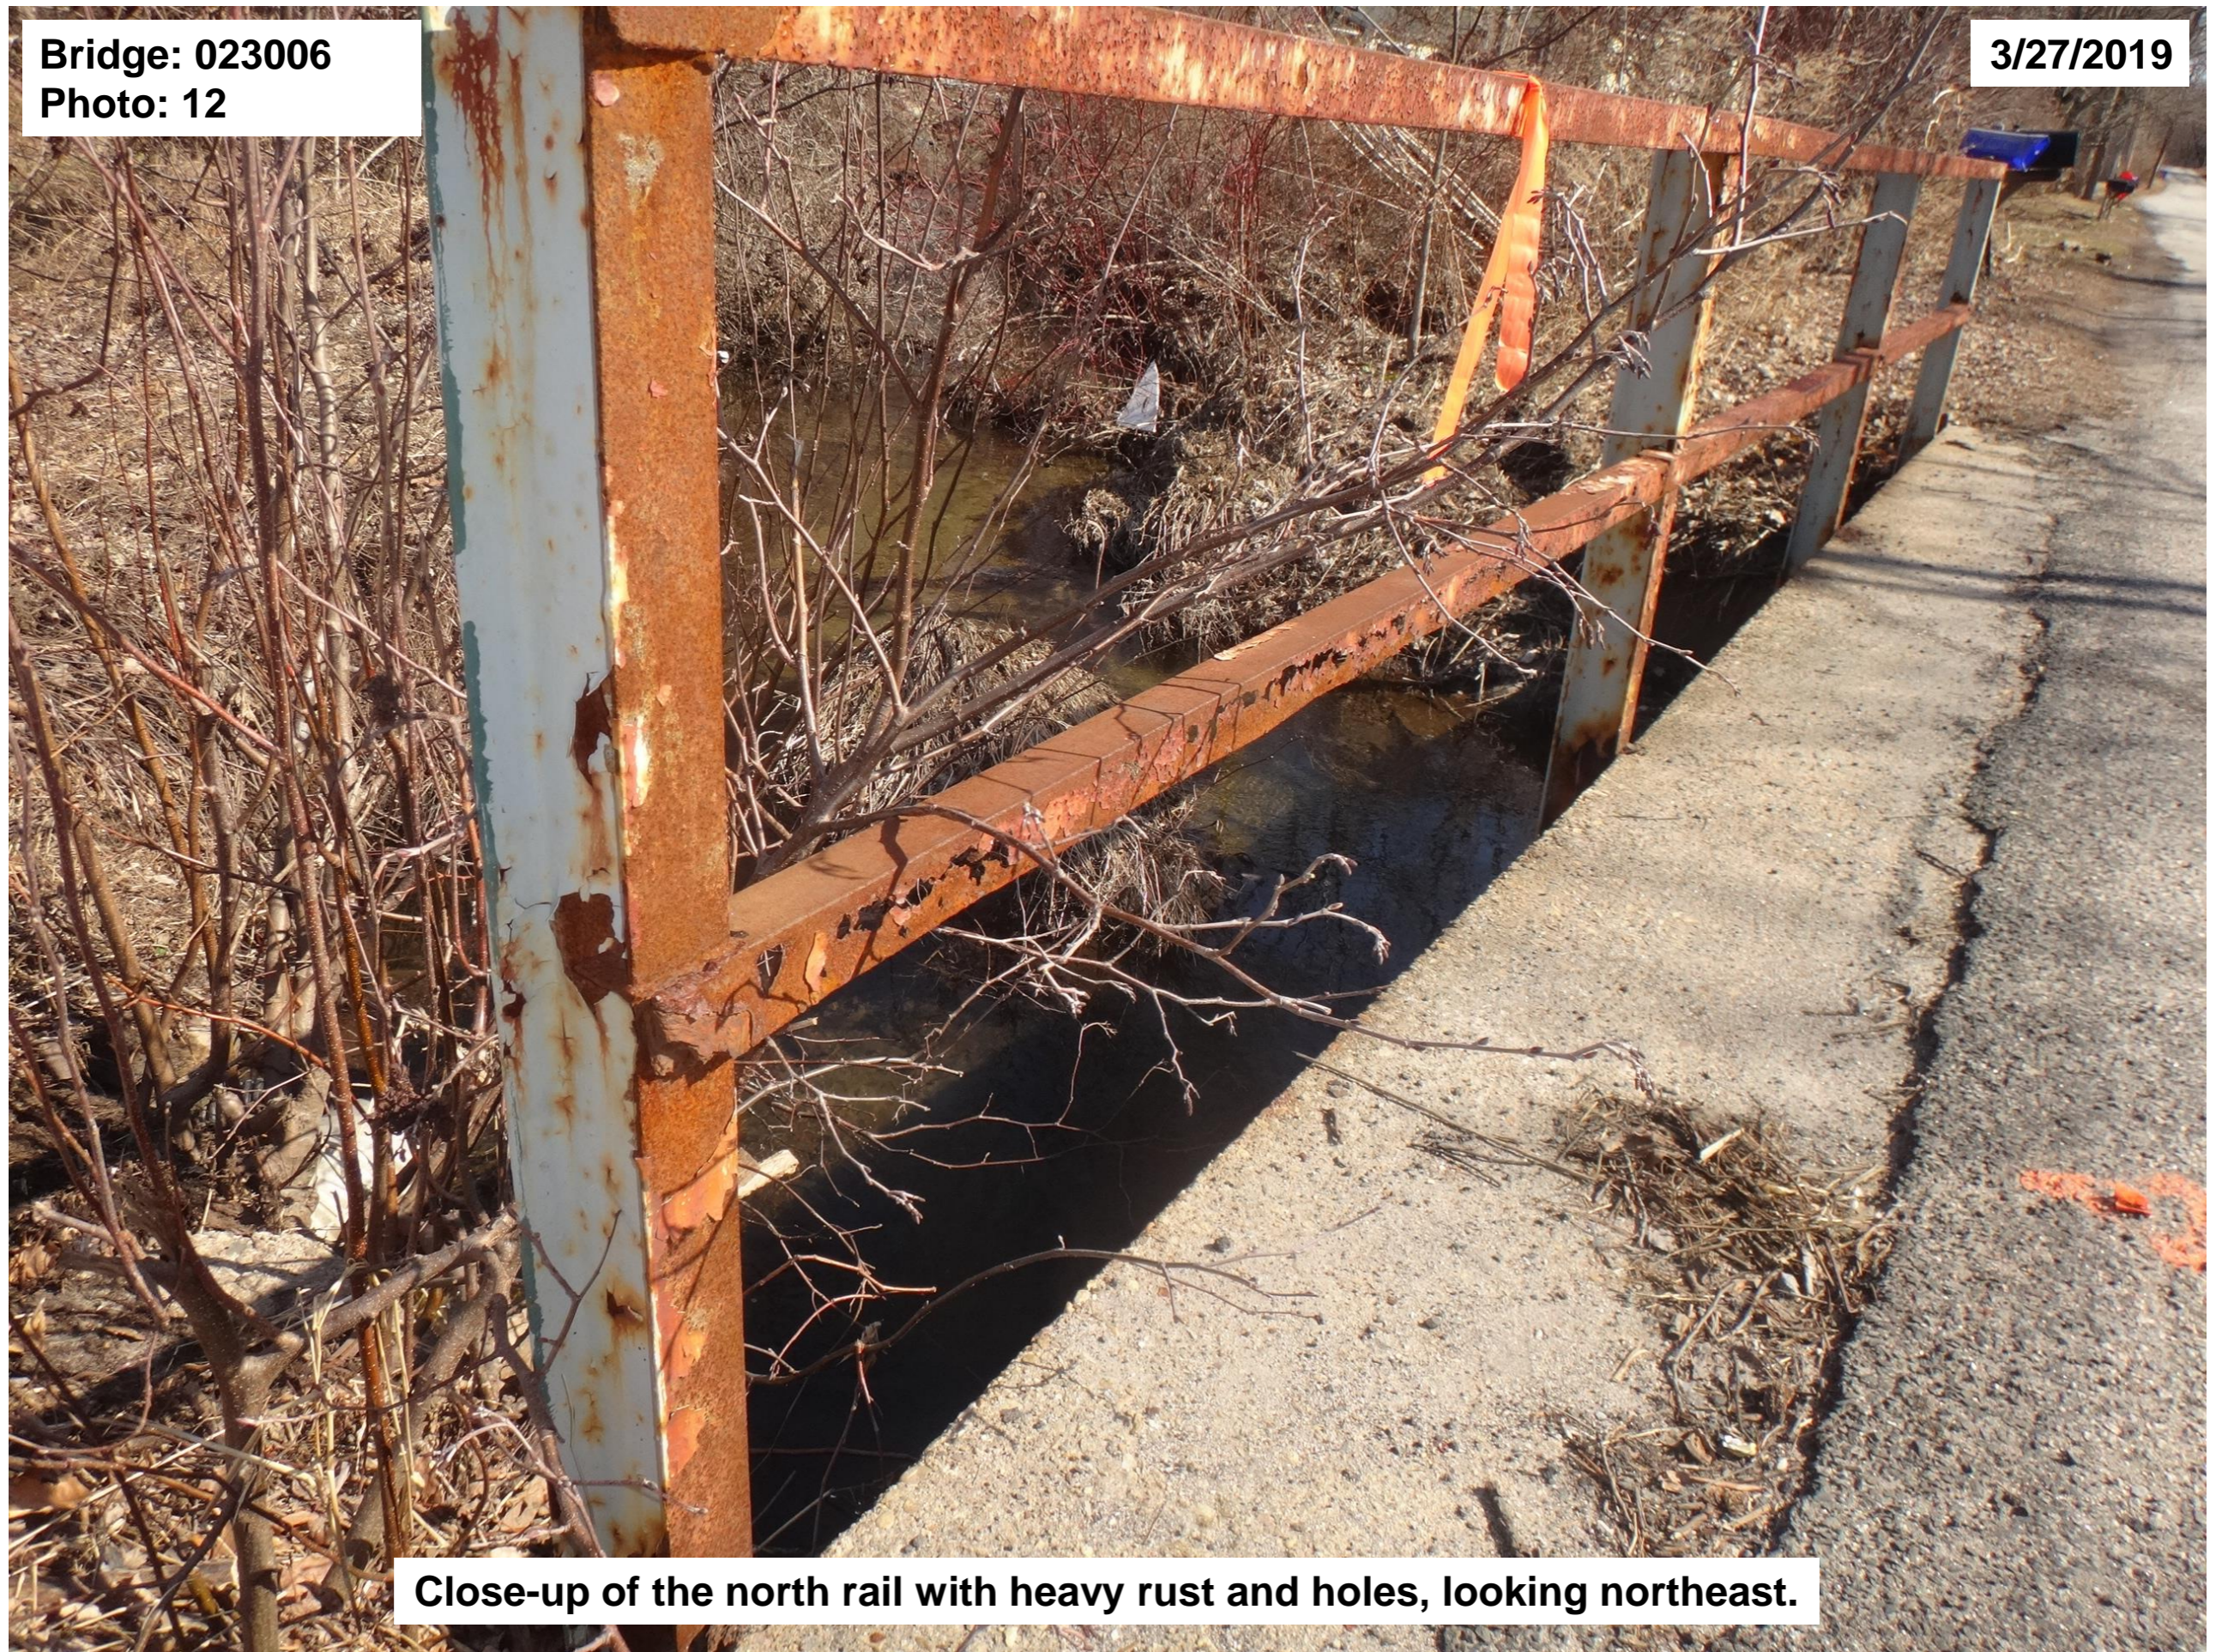
**Close-up of the north rail with heavy rust and holes, looking northeast.**

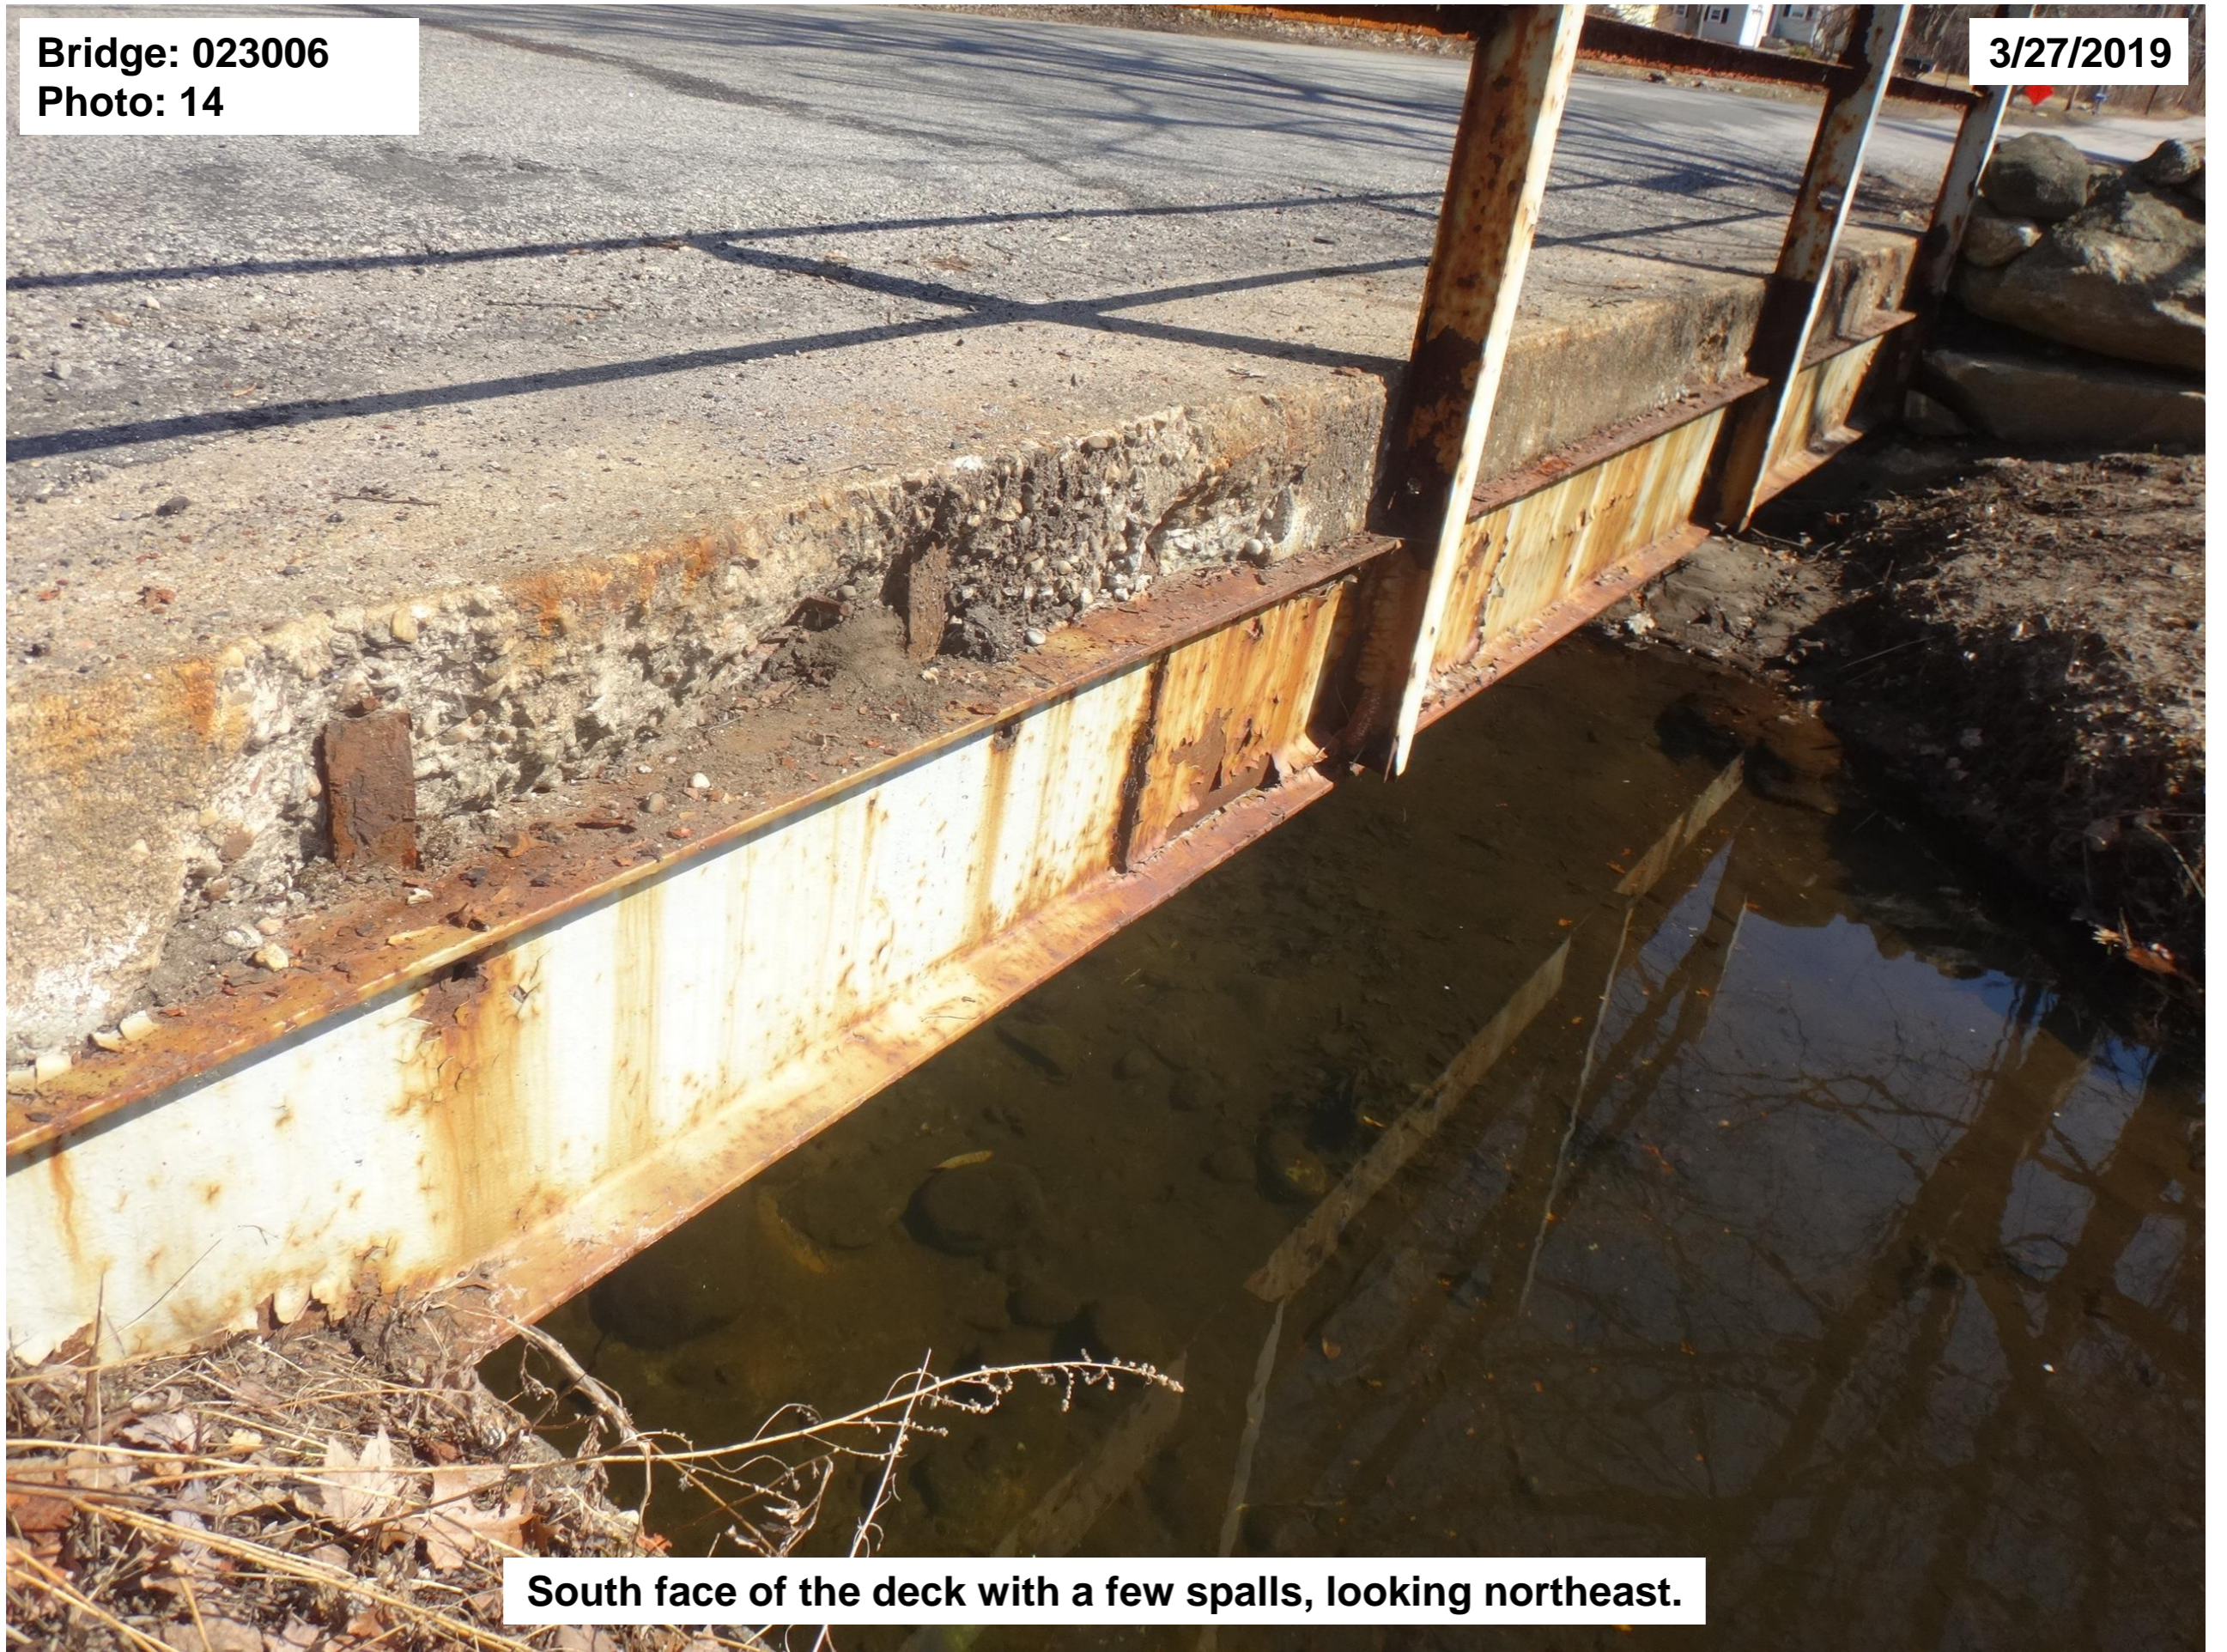
Bridge: 023006  
Photo: 15

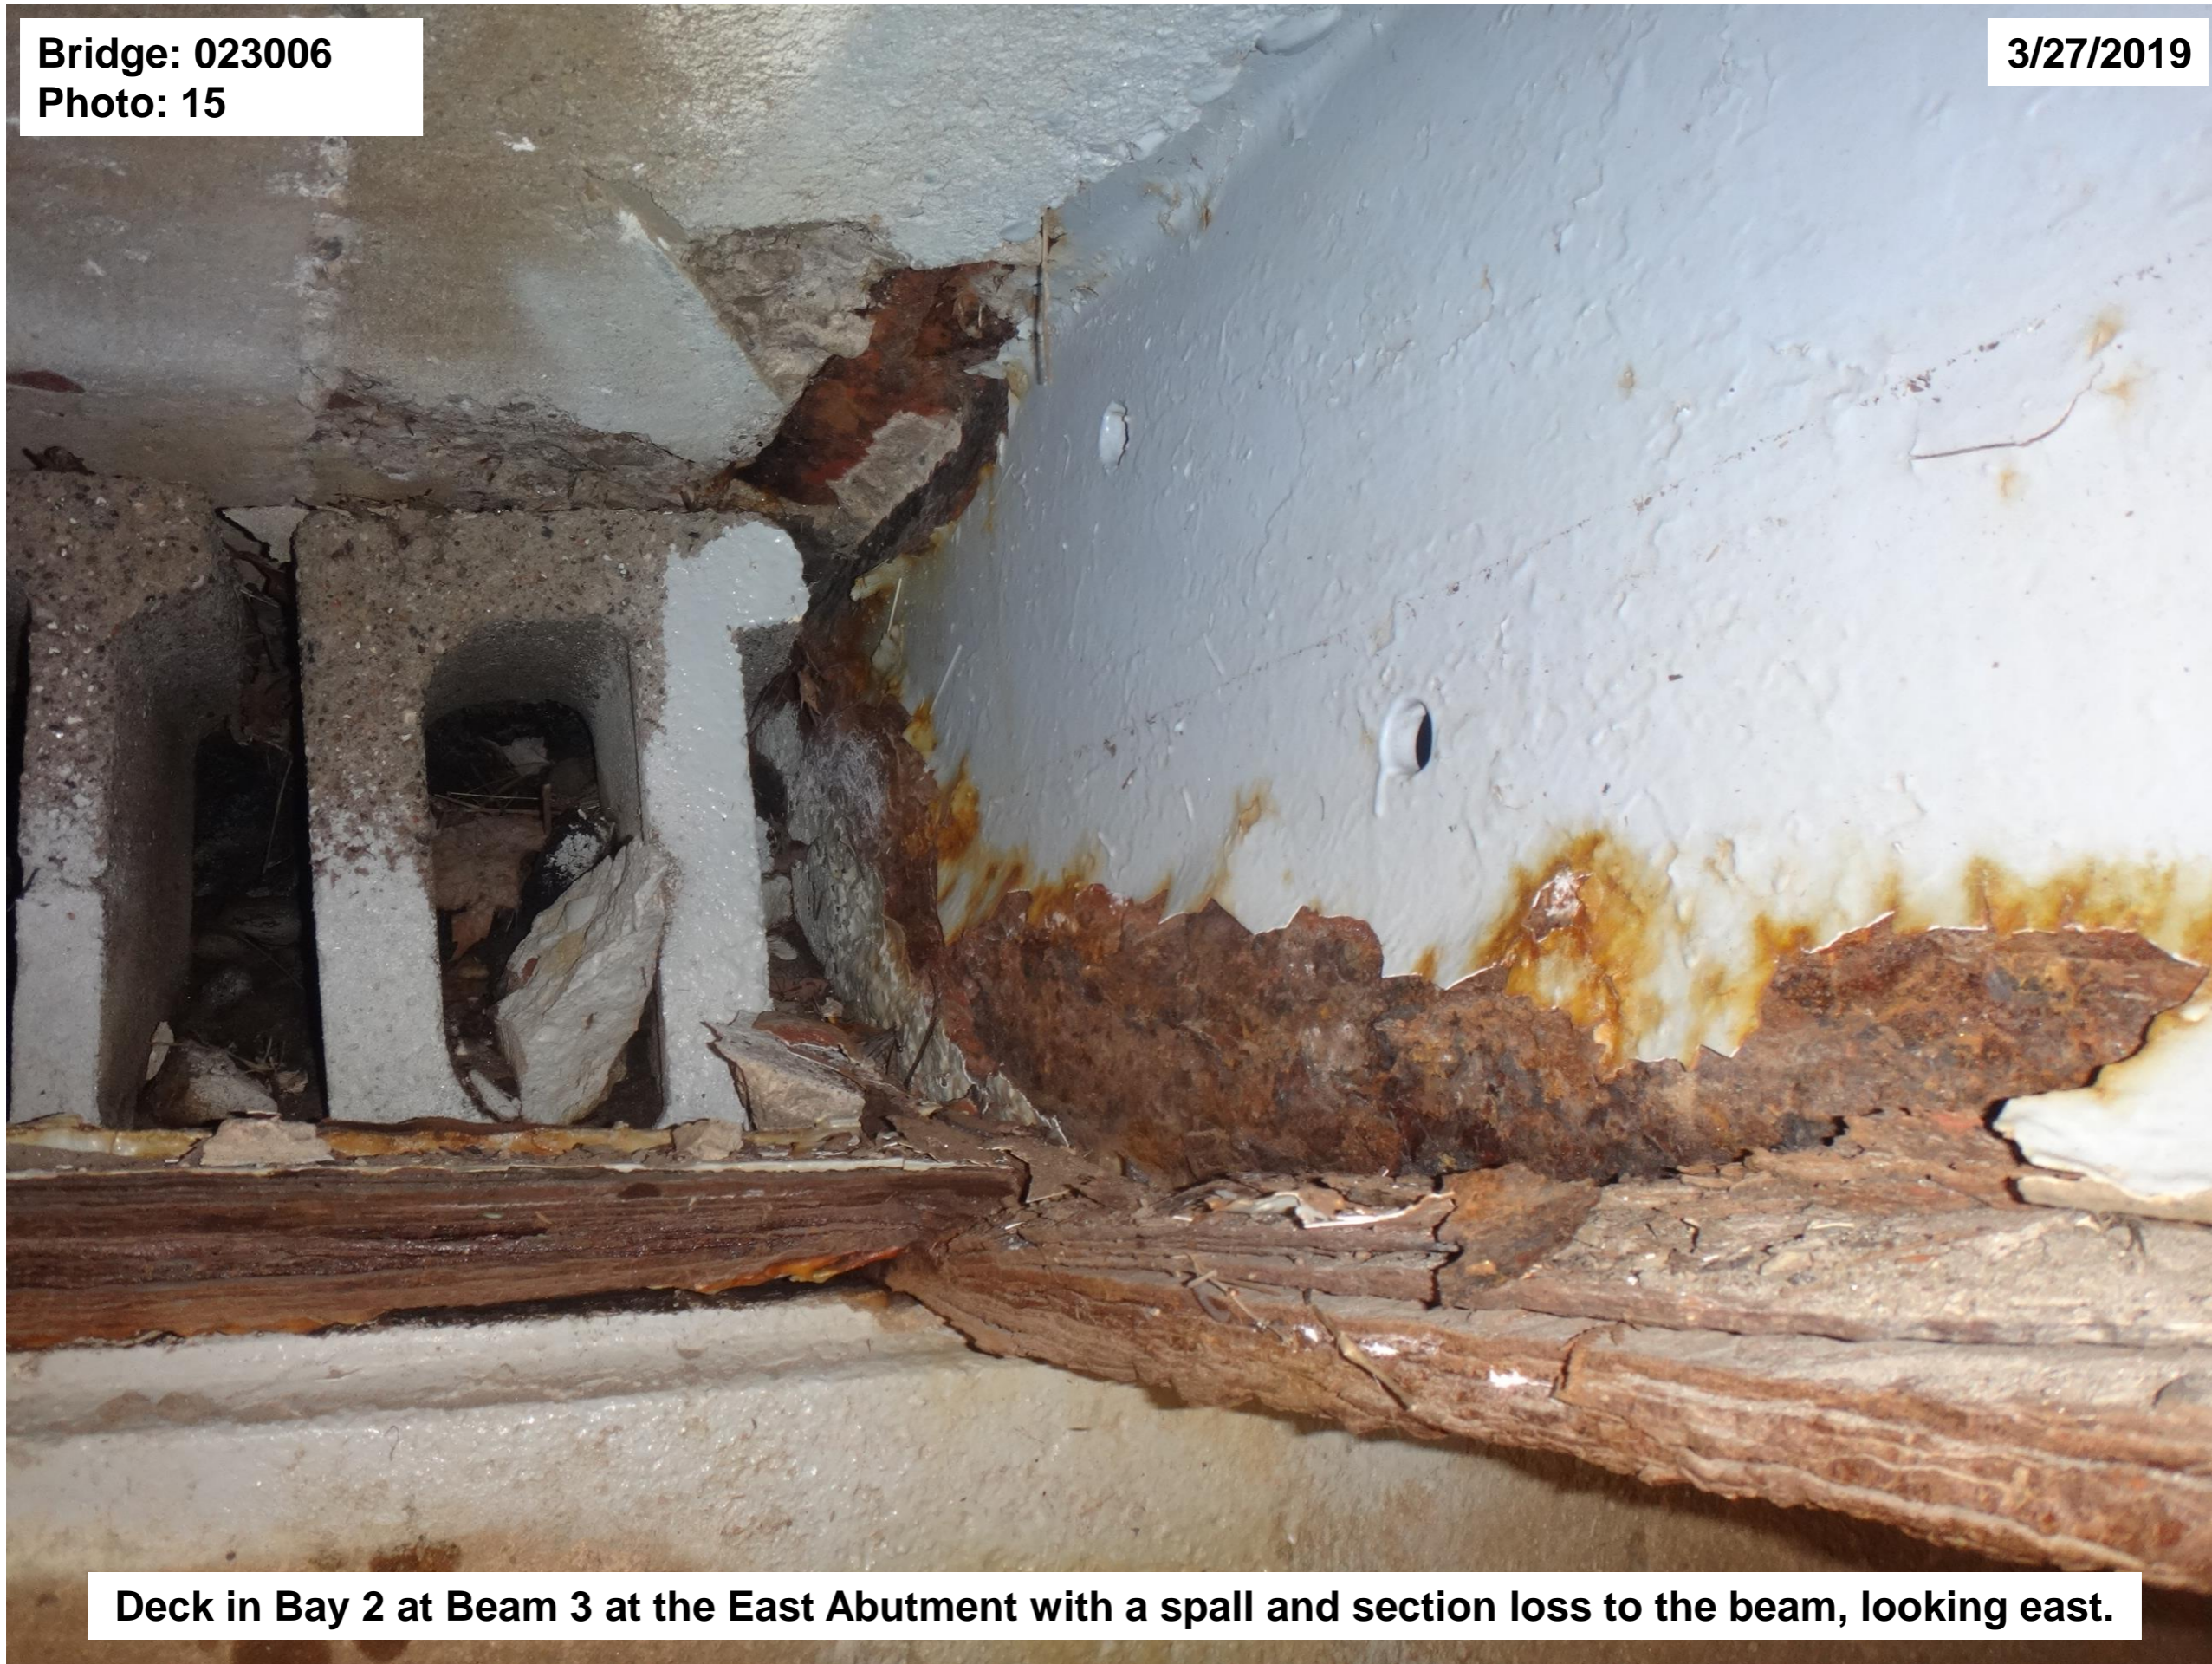
Deck in Bay 2 at Beam 3 at the East Abutment with a spall and section loss to the beam, looking east.

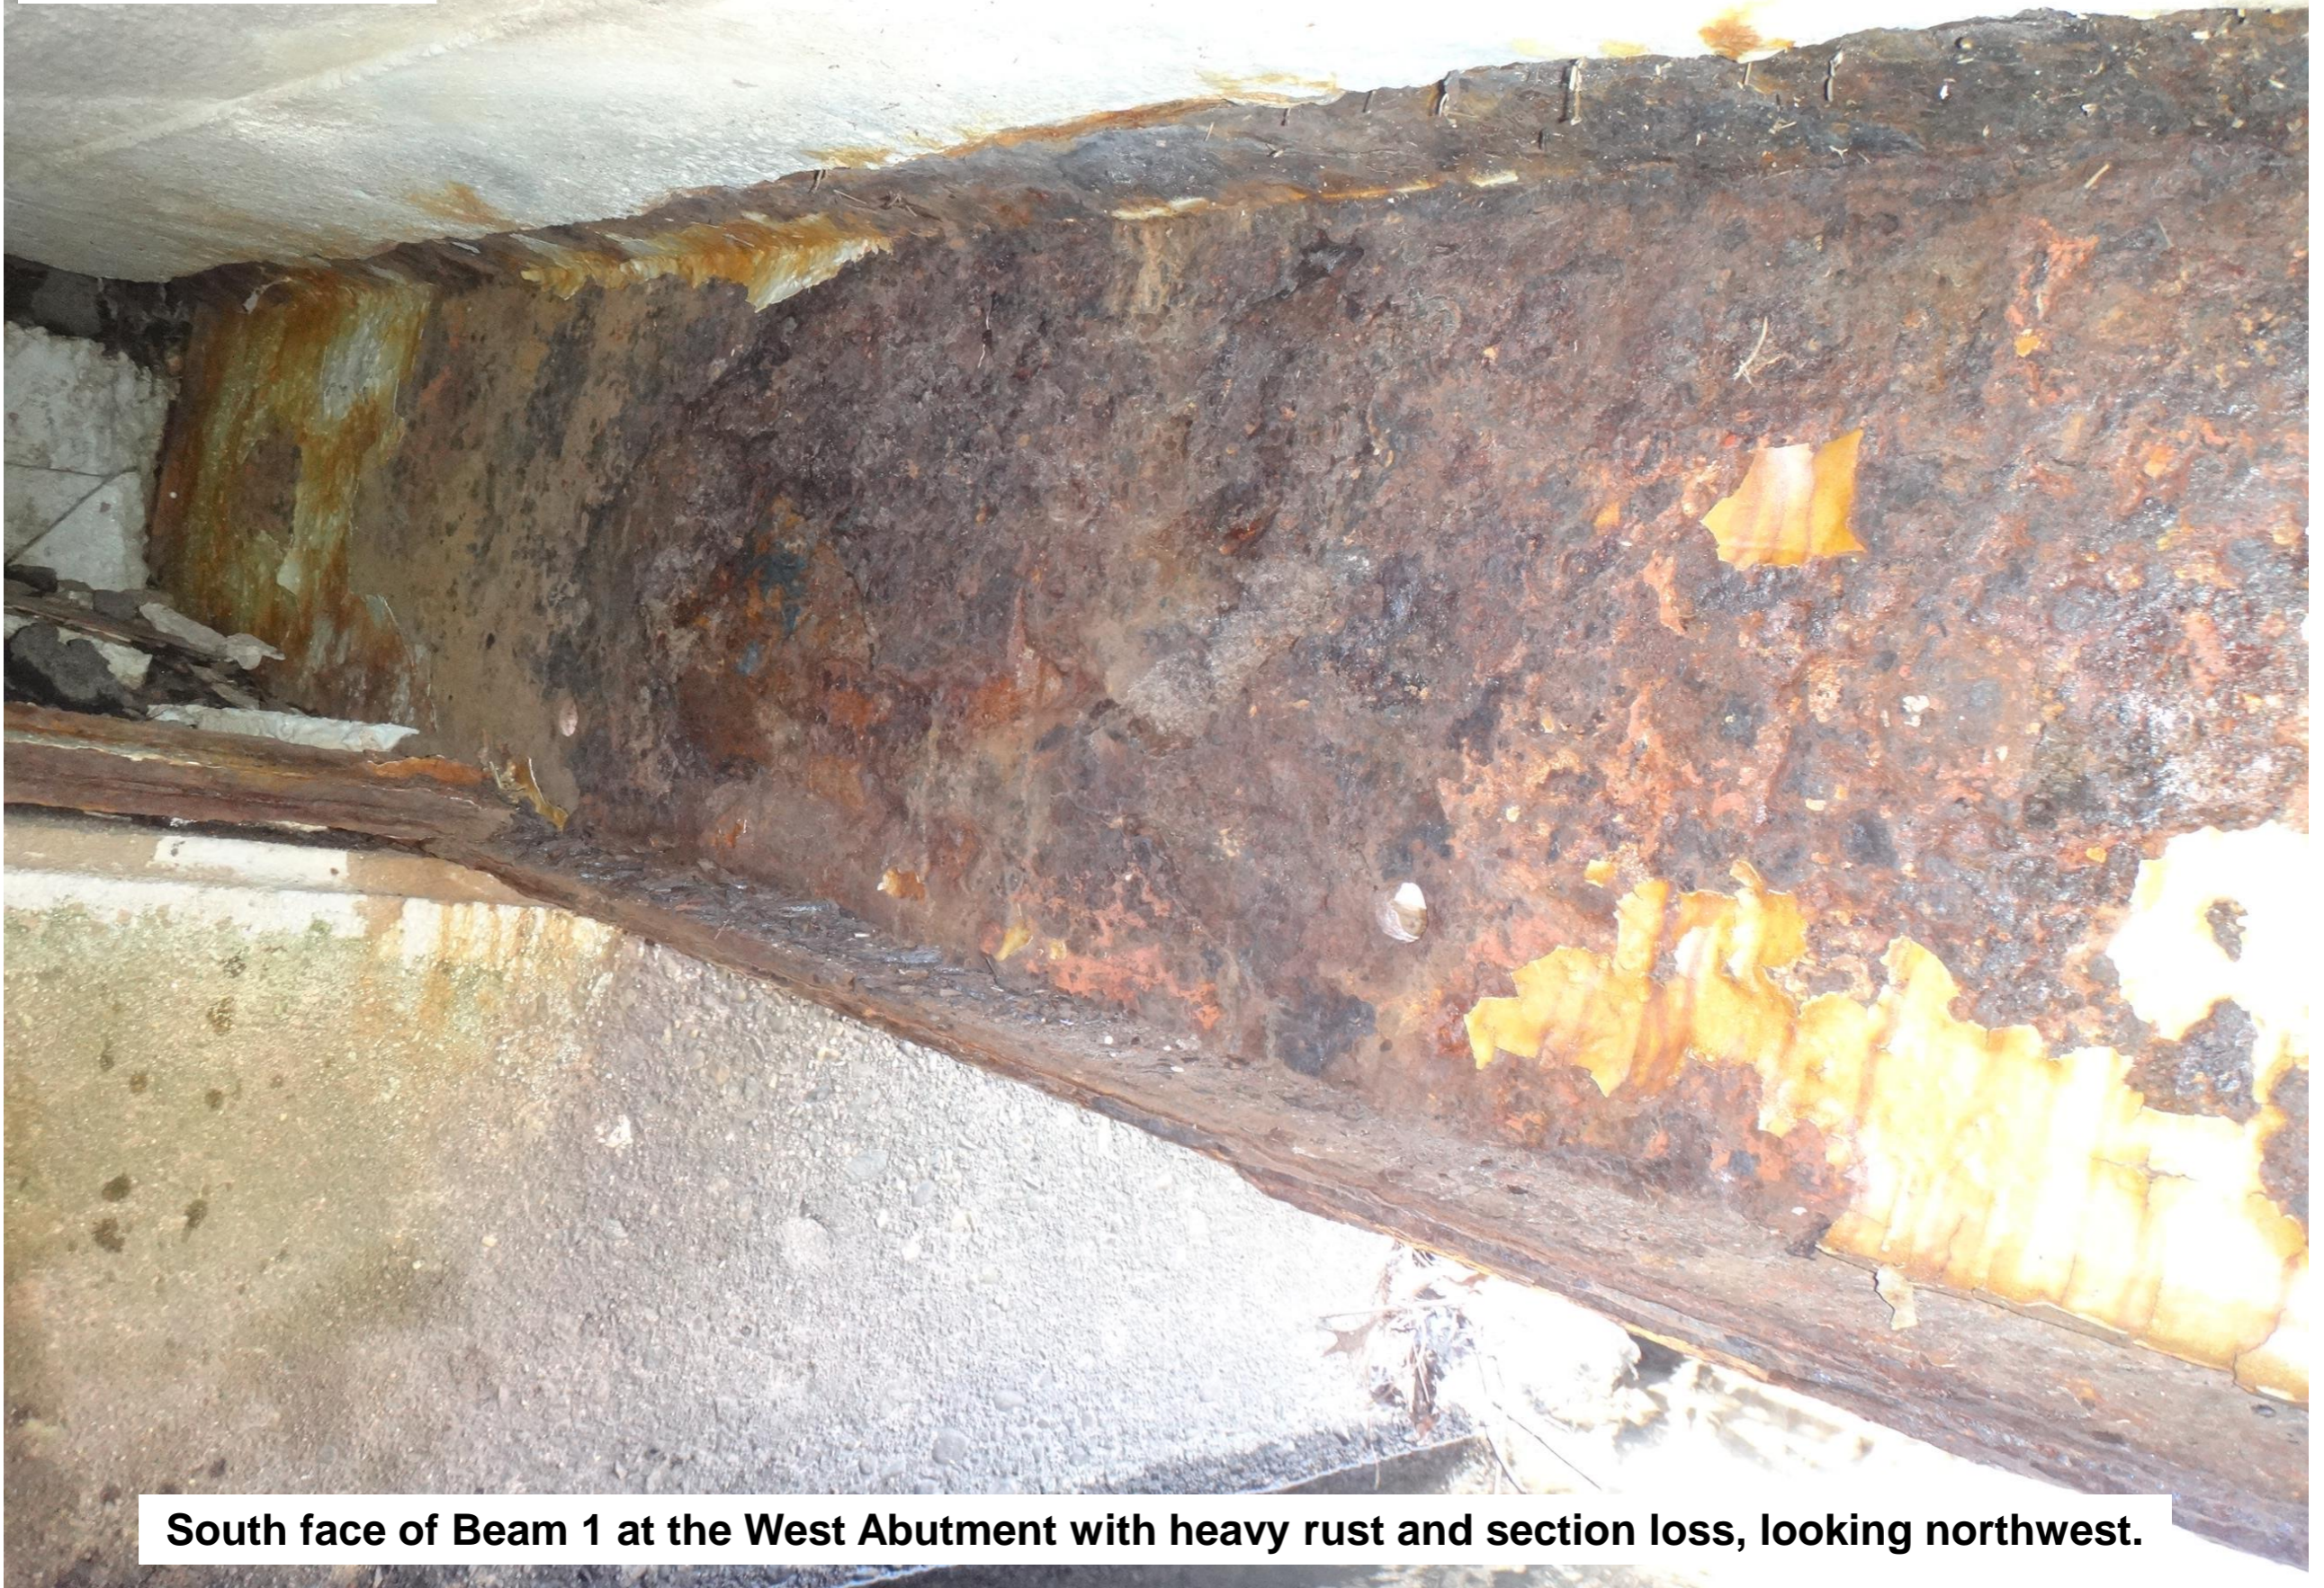
South face of Beam 1 at the West Abutment with heavy rust and section loss, looking northwest.

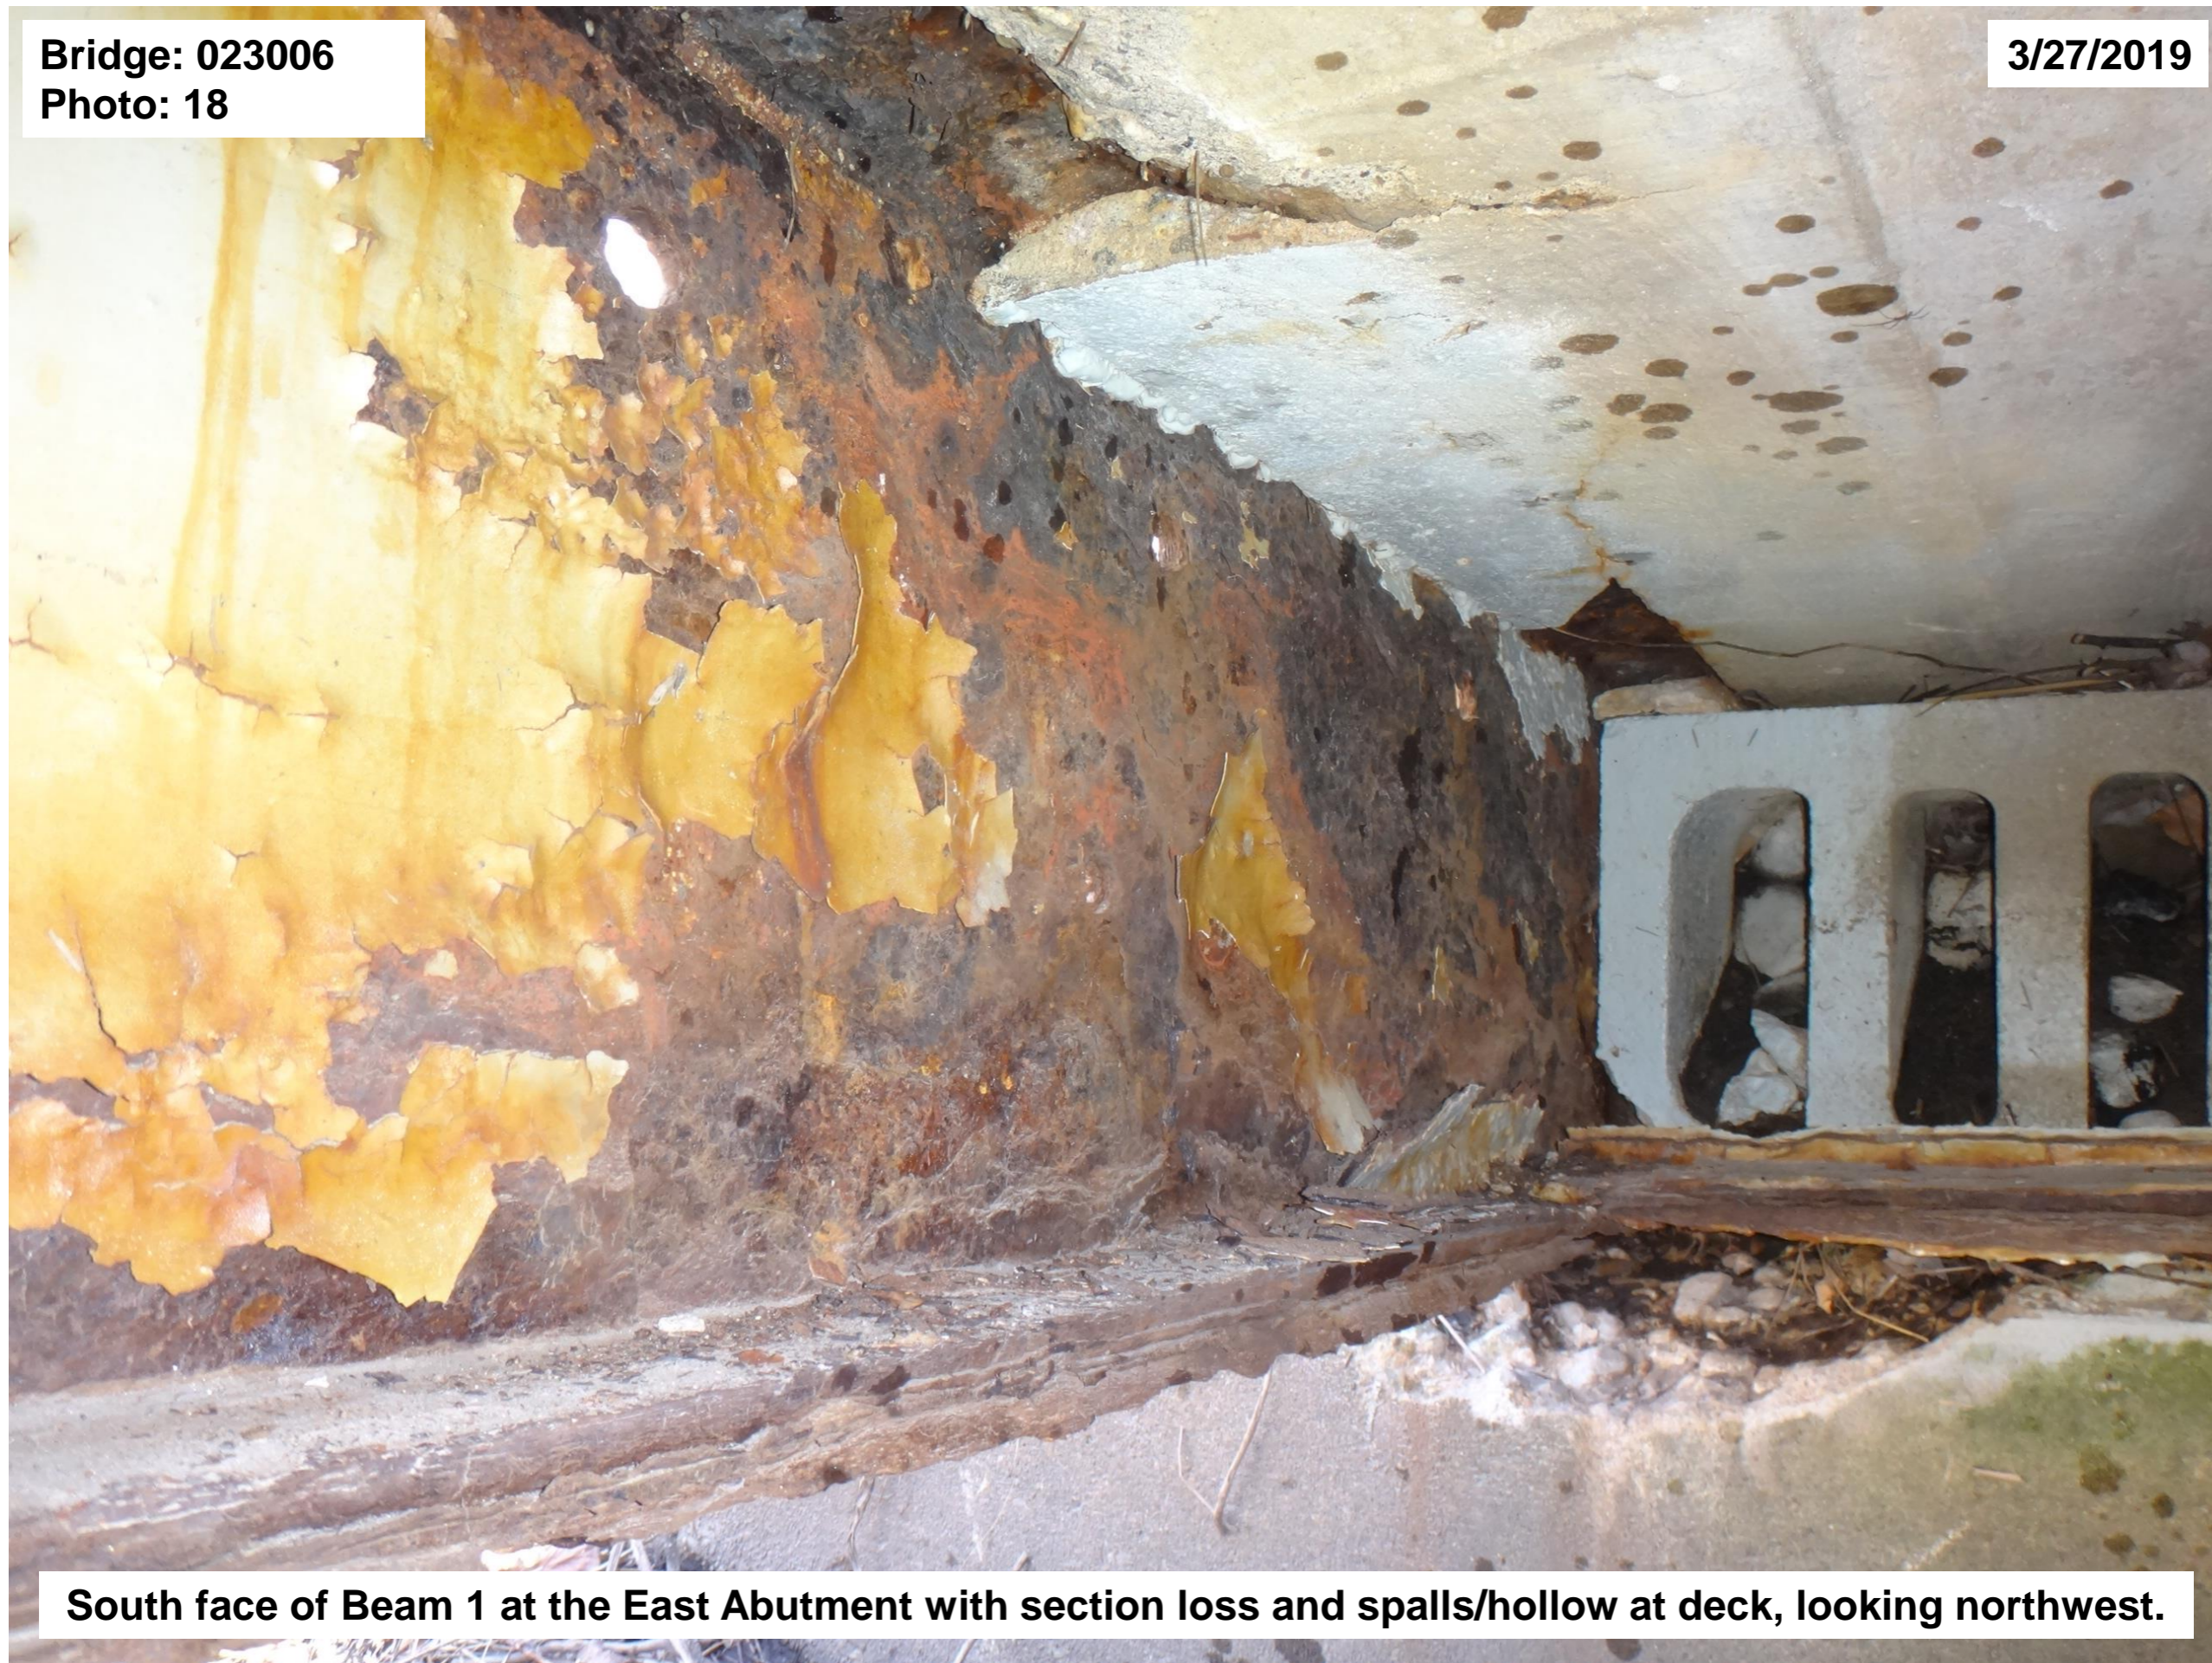
South face of Beam 1 at the East Abutment with section loss and spalls/hollow at deck, looking northwest.
