# Table of Contents

OLD CANTON BRIDGE SIGNED APPLICATION.pdf .....	104
WASHBURN BRIDGE SIGNED APPLICATION.pdf .....	106

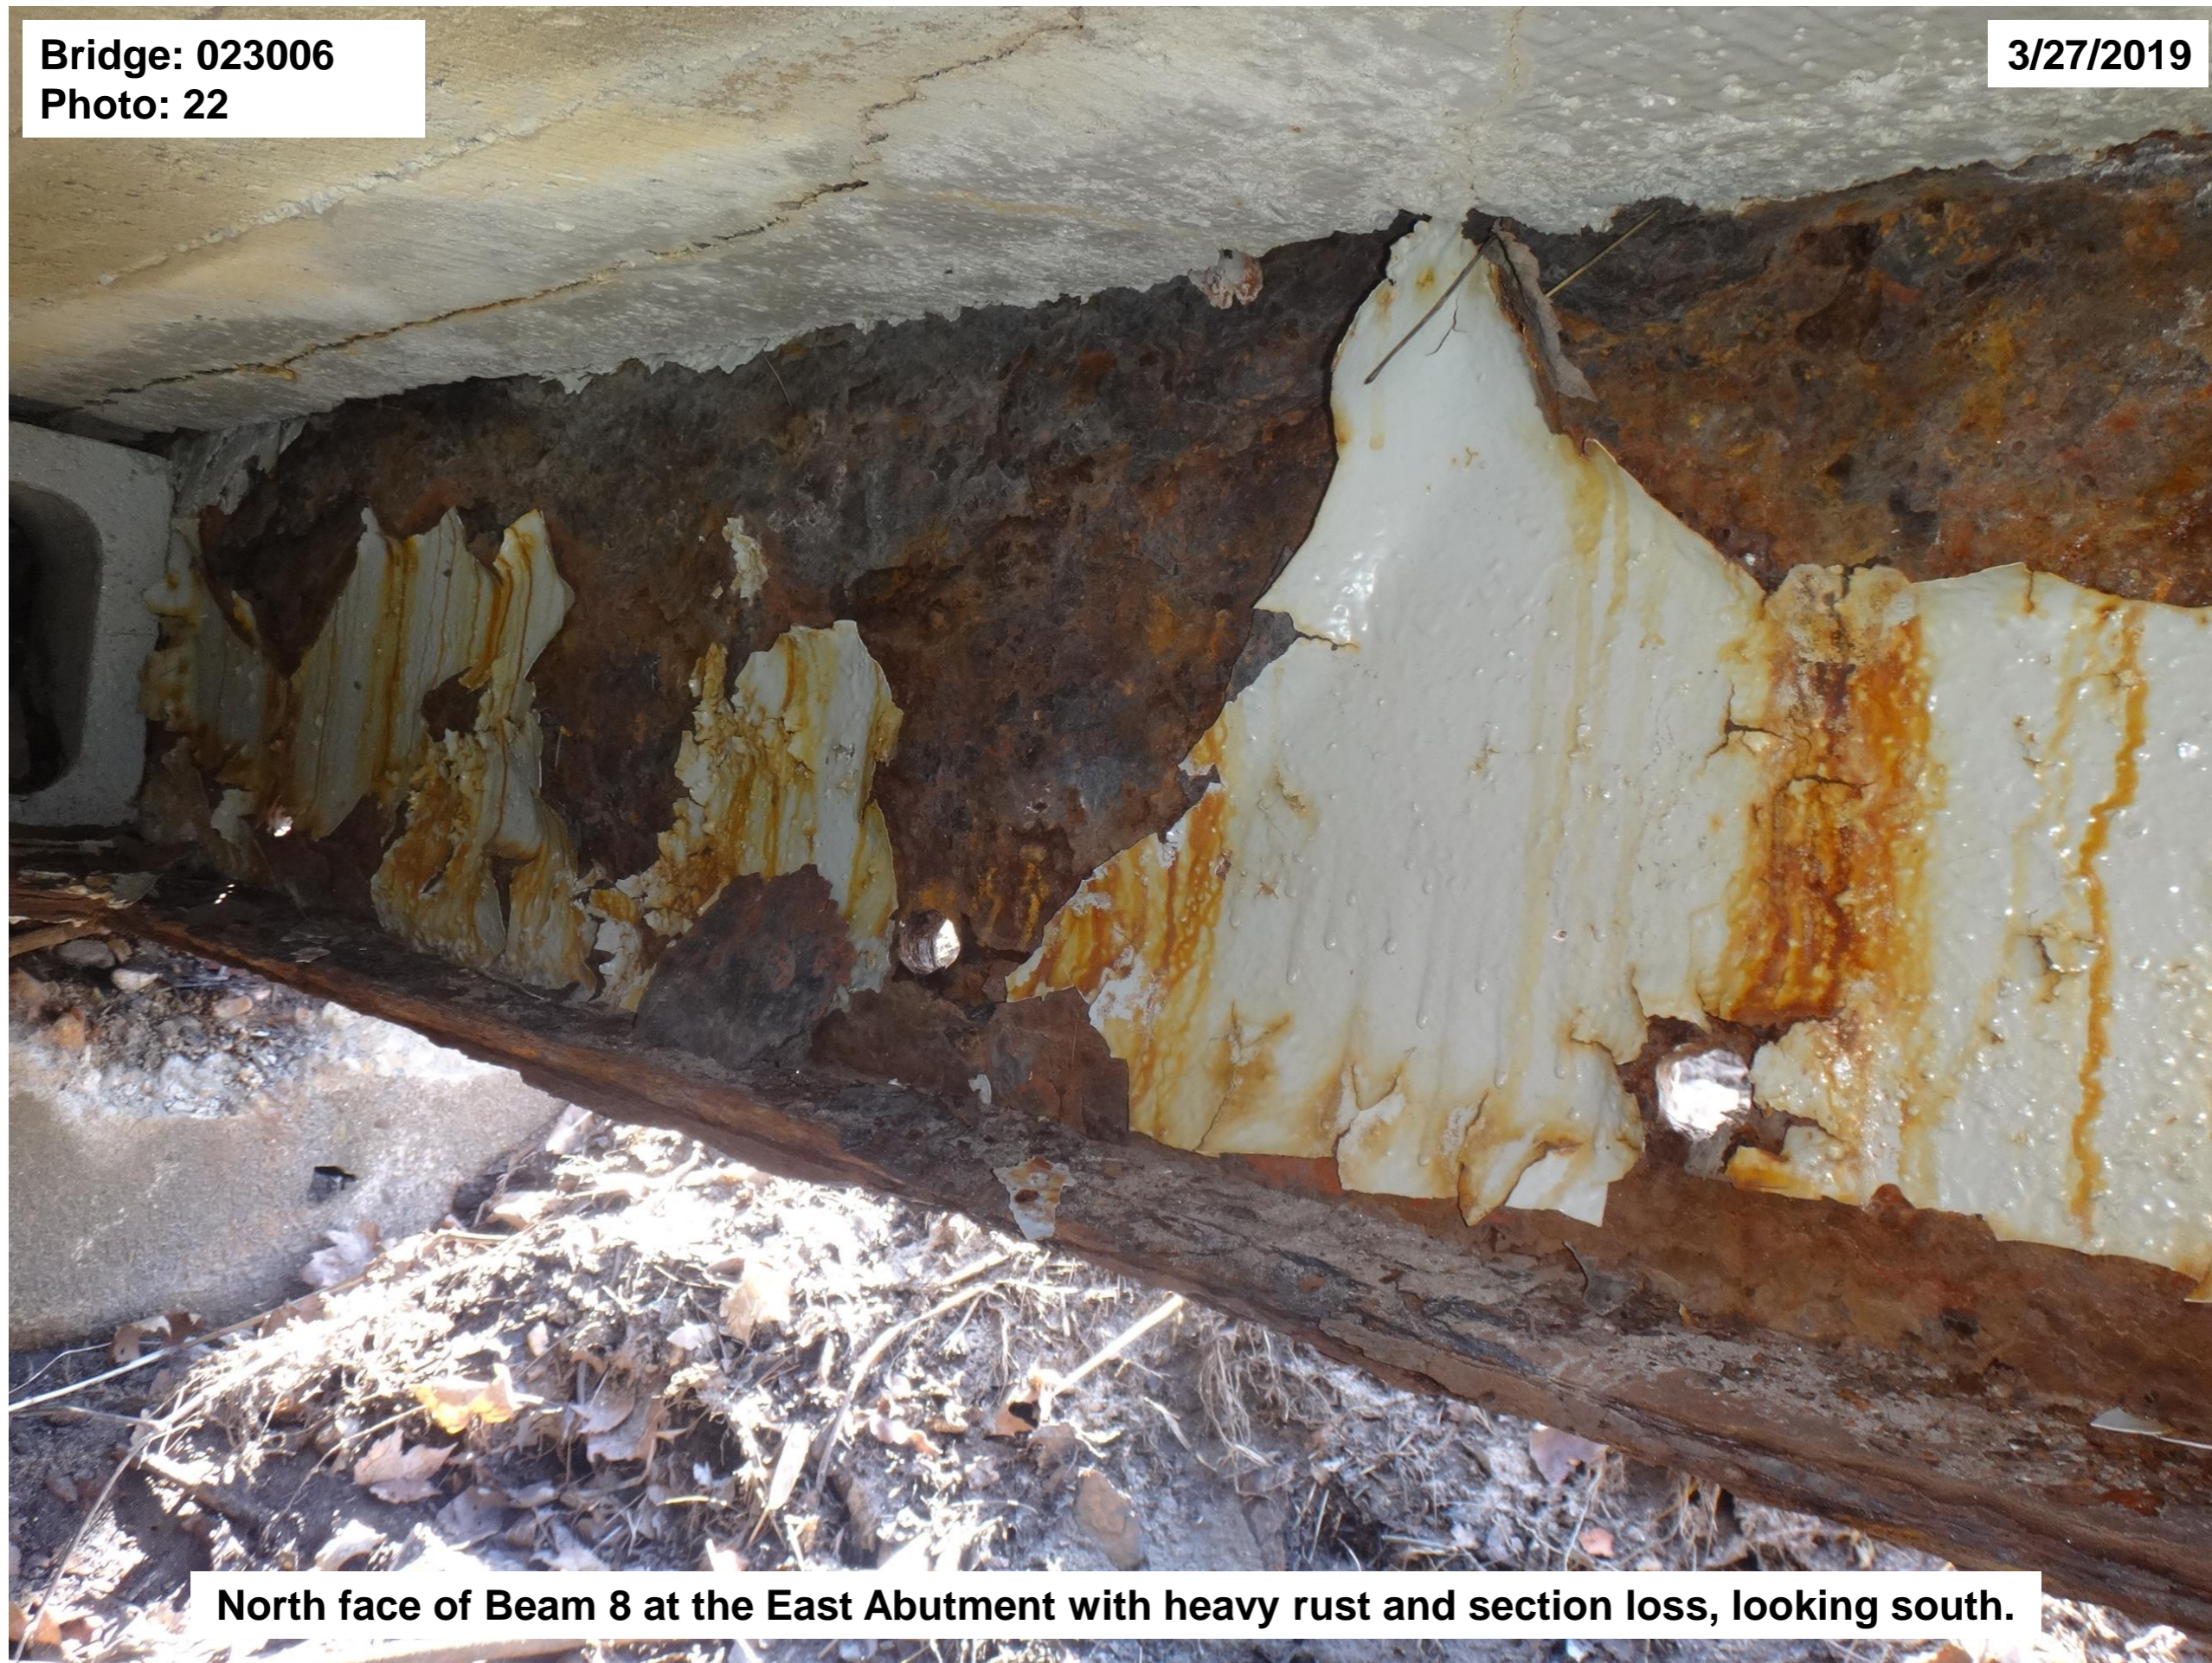
North face of Beam 8 at the East Abutment with heavy rust and section loss, looking south.

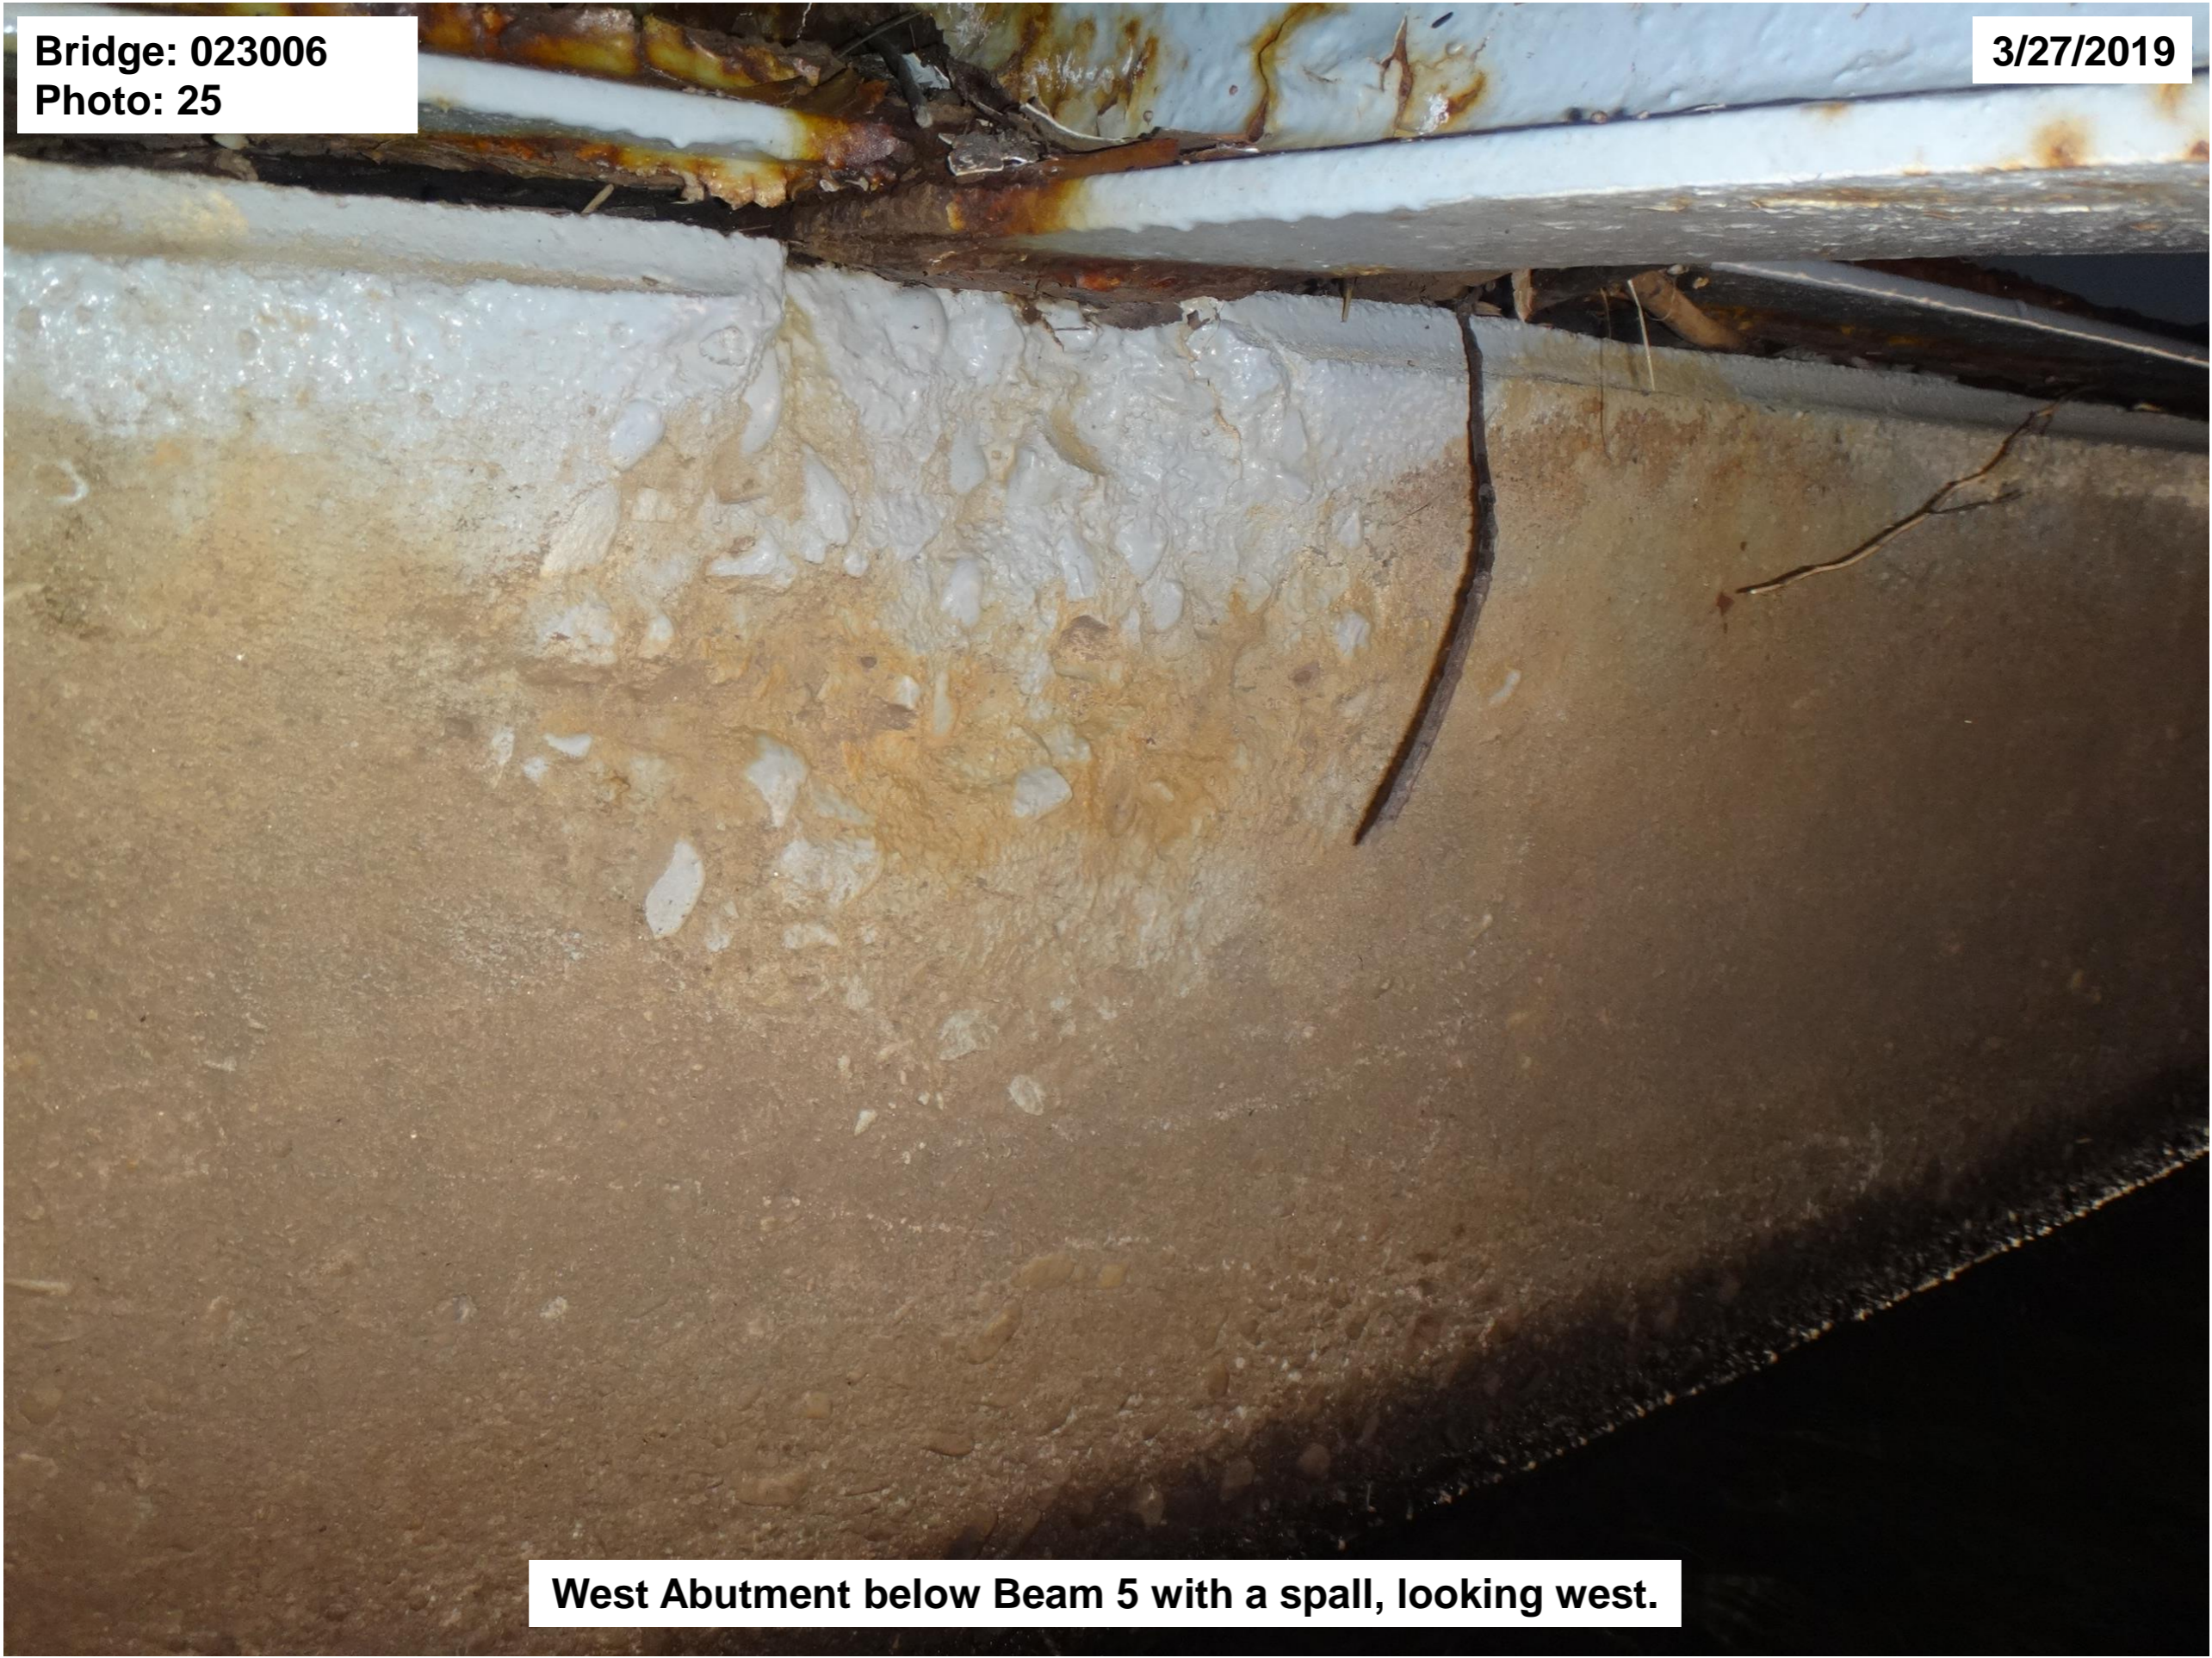
Bridge: 023006  
Photo: 26

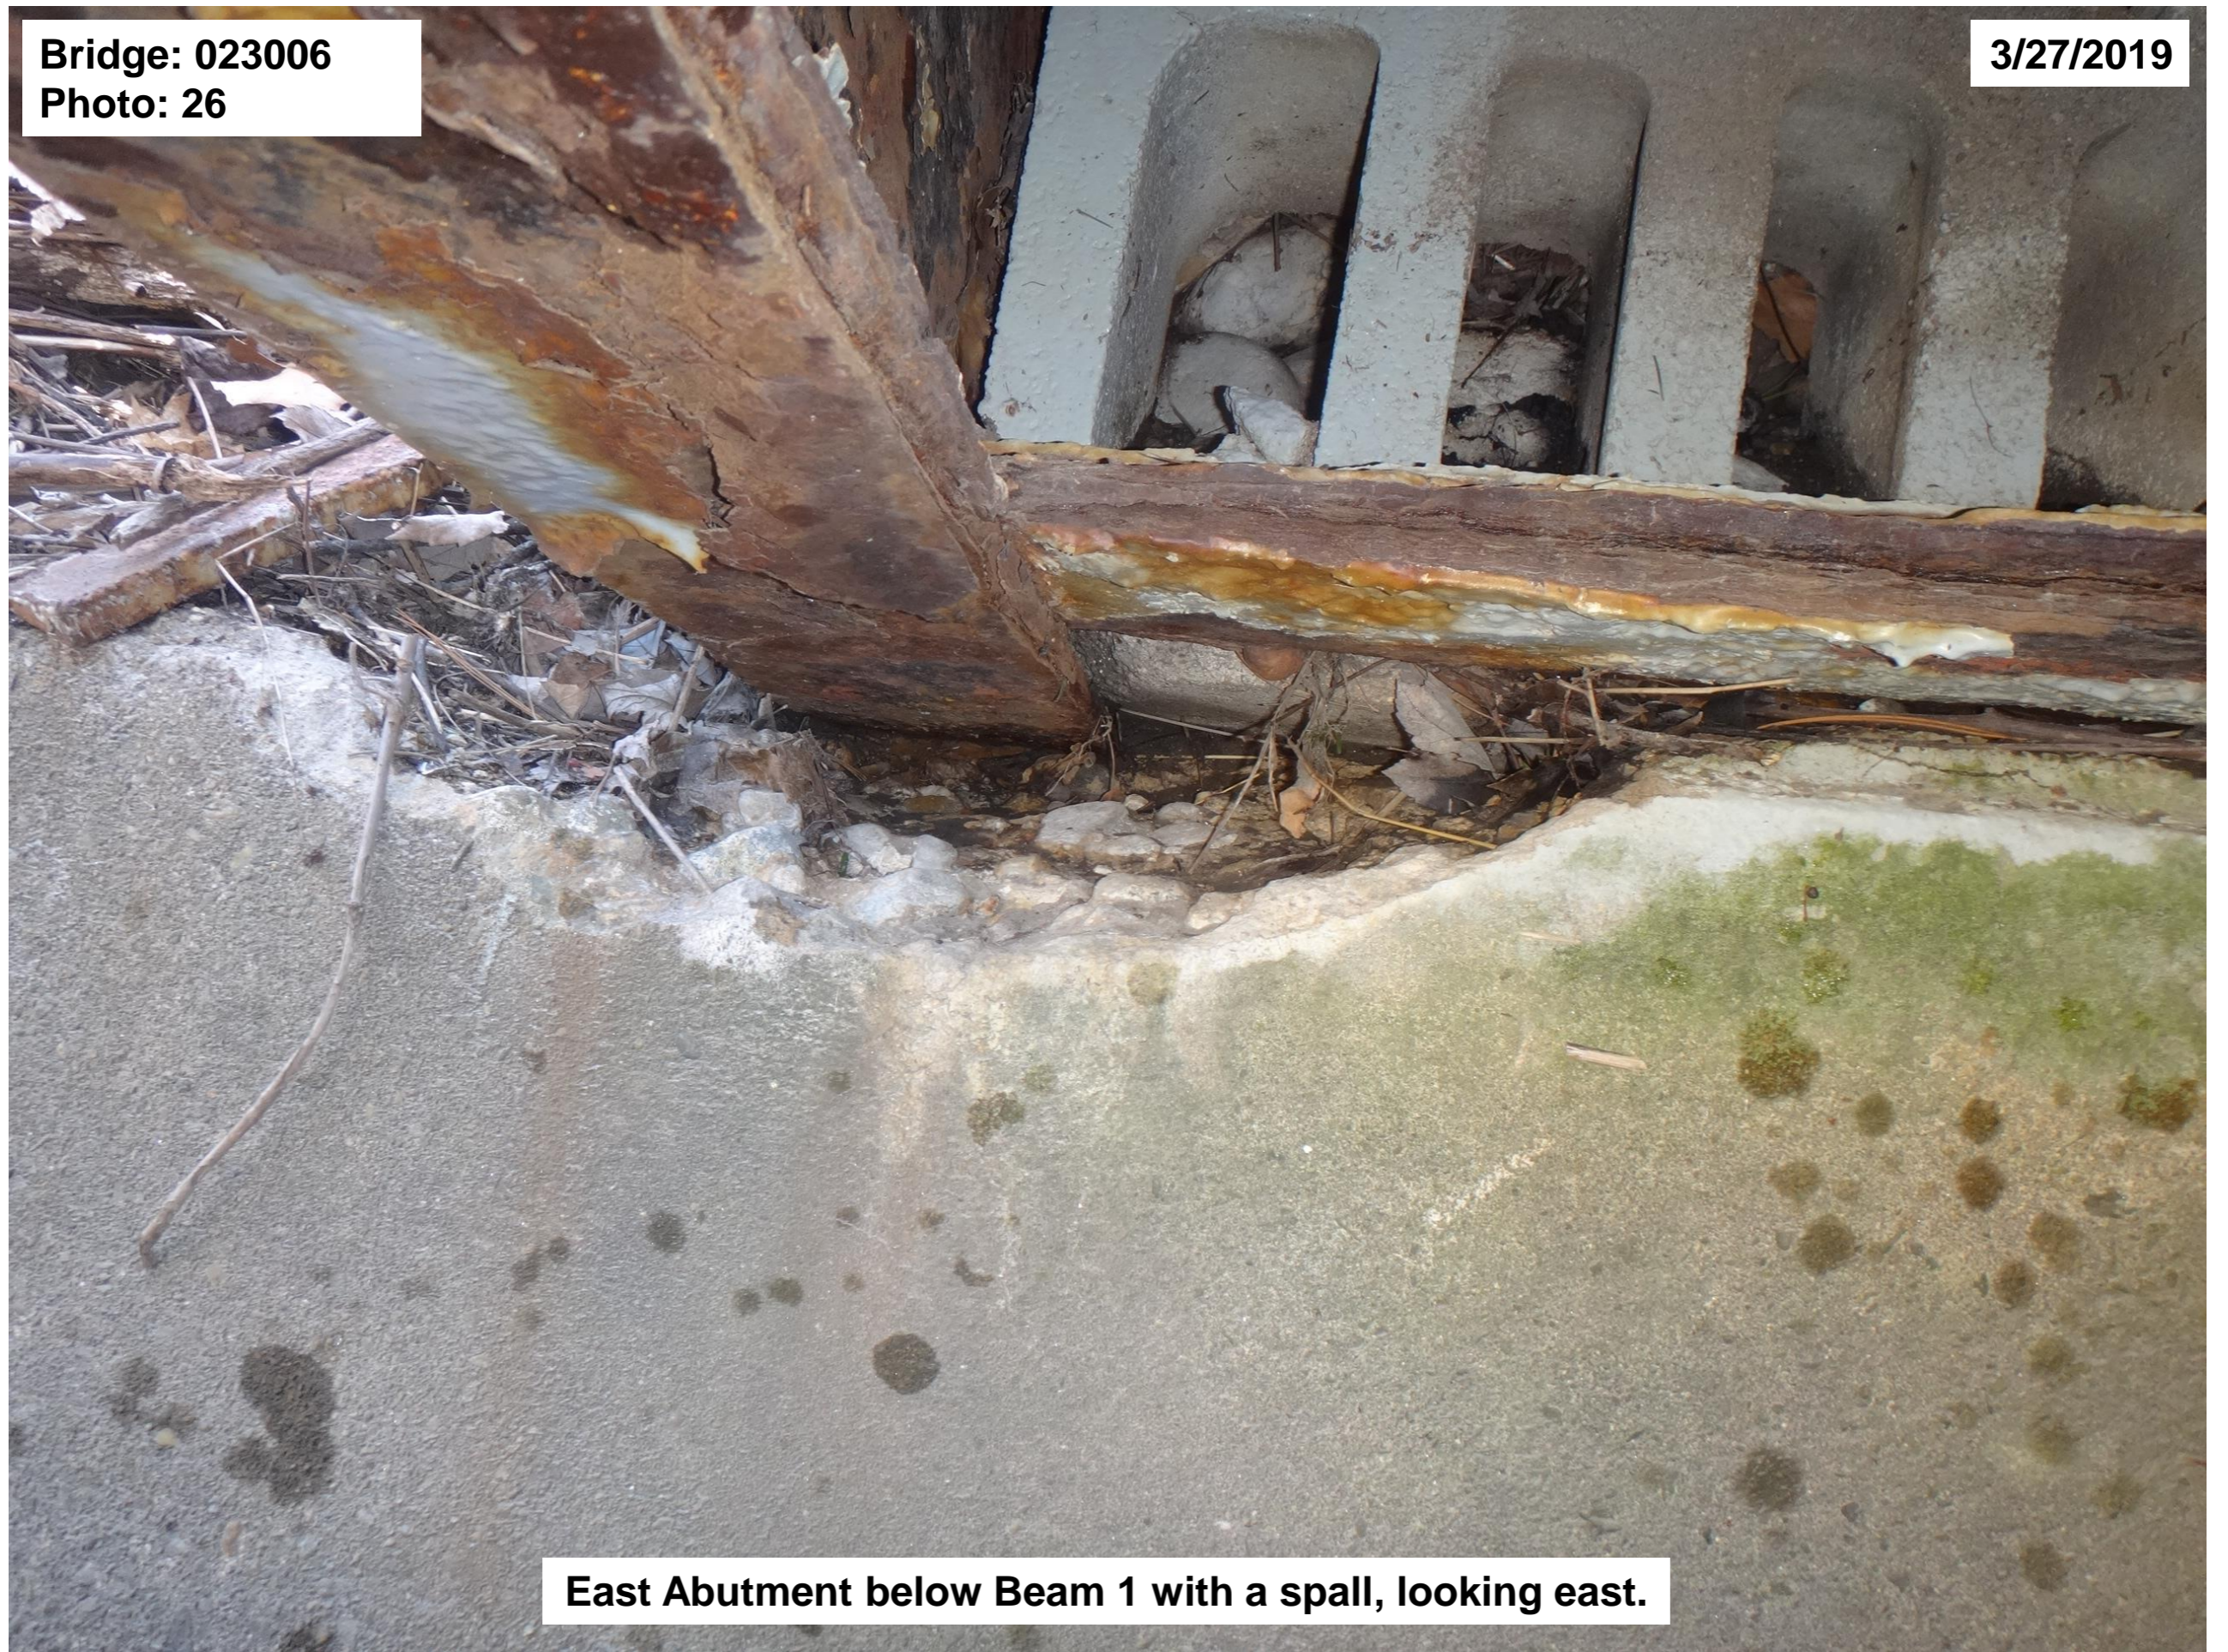
Bridge: 023006  
Photo: 27

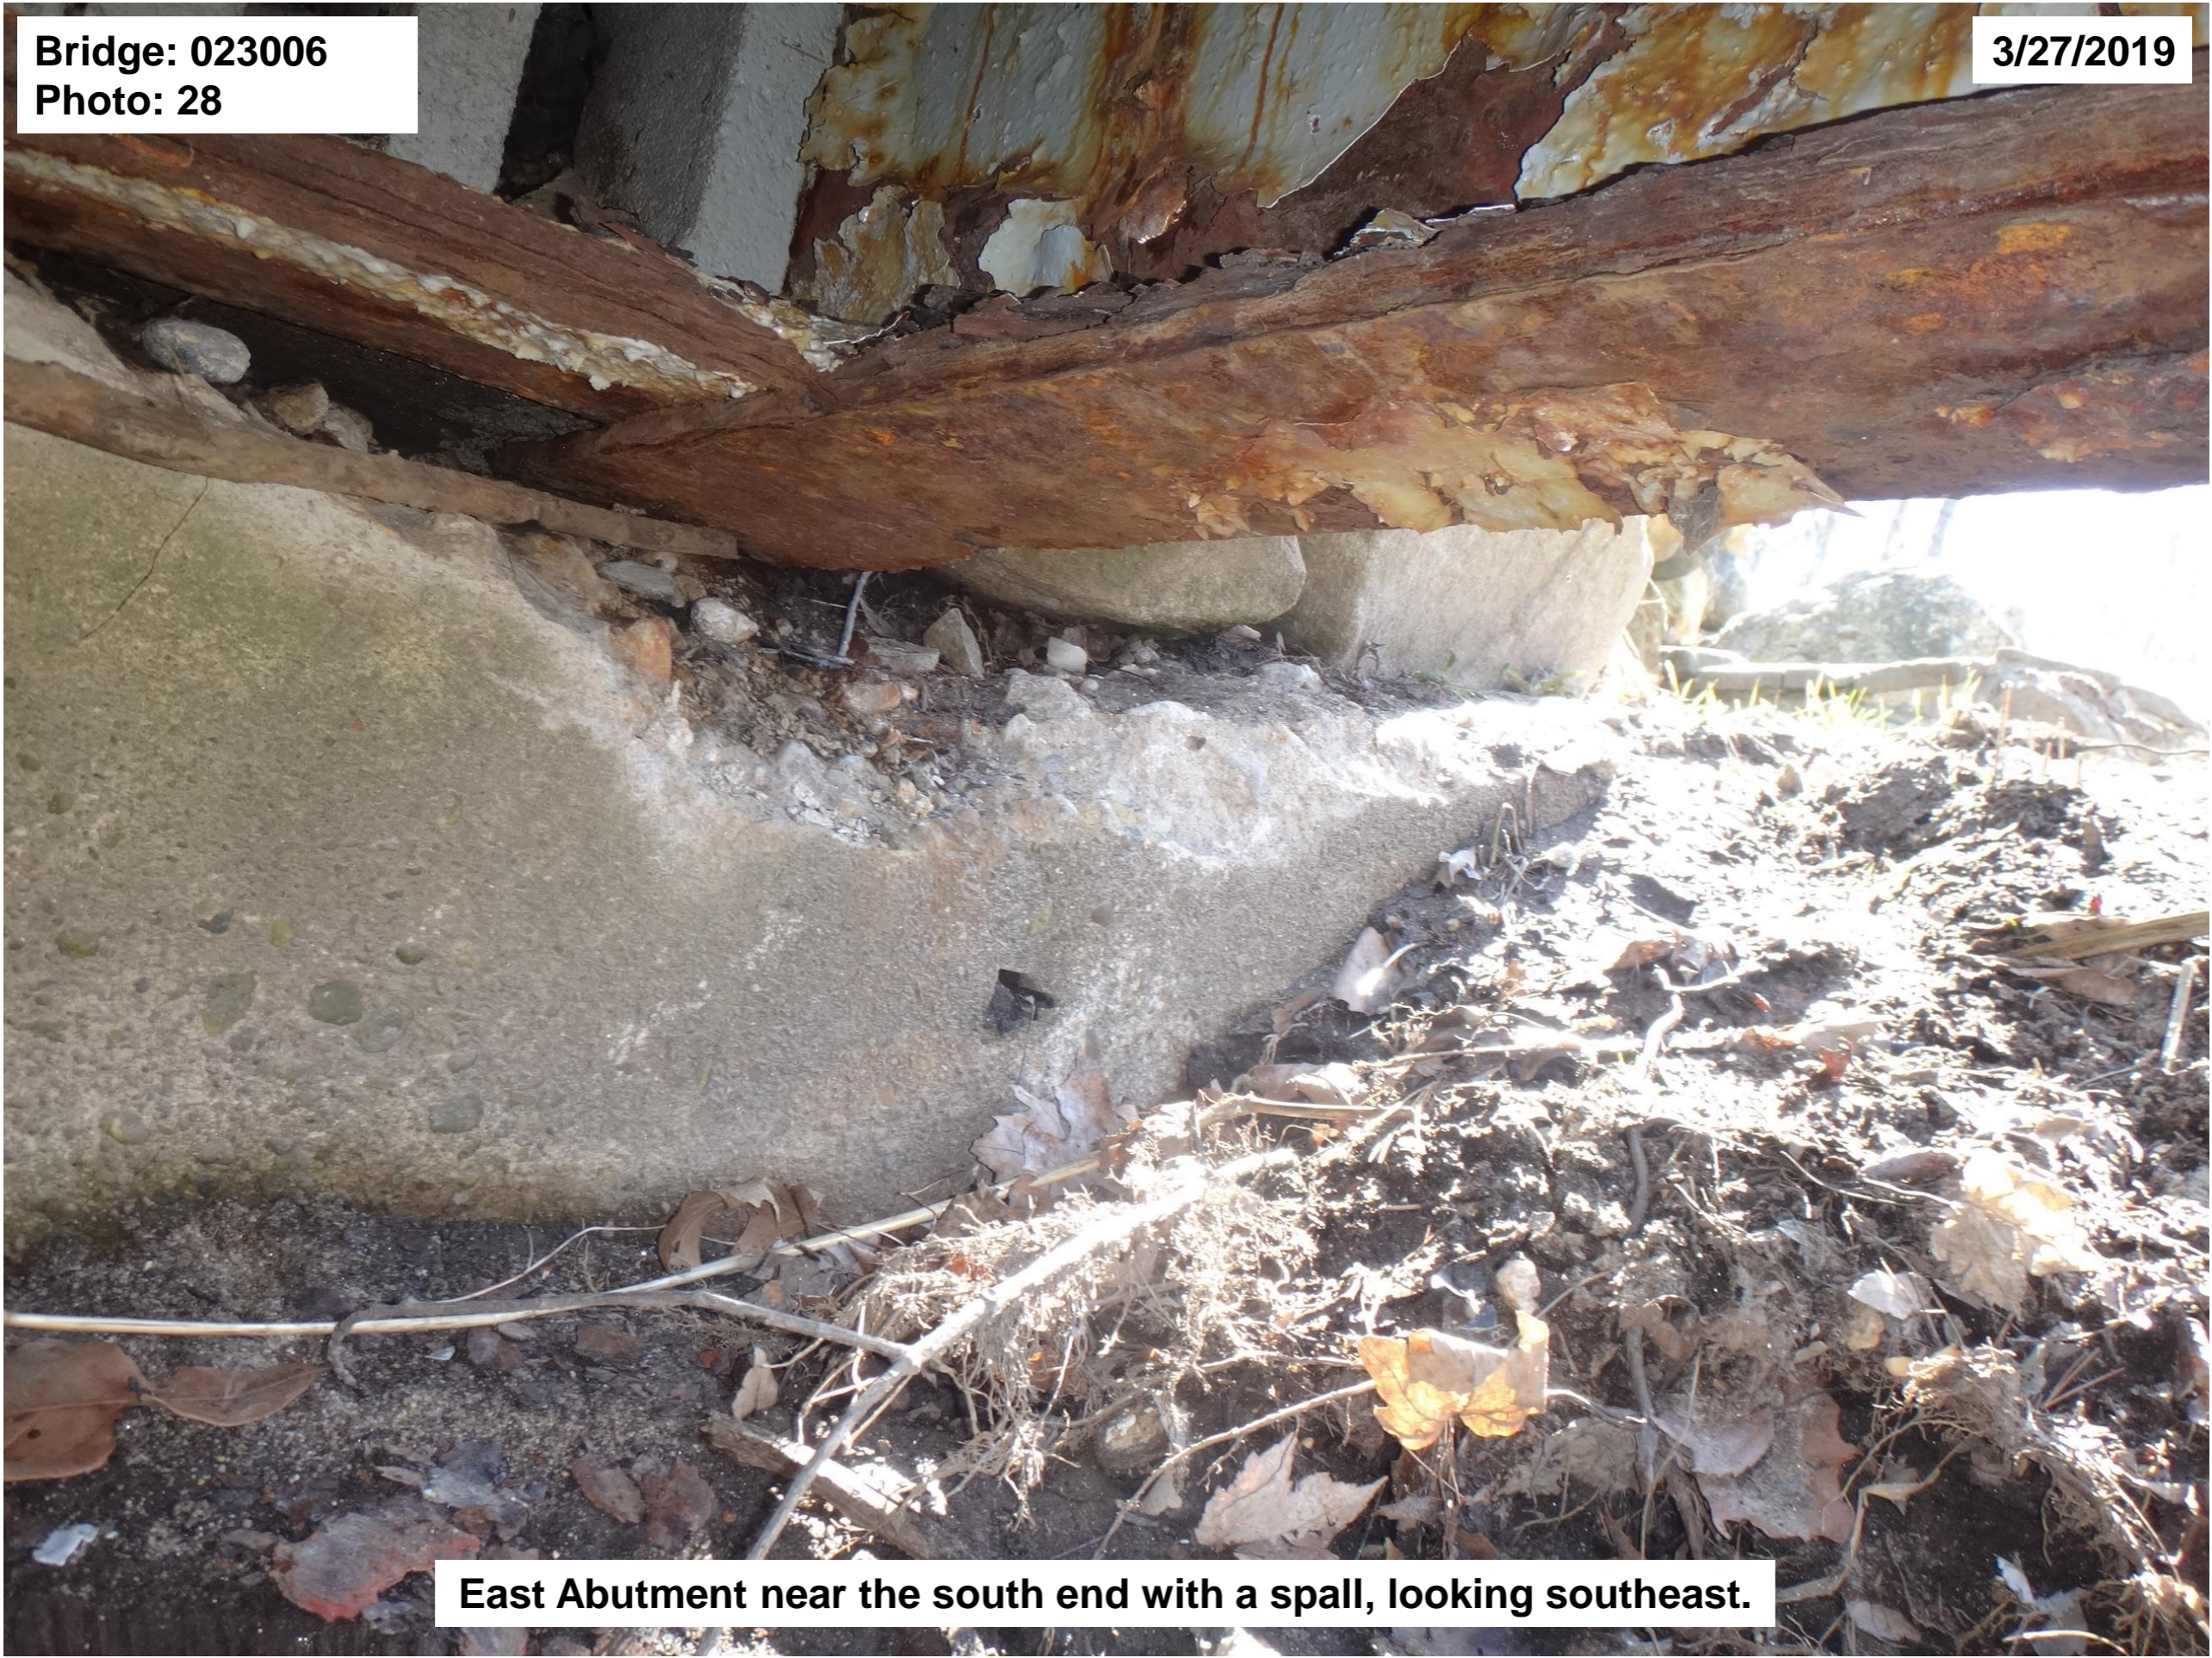
Bridge: 023006  
Photo: 29

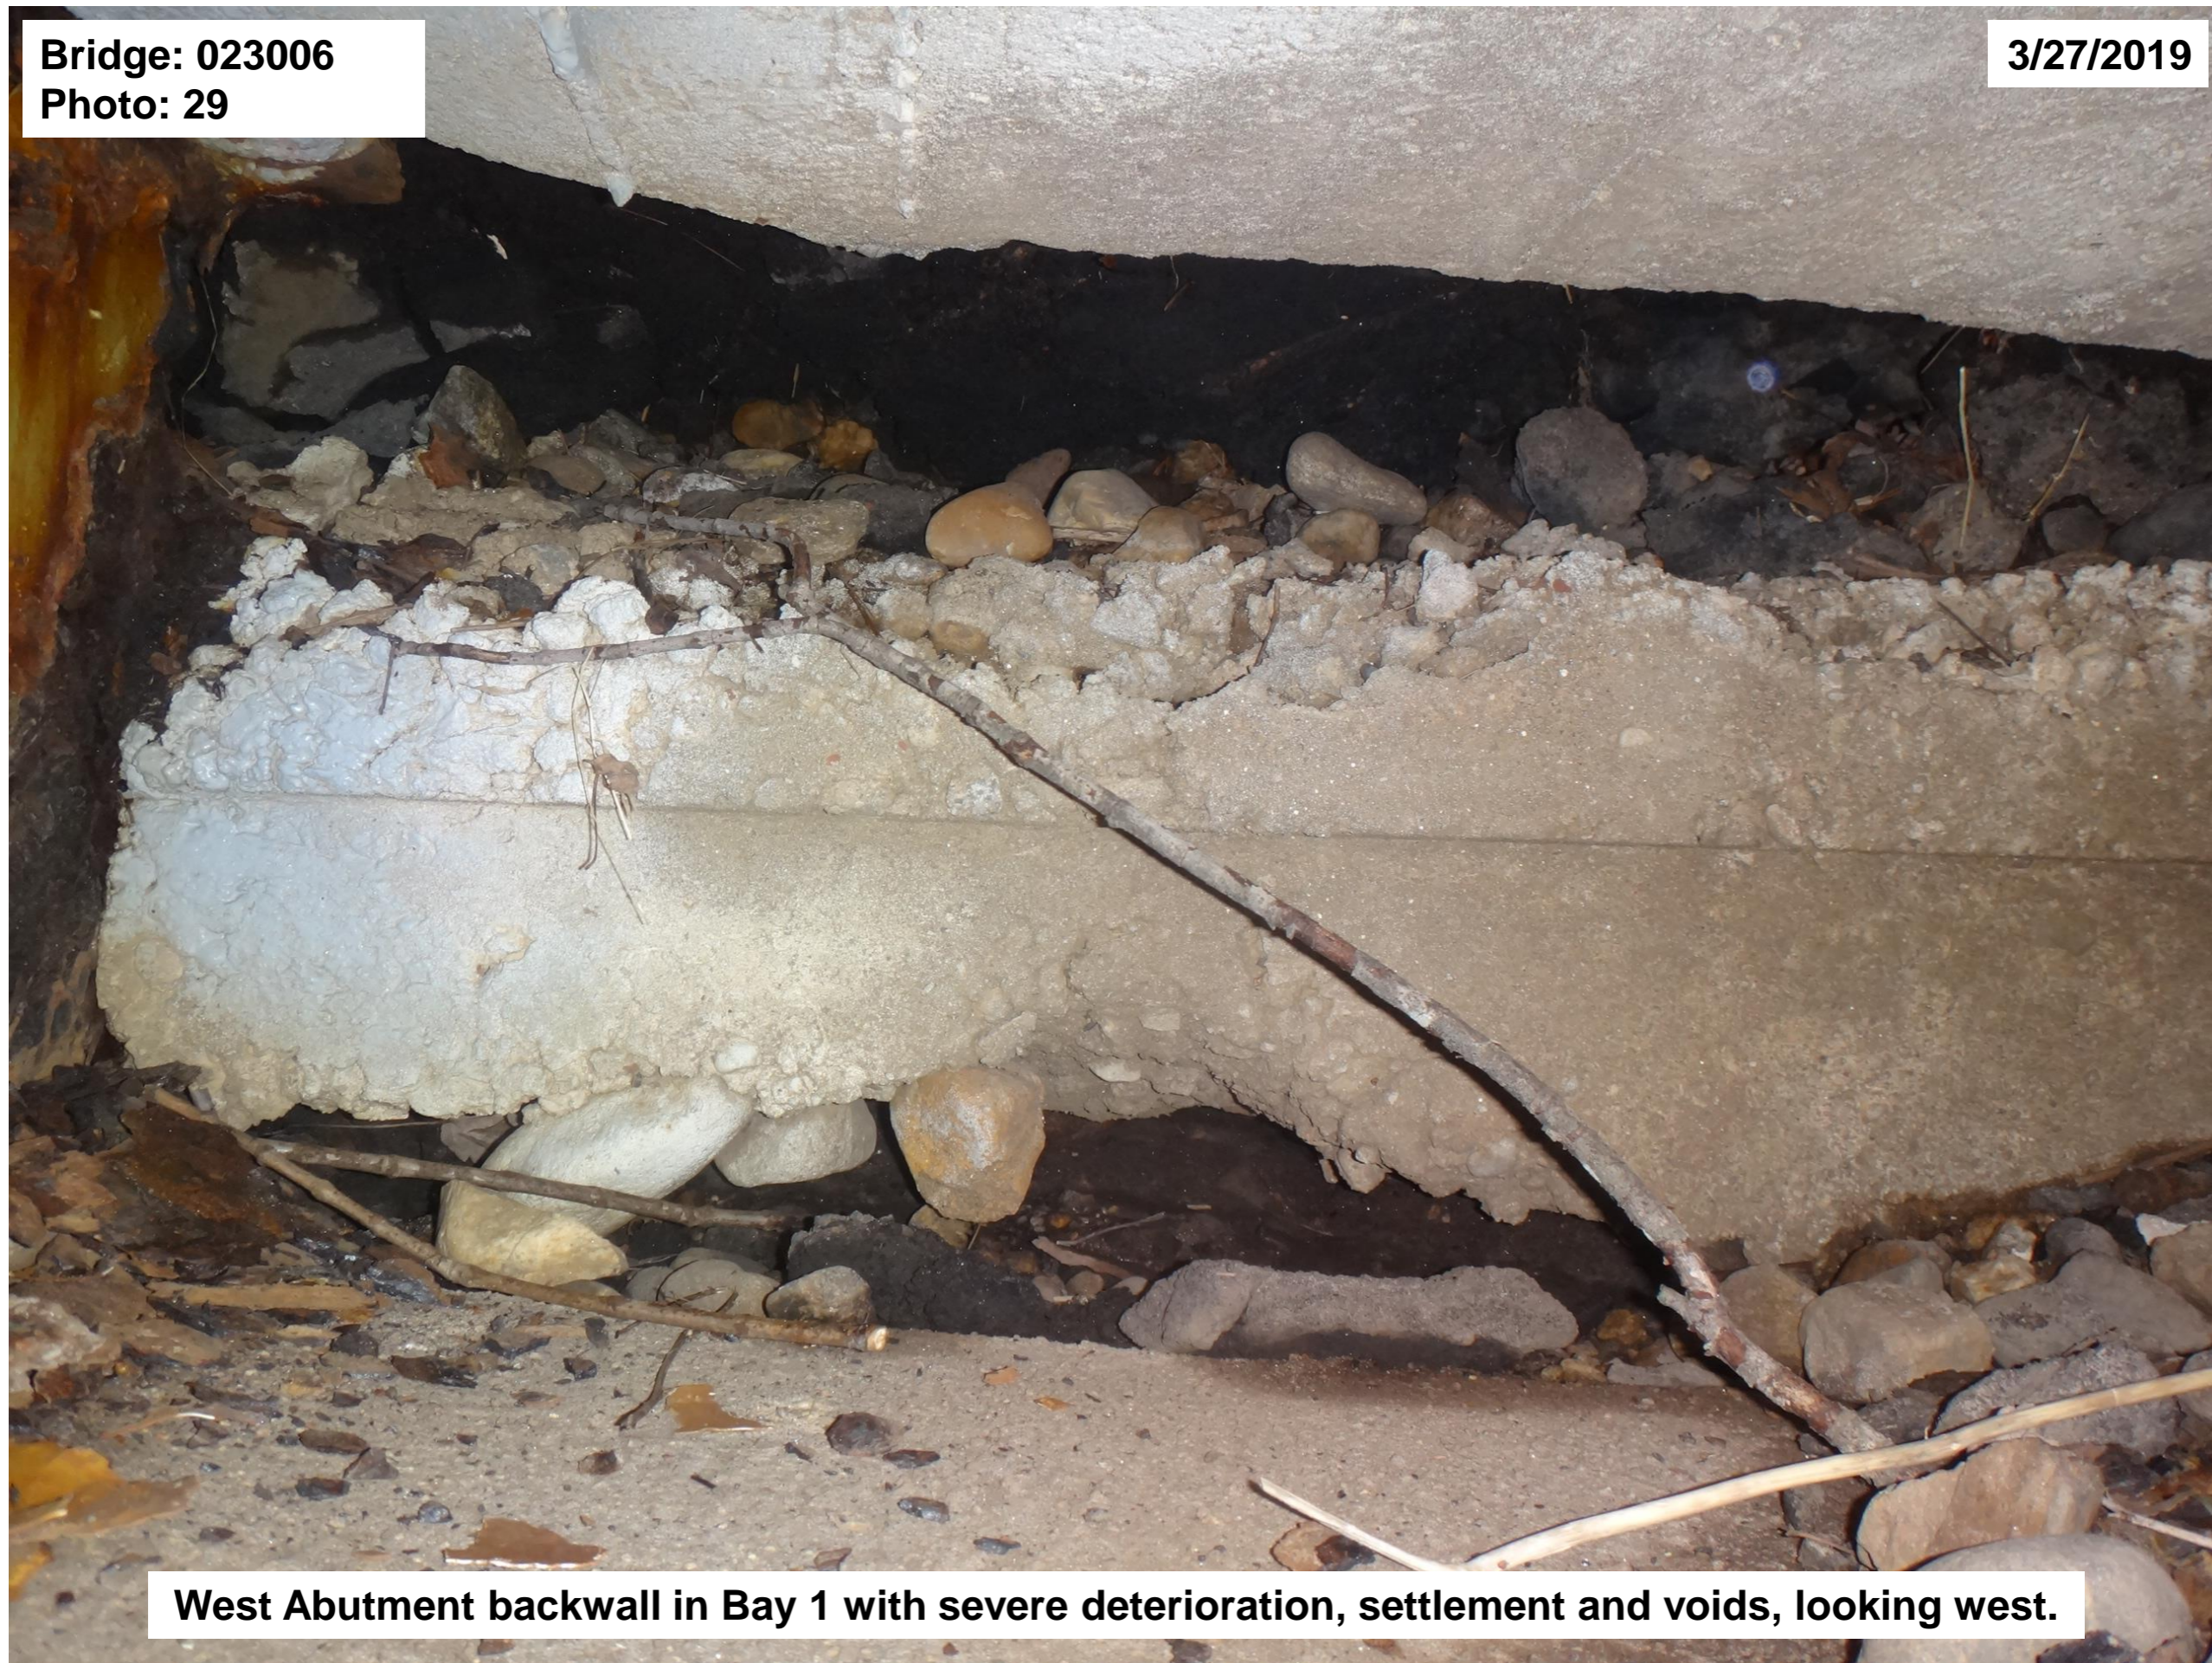
West Abutment backwall in Bay 1 with severe deterioration, settlement and voids, looking west.

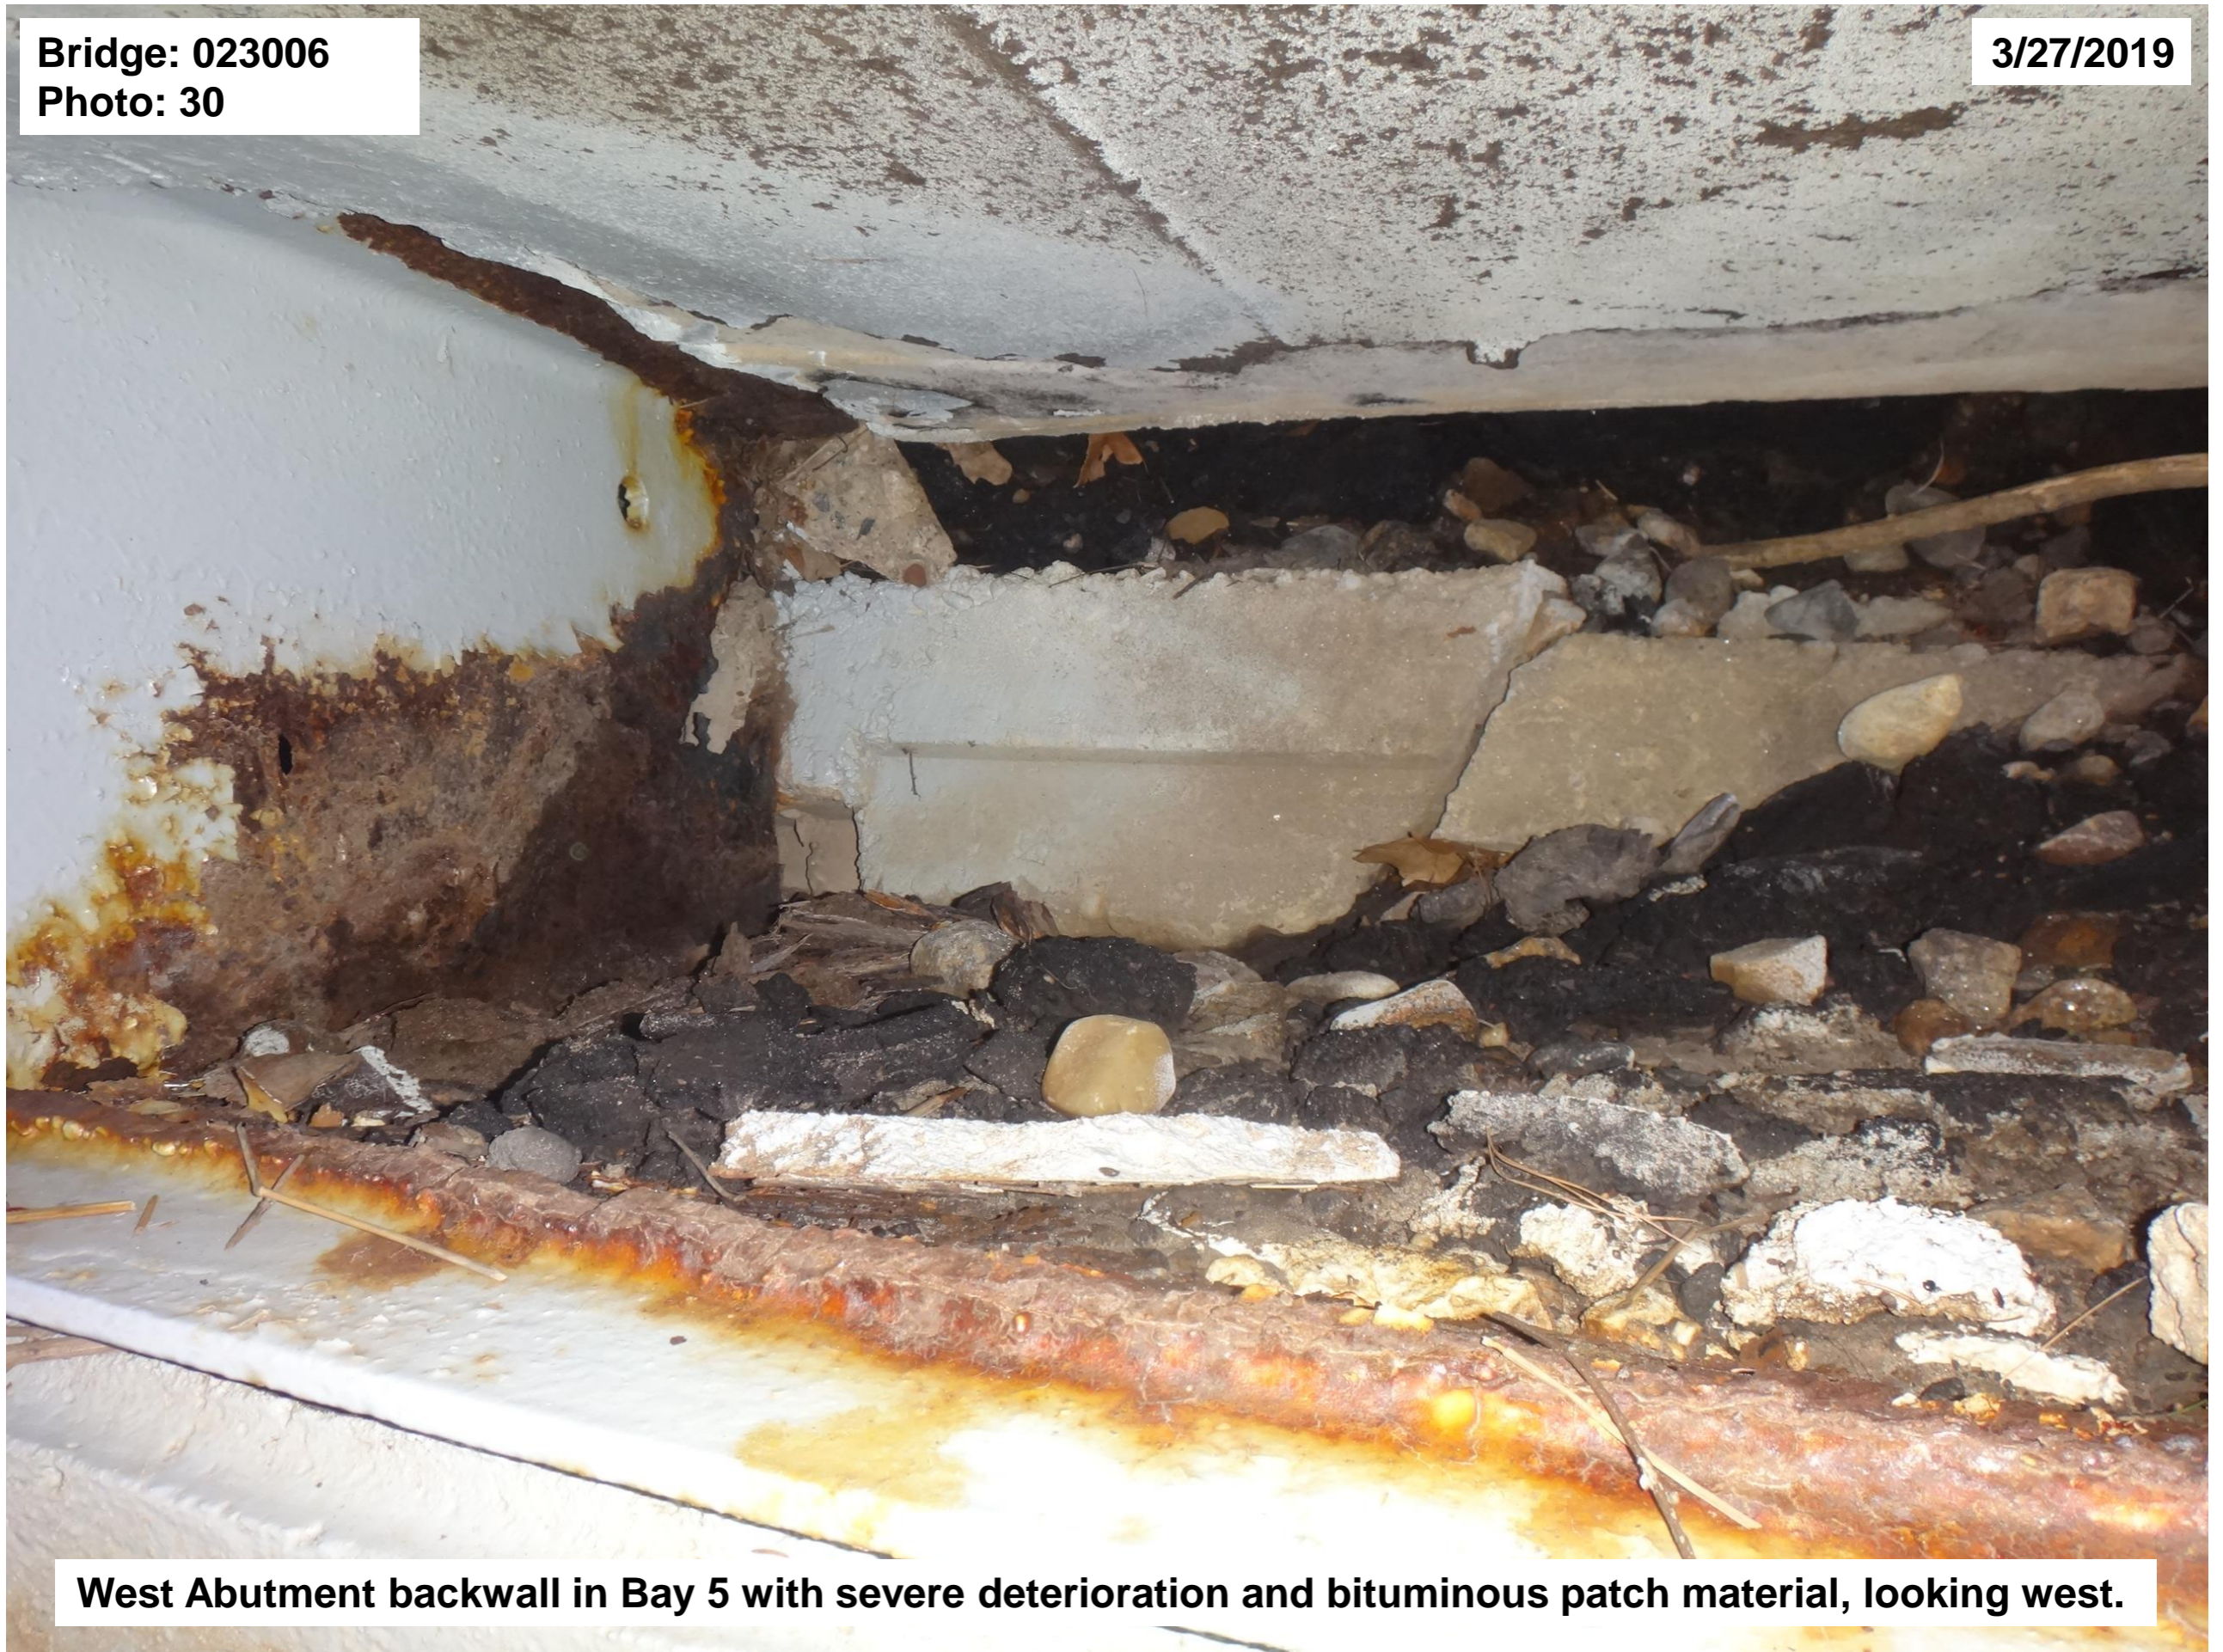
West Abutment backwall in Bay 5 with severe deterioration and bituminous patch material, looking west.
