# Table of Contents

OLD CANTON BRIDGE SIGNED APPLICATION.pdf .....	104
WASHBURN BRIDGE SIGNED APPLICATION.pdf .....	106

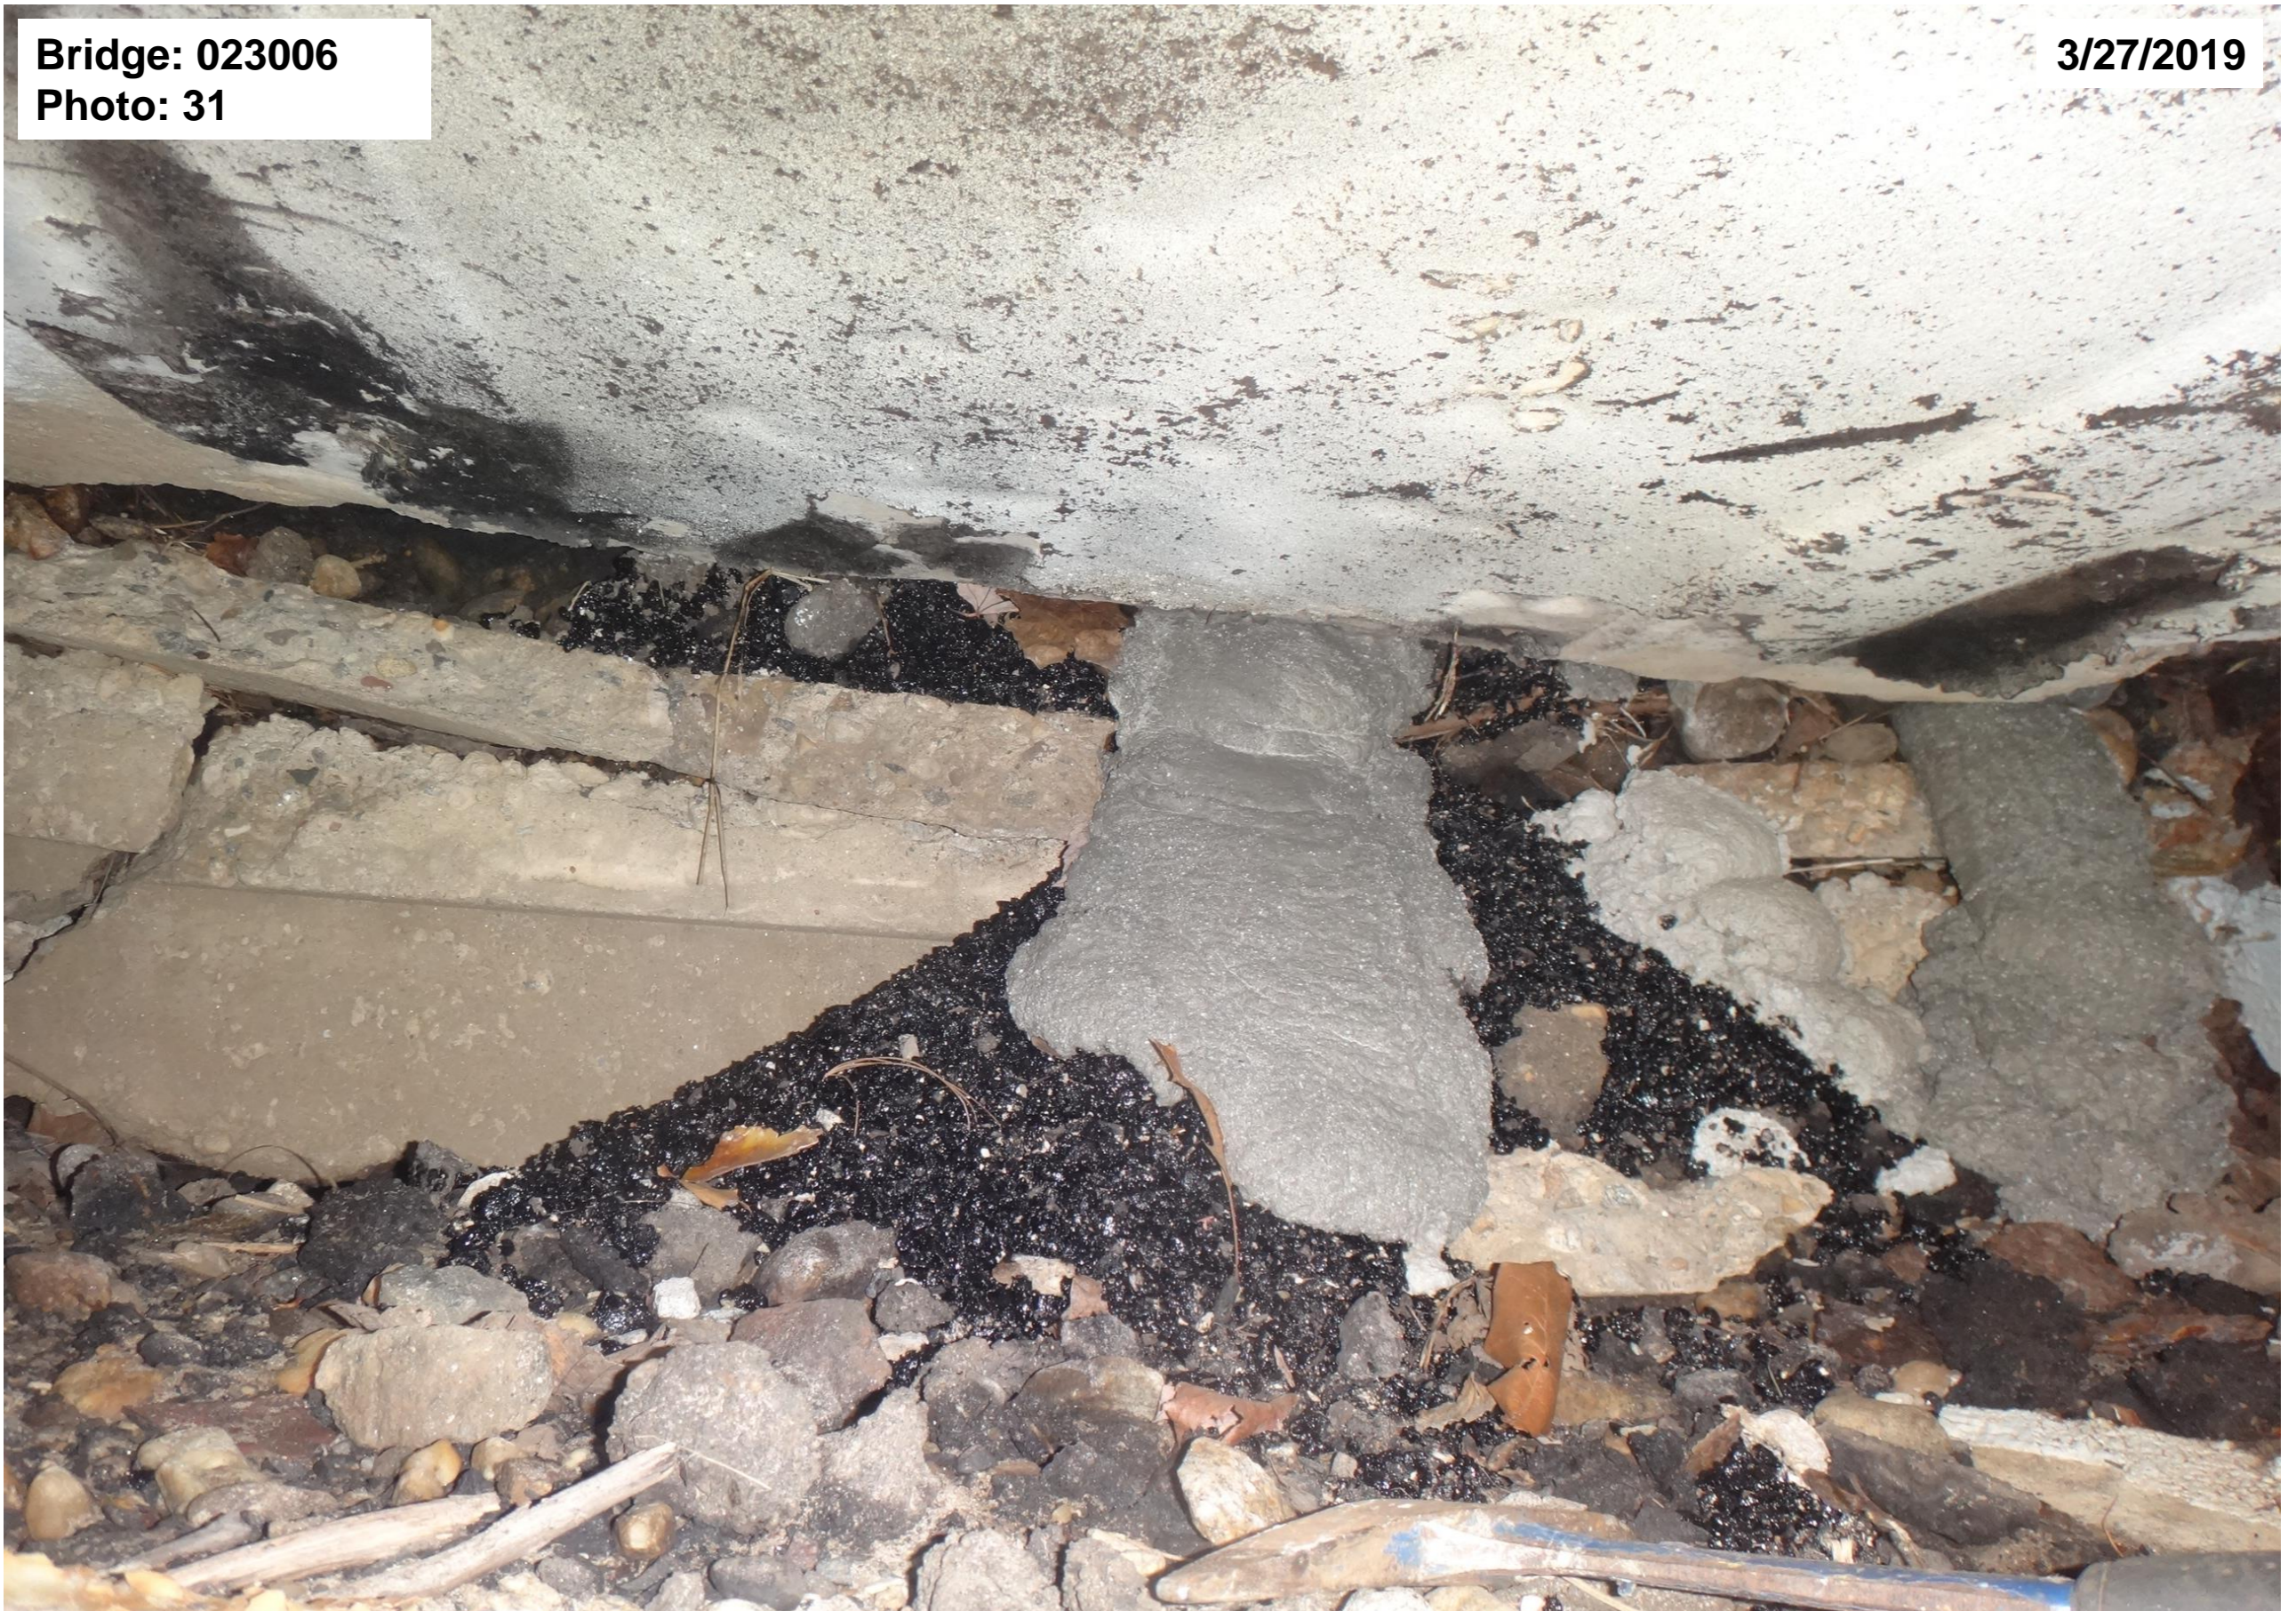
West Abutment backwall in Bay 6 with severe deterioration, settlement and bituminous patch material, looking west.

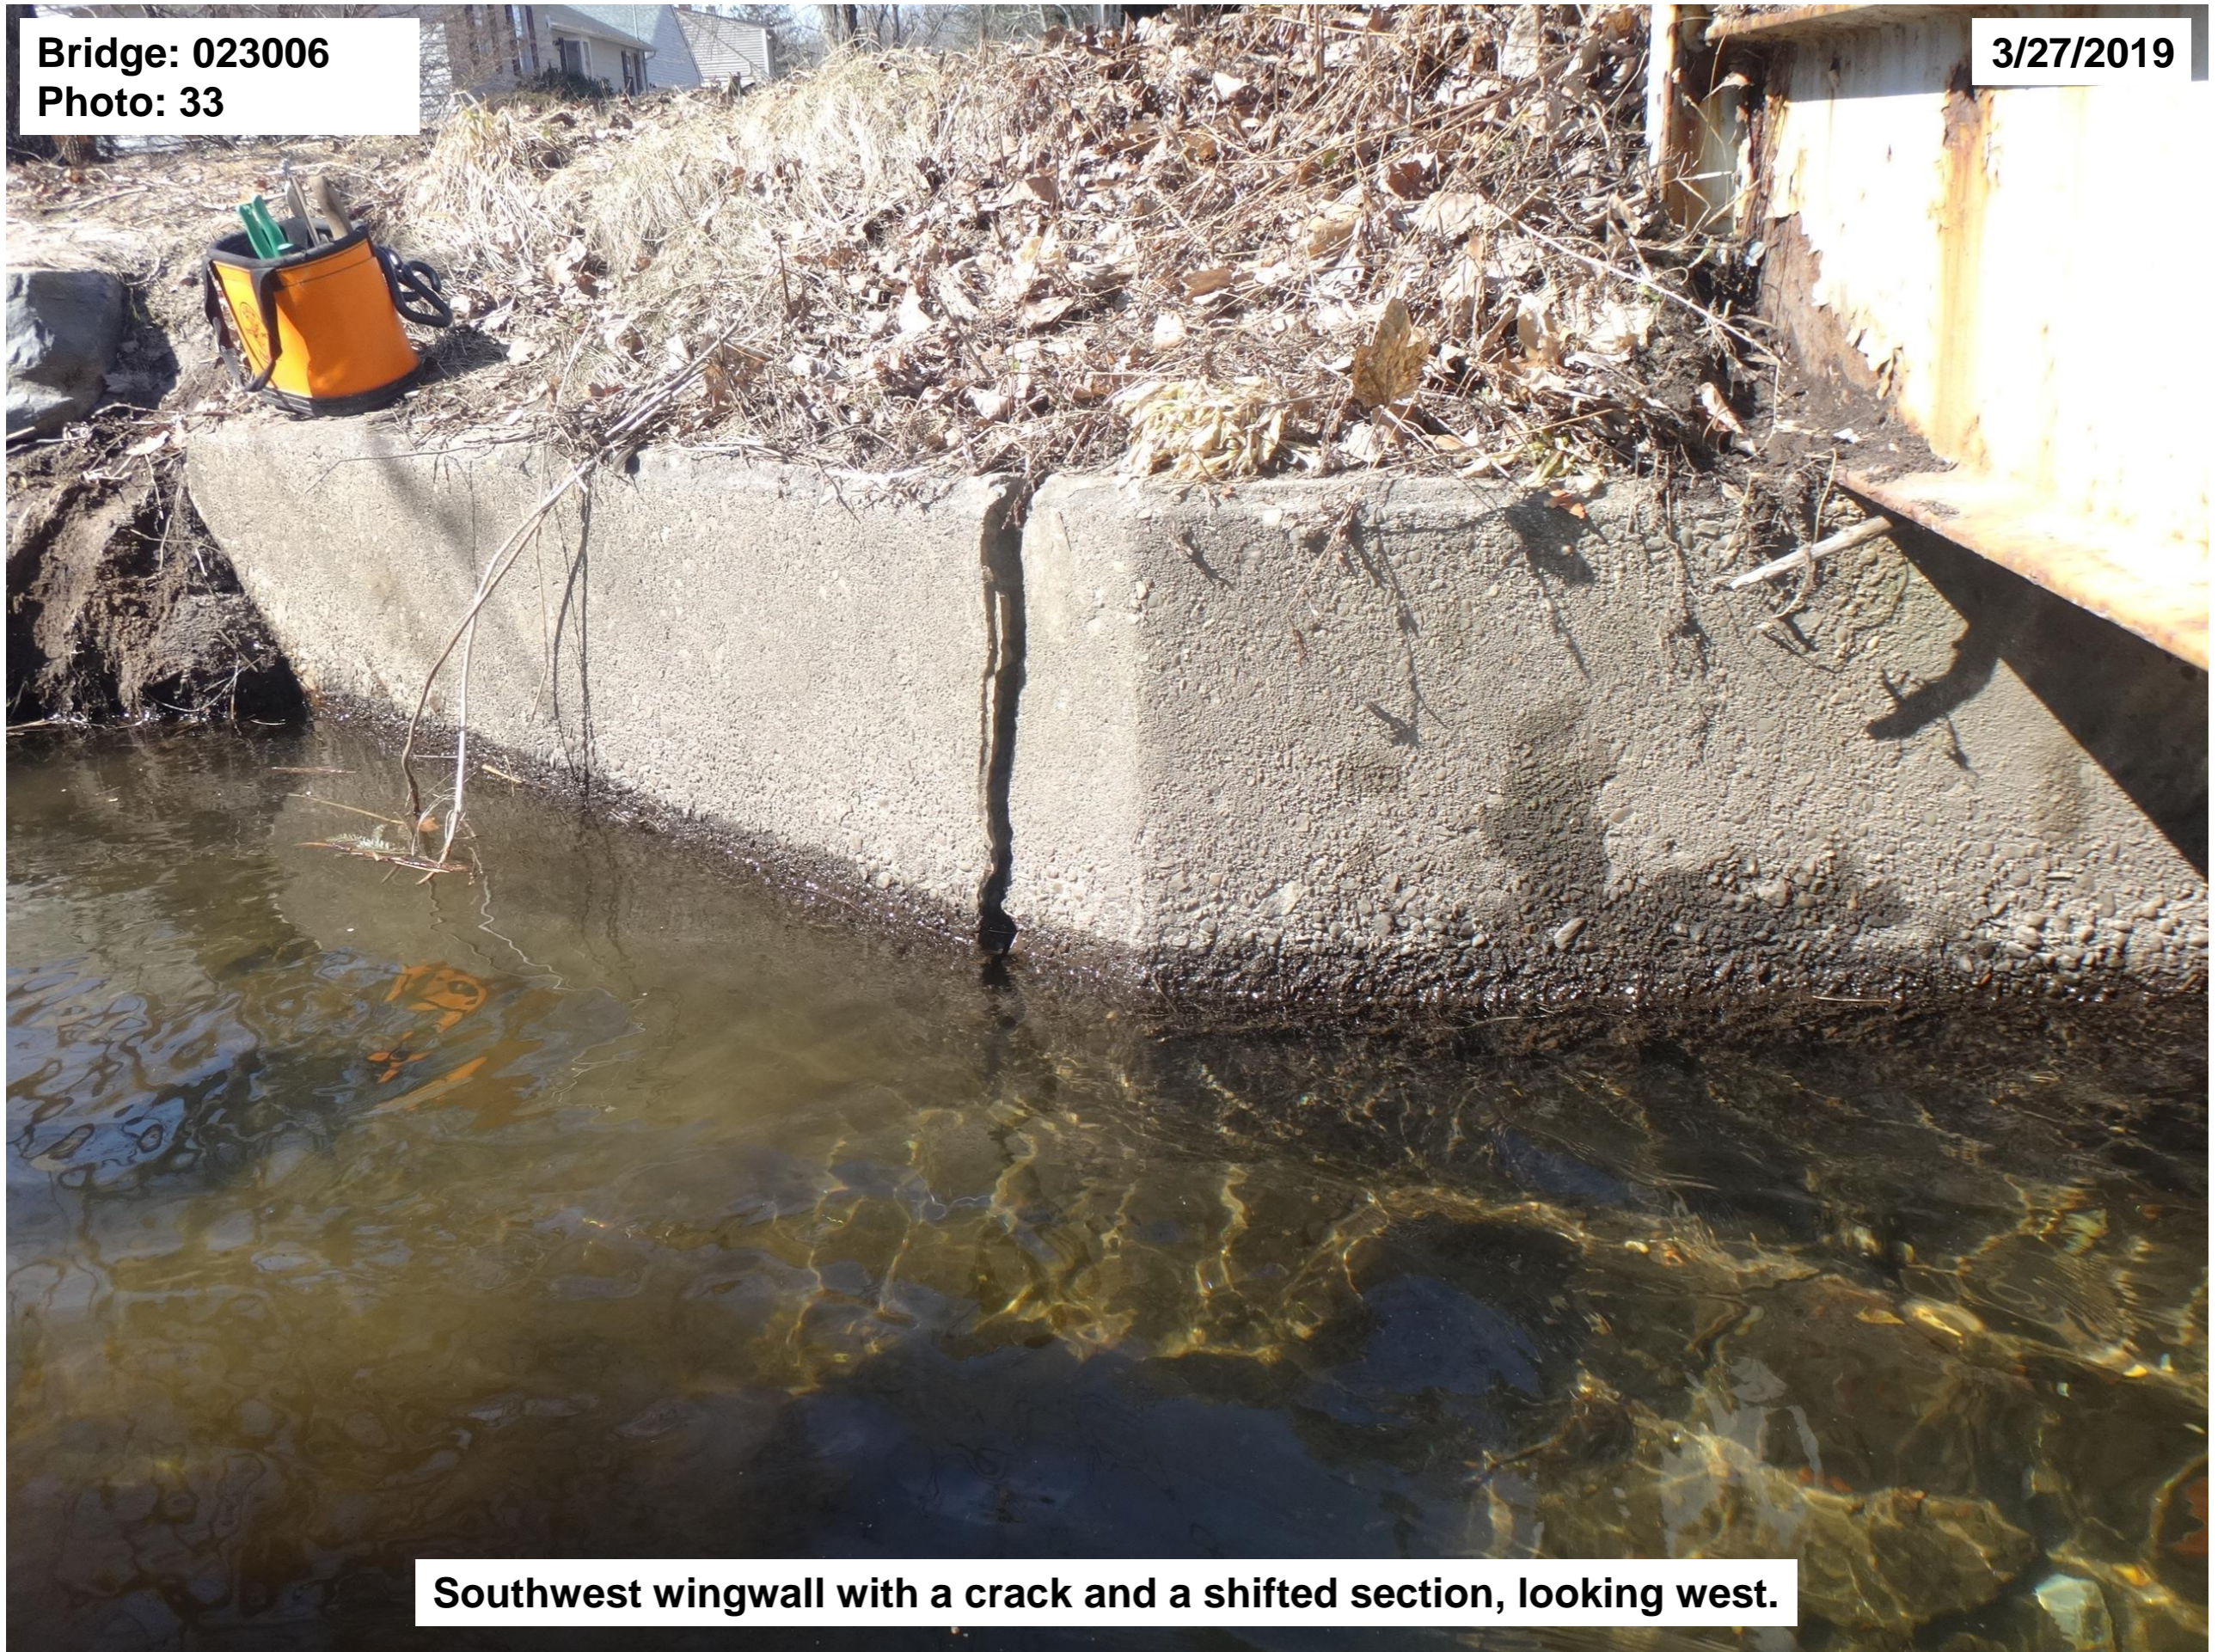
**Bridge: 023006**  
**Photo: 34**

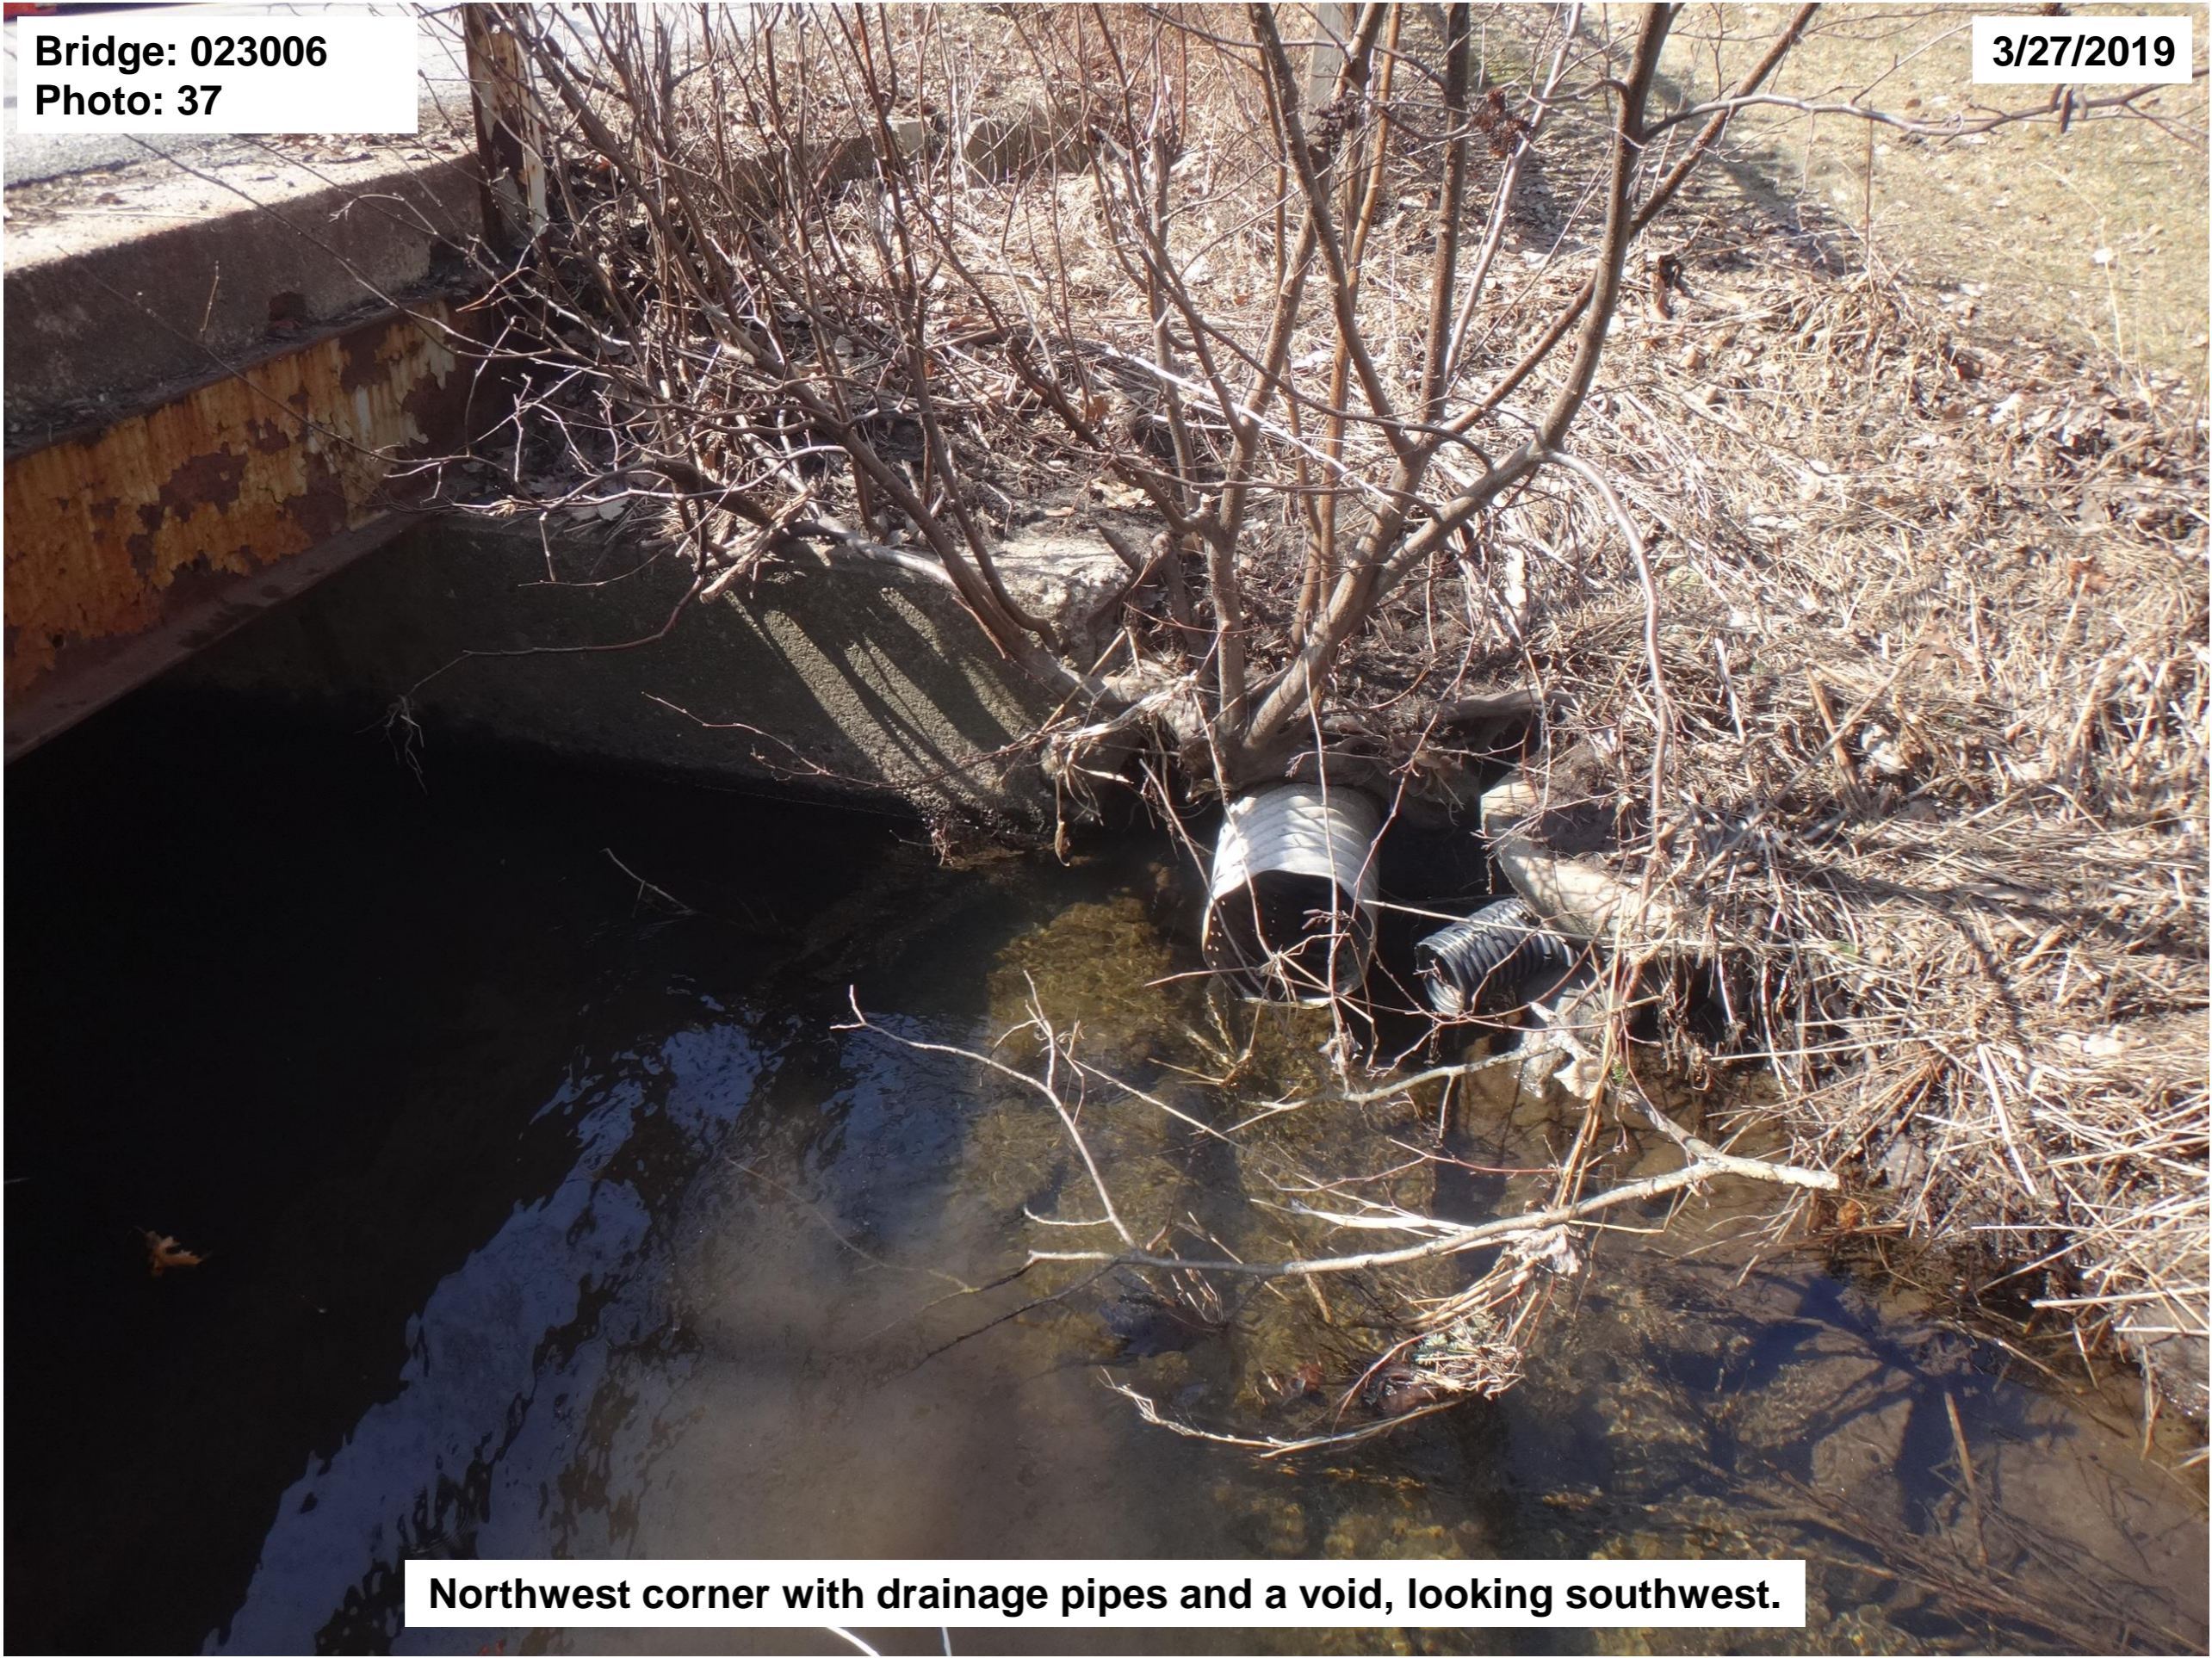
**TOWN OF CANTON  
 BRIDGE NO. 023006  
 OLD CANTON RD OVER RATTLESNAKE BROOK  
 ROUTINE AND IN-DEPTH INSPECTION  
 IMMEDIATE BRIDGE REPAIR ESTIMATE  
 MAY 2019**
